College of Micronesia - FSM Space Utilization and Facilities Master Plan Study, Part 3 - Detailed Report for the National Campus

Prepared for the College of Micronesia - FSM

Prepared by Beca International Consultants Ltd (Beca)

28 February 2014

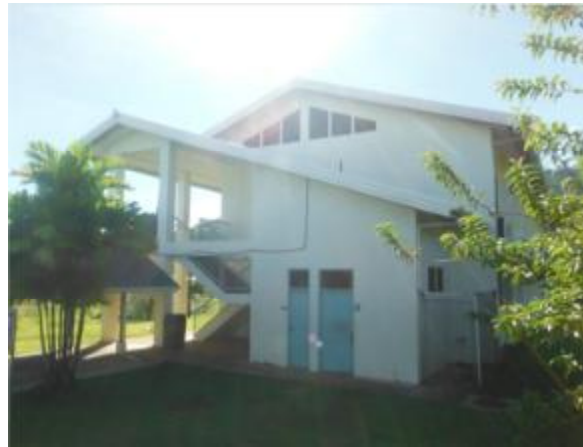
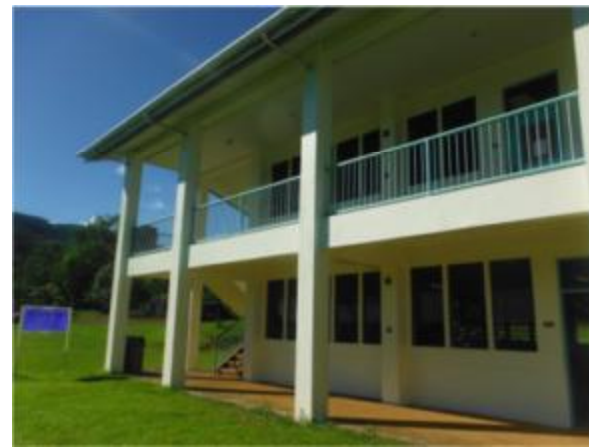
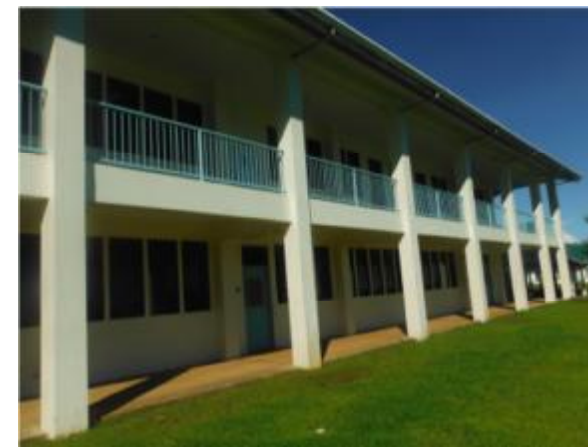
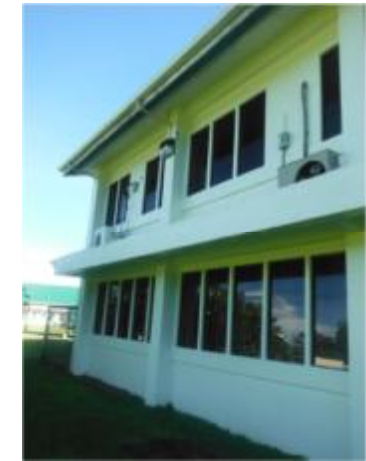
A – SPECIALIZED CLASSROOM

| Building | Outline |
|---|---|
| <p>Points to consider for future planning – look at options to create more floor space in the science store room for needed project space by using mobile shelving samples, references</p> | <p>Disabled access - not provided to the second floor</p> <p>Teaching spaces -</p> <p>Amenities, toilets - Toilets on the ground floor at each end of the building – 2 mens/ 2womens</p> <p>Building condition points -Targeted regular maintenance and cleaning to extend asset life. Treat rust and spot prime balustrades immediately. Re-paint roof immediately</p> <p>Building age – 17 years</p> |

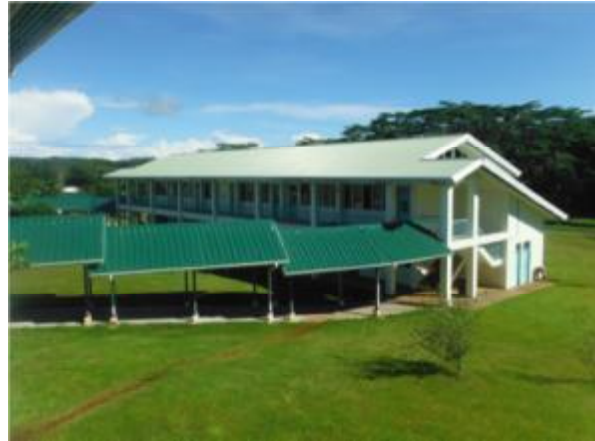
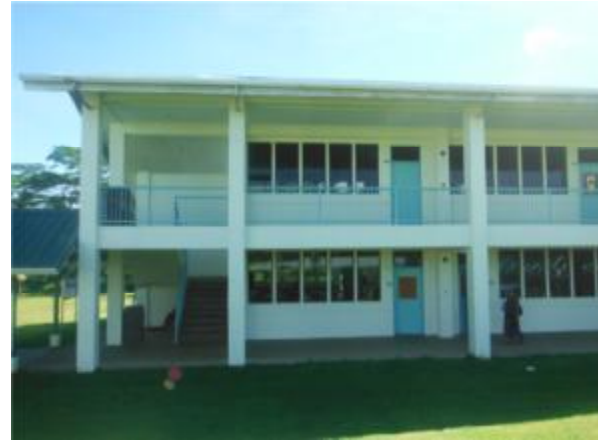
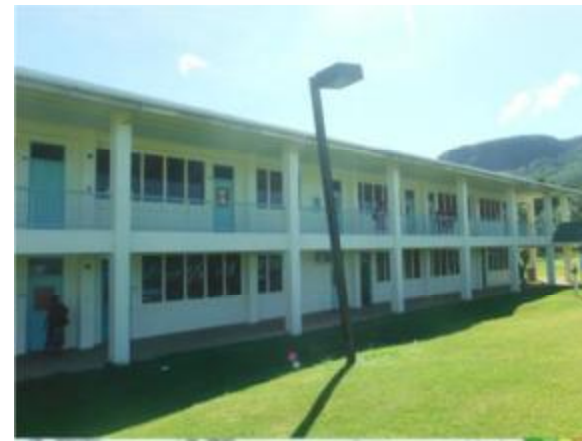
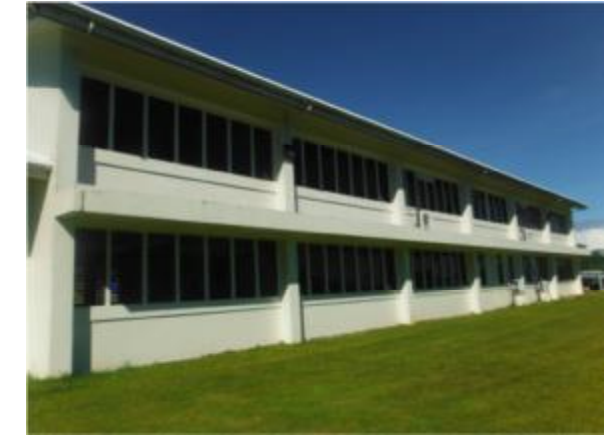
B – STANDARD CLASSROOMS

| Building | Outline |
|---|---|
| <p>B – Standard Classrooms</p> | <p>Building B is a two storey classroom</p> <p>Location for its function - Well located in the academic zone</p> <p>Quality and suitability of spaces for its function - Adequate space in the classrooms for the class sizes – a range of classroom layouts were observed from desks in rows to a semicircle layout</p> <p>Disabled access - not provided to the second floor</p> <p>Teaching spaces -</p> <p>Amenities, toilets - Toilets on the ground floor at each end of the building– 2 mens/ 2womens</p> <p>Building condition points - Evidence of a couple leaks to upper floor. Repaint roof immediately</p> <p>Building age -17 years</p> |

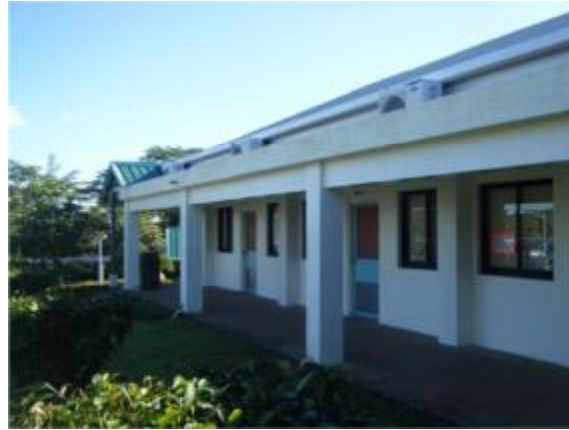
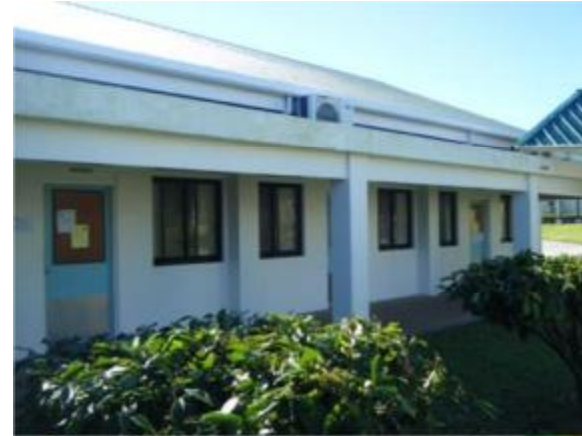
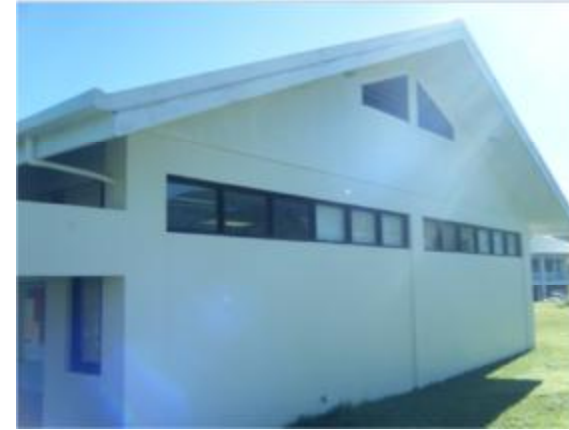
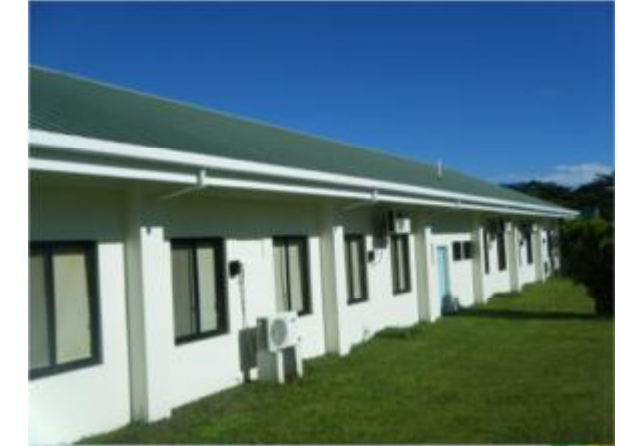
F - FACULTY OFFICE (OLD)

| Building | Outline |
|---|---|
| <p>Building F - Faculty Offices (old)</p> | <p>Building F is a faculty and administration building (Human Resources). It is broken down into seven individual spaces 600sqft in size. These are one lounge and six faculty spaces (400sqft of open office area and a 180sqft faculty head office)</p> <p>Location for its function – Located in a good location within the academic zone</p> <p>Quality and suitability of spaces for its function – Spaces allow for adaptation and function changes - The human resources team have moved into the previous Public Health faculty area in Fall 2013. More open spaces could be created by removing portion of the wall between rooms, also a change in furniture layout to long desks instead of angled desks would increase the number of people who could be accommodated. These spaces could also be converted to seminar rooms if required.</p> <p>Disabled access - Level access</p> <p>Teaching spaces - nil</p> <p>Amenities, toilets - toilets for faculty</p> <p>Building condition points - Evidence of damaged/marked/stained ceiling</p> <p>Tiles Air-Conditioning - DX/Split System Most not used, some not working Profiled Metal Sheet Roof Cladding (Pre-Finished) Evidence of faded paint – re-paint immediately</p> <p>Building age -17 years</p> |

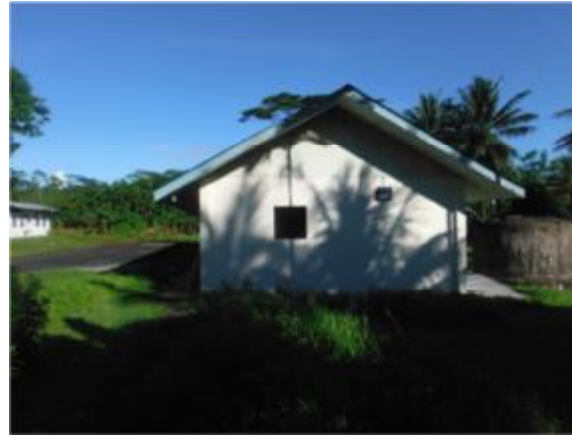
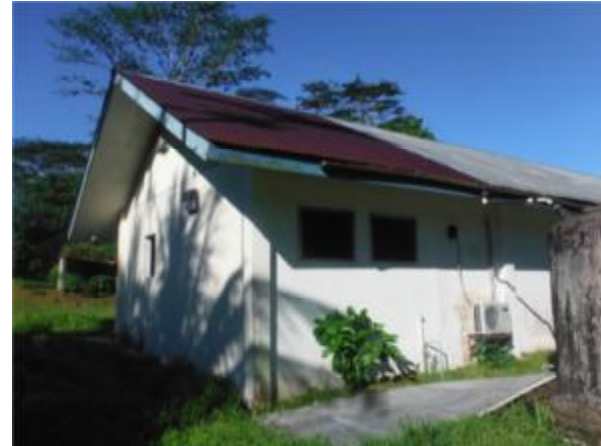
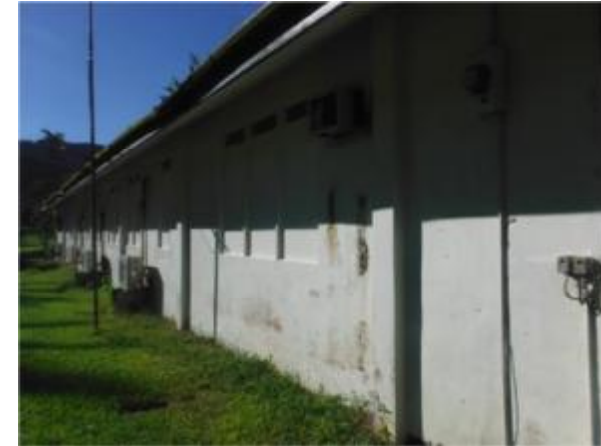
I - AGRICULTURE

| Building | Outline |
|--|---|
| <p>Building I – Agriculture</p> | <p>Building I is the Agriculture building</p> <p>Location for its function – Located adjacent to the agriculture area</p> <p>Quality and suitability of spaces for its function - Adequate</p> <p>Disabled access - level access</p> <p>Teaching spaces - one</p> <p>Amenities, toilets - 1mens/1women's</p> <p>Building condition points - Replace severely corroded sections of roof and missing/damaged gutters immediately. Review remainder of roof treat rust and roof or replace immediately. Treat borer damage to doors immediately</p> <p>Building age – 17 years</p> |

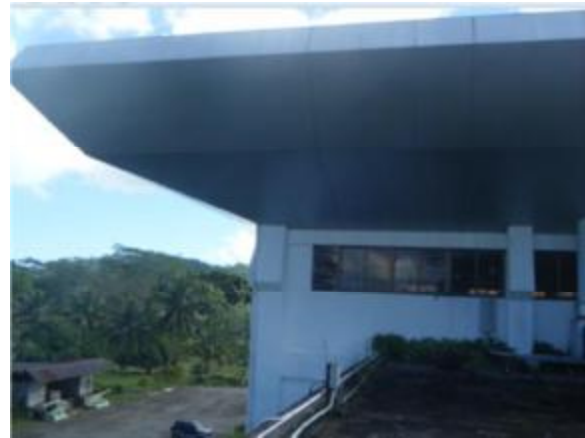
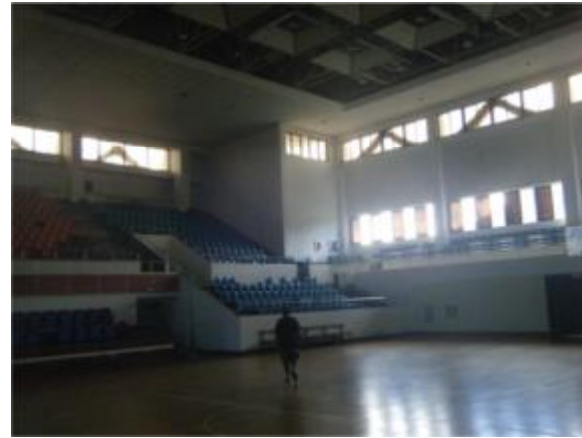
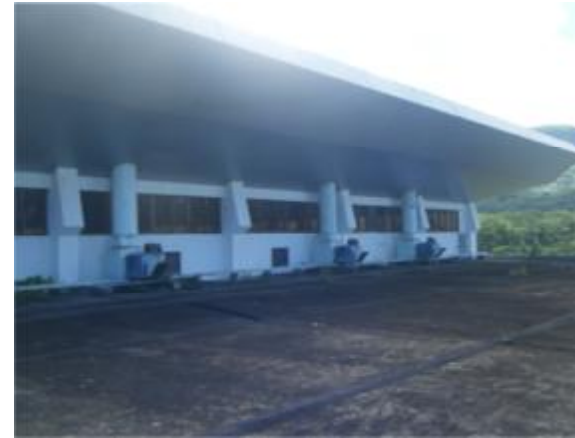
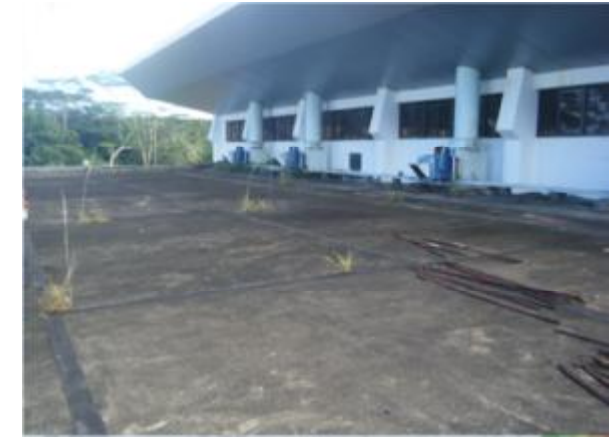
L – FSM – CHINA FRIENDSHIP SPORTS CENTER

1. China Friendship Sports Center. 31% of the operational costs are dedicated to this building which has a condition grade 4 highlighting that it is in poor condition and is showing signs of significant failure. Replacement windows (a health and safety issue) and the repair of leaks are required urgently. This asset needs specific funding to prevent deterioration and to extend its life.

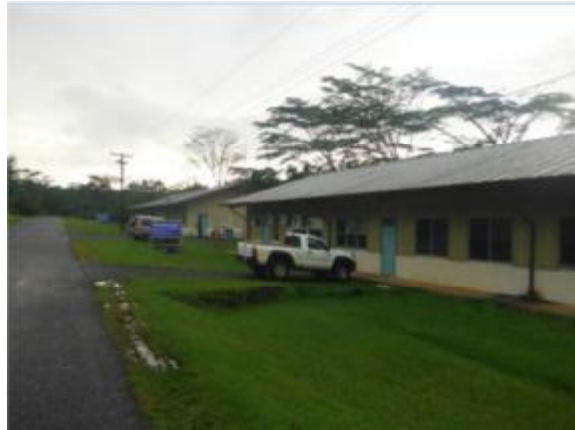
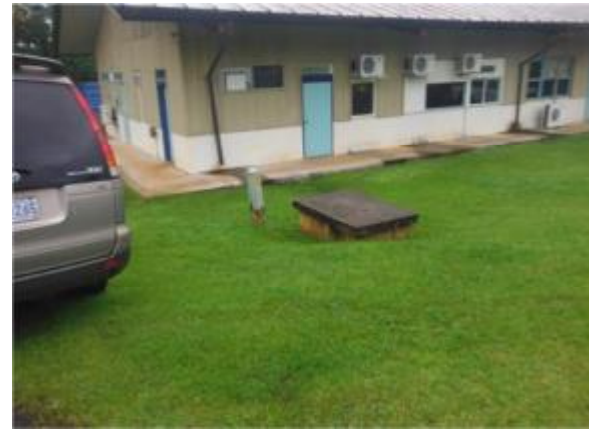
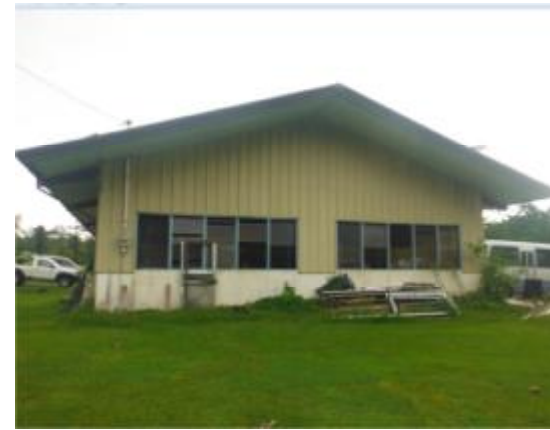
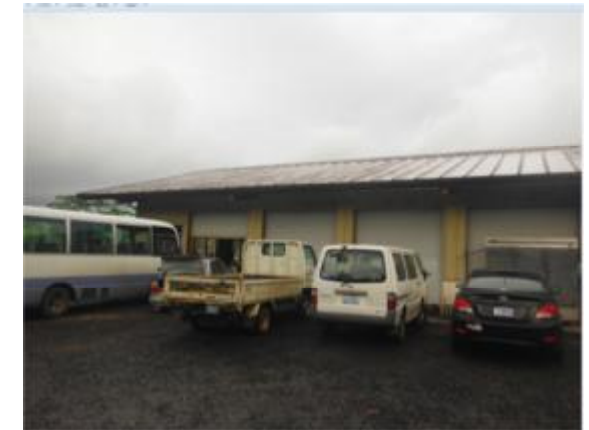
N - MAINTENANCE CRE, MUSIC CLASSROOM

| Building | Outline |
|--|---|
| <p>Building N – Maintenance, CRE, Music Classroom</p> | <p>Building N is the maintenance area, CRE and music room</p> <p>Location for its function – The music room seems disconnected from the rest of the campus - a location in the academic zone in a suitably acoustically treated space would seem more appropriate</p> <p>Quality and suitability of spaces for its function – Wide span building suits the maintenance function</p> <p>Disabled access - level access</p> <p>Teaching spaces - nil</p> <p>Amenities, toilets - 1 mens/ 1 womens</p> <p>Building condition points - Localized roof, gutter and soffit repairs or rust treatment required immediately</p> <p>Building age – 17 years, mid 1990s</p> |
