College of Micronesia - FSM Facilities Master Plan, Part 3 - Detailed Report for the Pohnpei Career and Technical Education Center

Prepared by Beca International Consultants Ltd (Beca)

28 February 2014

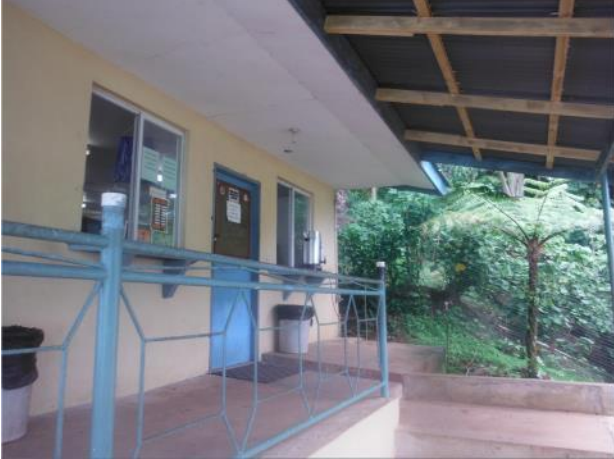
<p>B – Bookstore</p>

<p>Points to consider for future planning – Consider removal for ramp access at the high level.</p>	<p>Building B is the bookstore</p> <p>Location for its function – hard to access for deliveries</p> <p>Quality and suitability of spaces for its function – issues with termites compromises function</p> <p>Disabled access – nil (stairs)</p> <p>Teaching spaces - nil</p> <p>Amenities, toilets - nil</p> <p>Building condition points – Targeted regular maintenance and cleaning. Localised structural wall and frame repairs required.</p> <p>Building age – not available (more than 10 years)</p>

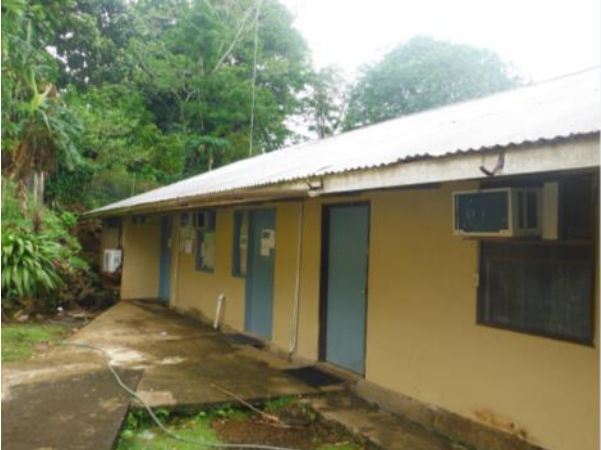
Building	Outline
<p>C – I.C. Building/ Electronics Classrooms</p>

<p>Points to consider for future planning – Consider removal.</p>	<p>Building C is the electronics classrooms and faculty rooms</p> <p>Location for its function – better closer to technology area</p> <p>Quality and suitability of spaces for its function – mezzanine area for faculty compromises cross ventilation</p> <p>Disabled access – needs to be reviewed for adequacy</p> <p>Teaching spaces - 2</p> <p>Amenities, toilets - nil</p> <p>Building condition points - Due to sub-standard foundations and evidence of structural cracking recommend building is demolished and replaced by 2018. In the interim carry out minimal maintenance (address any health and safety issues e.g. missing beam) only. Run asset down and demolish.</p> <p>Building age – not available</p>
<p>D – Classroom Building A</p>

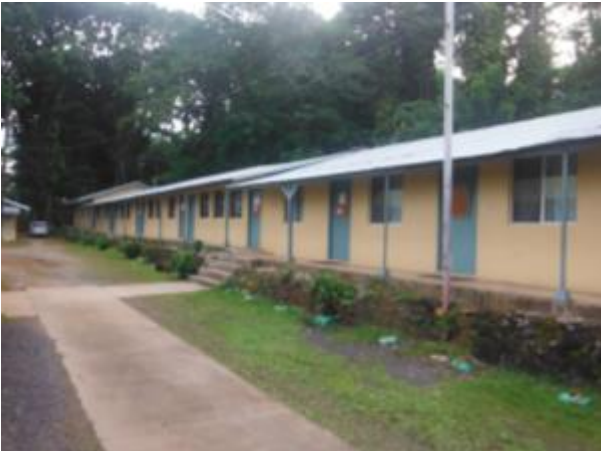
<p>Points to consider for future planning – Consider widening the walkway for pedestrian access and removal of the end of the building for through site vehicle access.</p>	<p>Building D is a long classroom block</p> <p>Location for its function – good location in the lower area</p> <p>Quality and suitability of spaces for its function – noise from the walkway is an issue as it is the main access way</p> <p>Disabled access - nil</p> <p>Teaching spaces - 5</p> <p>Amenities, toilets -2 urinals and 2 mens wc, 2 womens wc</p> <p>Building condition points - Targeted regular maintenance and cleaning. Repair roof, wall and window leaks and male WC immediately.</p> <p>Building age – not available</p>

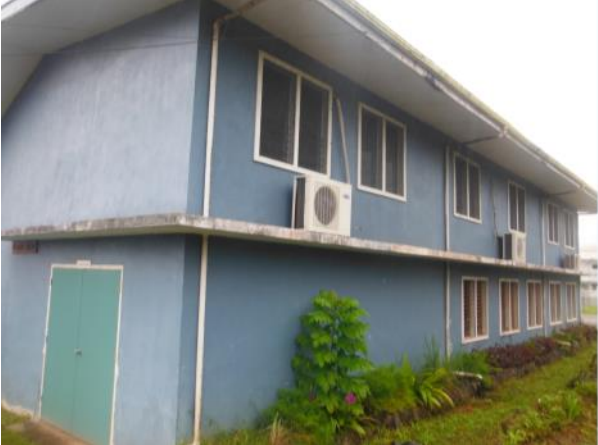
<p>Points to consider for future planning – Consider removal to release land for a specifically designed building.</p>	<p>Building F is the carpentry shop with a mezzanine carpentry classroom and workshop below</p> <p>Location for its function – well located next to the main road, more could be made of this location</p> <p>Quality and suitability of spaces for its function – needs to be larger in size for workshop space and storage</p> <p>Disabled access - nil</p> <p>Teaching spaces - 1</p> <p>Amenities, toilets - 2 wc</p> <p>Building condition points – Targeted regular maintenance and cleaning. Repair leaks and rot in soffits/ceilings and replace sections of gutter immediately.</p> <p>Building age – not available</p>

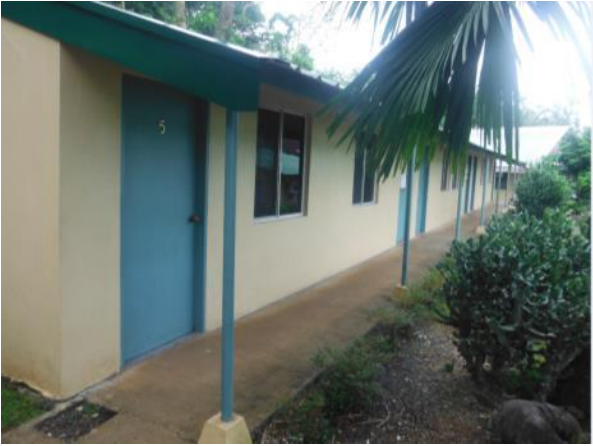
<p>Building J is the second dedicated classroom block on the site</p> <p>Location for its function – well located in the lower campus</p> <p>Quality and suitability of spaces for its function – adequate sized rooms</p> <p>Disabled access – difficult changes in level, no external ramps</p> <p>Teaching spaces - 3</p> <p>Amenities, toilets - nil</p> <p>Building condition points - Targeted regular maintenance and cleaning. Localised roof and frame repairs due to tree damage required.</p> <p>Building age – not available</p>

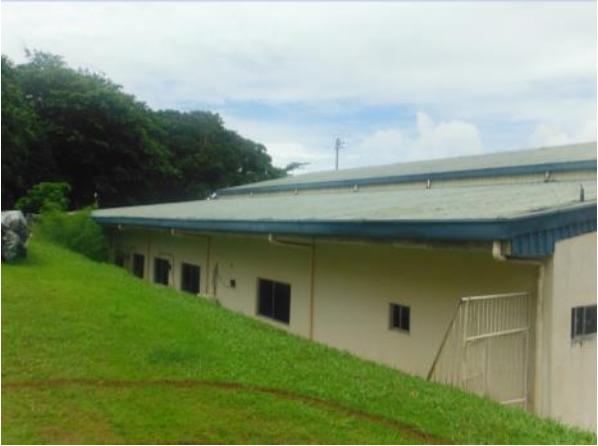
<p>Building L is the student services Center on the side of the gymnasium</p> <p>Location for its function –well located in close proximity to other student services</p> <p>Quality and suitability of spaces for its function – proximity to gymnasium limits space required for quiet study</p> <p>Disabled access – level access</p> <p>Teaching spaces - 1</p> <p>Amenities, toilets - 1 mens wc and 1 womens wc</p> <p>Building condition points – Targeted regular maintenance and cleaning. Repair leaks to Multipurpose room and treat/repair termite damage to doors.</p> <p>Building age – not available</p>
<p>M – Mechanic Shop</p>

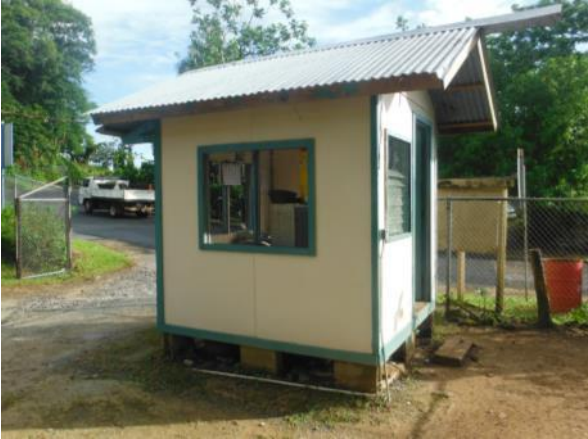
Building	Outline
<p>P – Security Shed</p>

<p>Building P is a security hut</p> <p>Location for its function – well located on site entry</p> <p>Quality and suitability of spaces for its function – acceptable size</p> <p>Disabled access - nil</p> <p>Teaching spaces - nil</p> <p>Amenities, toilets - nil</p> <p>Building condition points – Targeted regular maintenance and cleaning. Tie building to adequate foundations prior to next typhoon season. Repair water damage/decaying plywood linings immediately.</p> <p>Building age – not available</p>
<p>R – Maintenance Building</p>

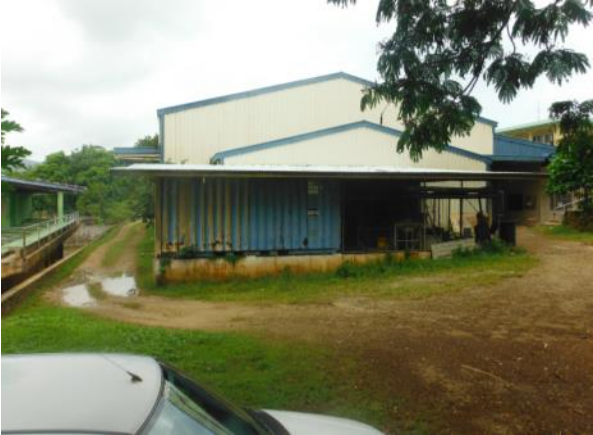
<p>Points to consider for future planning – Relocate maintenance to open up the gymnasium to viewing area out to the trees.</p>	<p>Building R is a container facility for the maintenance</p> <p>Location for its function – well located on the edge of the campus but adjacent to what could become a public area</p> <p>Quality and suitability of spaces for its function – adequate, location of function limits view for gymnasium adjacent</p> <p>Disabled access - nil</p> <p>Teaching spaces - nil</p> <p>Amenities, toilets - nil</p> <p>Building condition points – Targeted regular maintenance and cleaning. Localised repairs to metal roof and wall cladding and plywood cladding required immediately.</p> <p>Building age – not available</p>

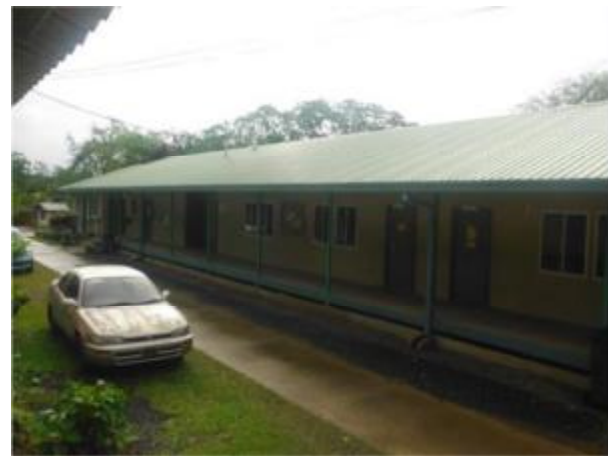
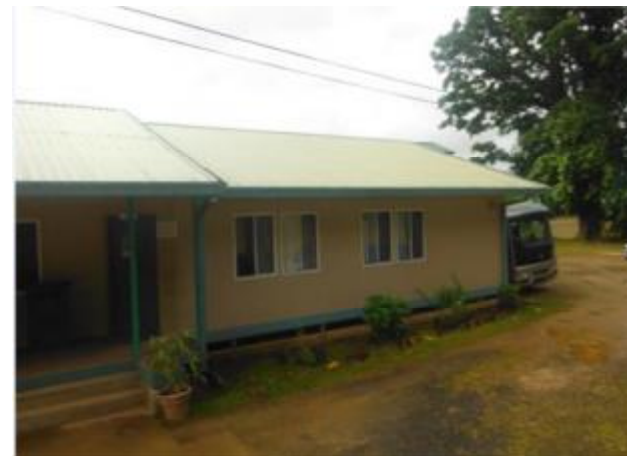
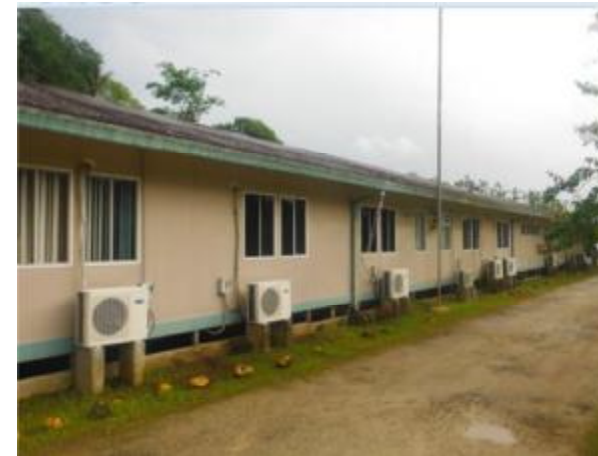
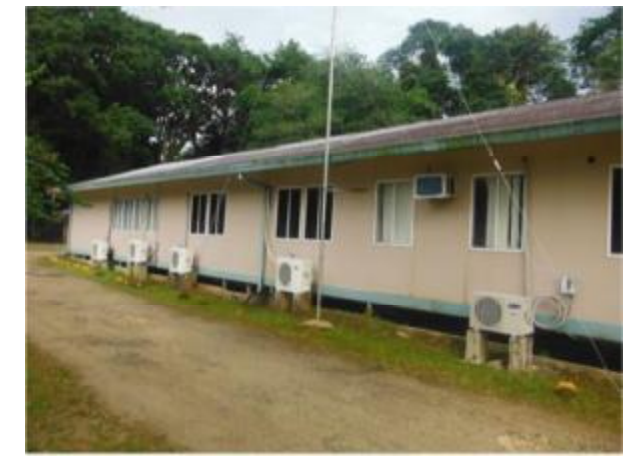
A - ADMINISTRATION BUILDING

1.00	Total Sub-Structure	3	50%						1,892	0	121,304	123,196	142,772	86.3%	Element Timber Floor Boards Severe decay of timber flooring present to outer edges of decking Structural Steel Frame Damaged perimeter edge beam to deck needs replacing Fibre Cement Cladding with Painted Finishes Evidence of decay and water damage at base of sheets and where penetrations not sealed adequately Timber Doors (Solid/No Glazing) Damaged door to computer lab Tiled Floor Finishes to toilets Some missing tiles, staining and cracked grout (say 20% of area) Overall Recommendation/Action Targeted regular maintenance and cleaning. Repair timber decking immediately (health and safety issue) and steel beam to deck. Repair decay and leaks in wall cladding immediately to extend asset life. Replace roof and refurbish external walls, windows and doors by 2023. Refurbish floor, wall and ceiling finishes and joinery fittings by 2023. Regularly maintain and replace mechanical and fire services by 2023.

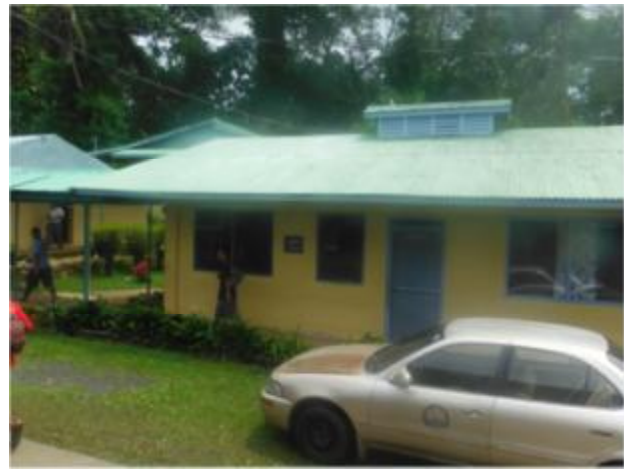
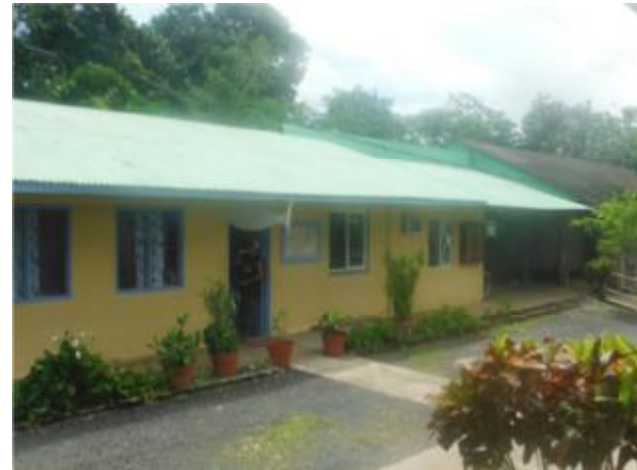
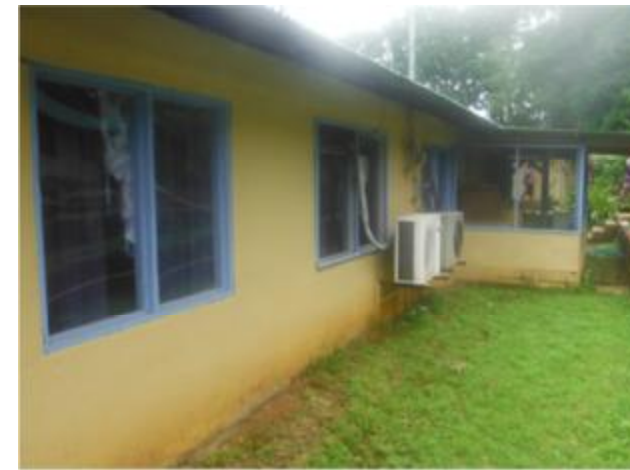
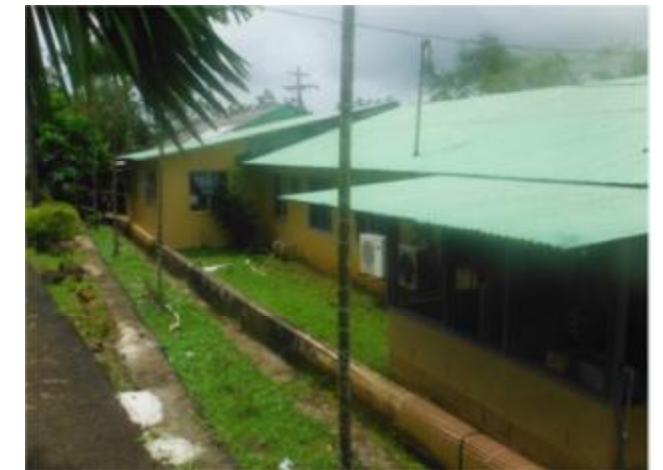
H – HOTEL AND TOURISM BUILDING

1.00	Total Sub-Structure	3	50%						0	0	0	0	95,720	0.0%	<p>TOP 5 MAJOR ELEMENTS REQUIRING URGENT MAINTENANCE, RENEWAL OR REPLACEMENT</p> <p>Element</p> <p>Observed Deterioration/Recommendations</p> <p>Timber Framed Windows & Doors -External Termite damage to sills and jambs to windows to café</p> <p>Ventilation - Wall/Ceiling mounted extract One broken unit to roof and one unit in wall not intended for mounting in an external wall</p> <p>Timber and Steel Frame (Portal/Truss/Steel Column/Timber Beams, etc.) Worn paint and wear and tear to steel column</p> <p>Solid Plaster Cladding with Painted Finishes Evidence of cracks and uneven plaster finish in several locations. Gaps and openings noticed around several window openings</p> <p>Flat Metal Sheet Wall Cladding to gas store Evidence of marks, staining, holes in cladding and impact damage to sheets. Exposed steel where bent and not painted at joins</p> <p>Overall Recommendation/Action Targeted regular maintenance and cleaning. Repair termite damage to windows immediately. Replace external windows and doors by 2023. Refurbish floor finishes by 2023. Regularly maintain and replace mechanical, fire and special services by 2023</p>

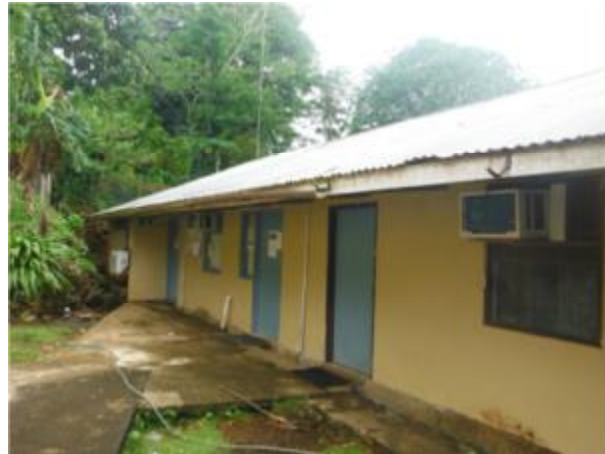
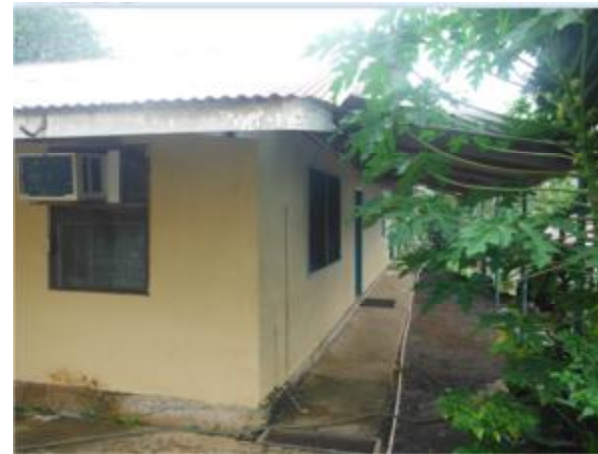
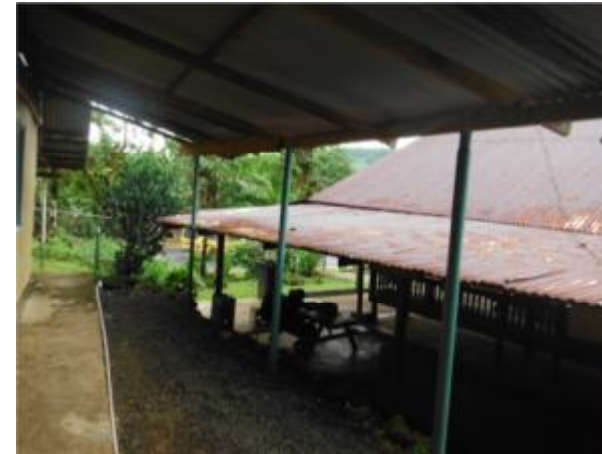
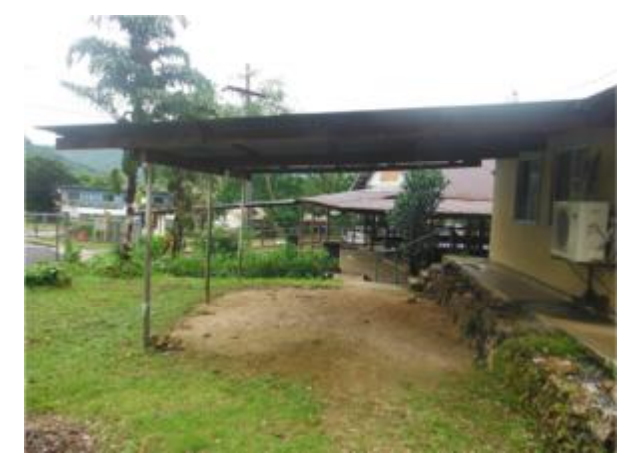
C – I.C BUILDING

1.00	Total Sub-Structure	5	90%						86,844	0	0	86,844	86,844	100.0%	Substructure, Foundations and Structural Walls	No proper foundation has been constructed (bricks laid over an old foundation). A beam is missing, cracking in walls. Provide temporary support (health & safety issue). Demolish and replace asset.

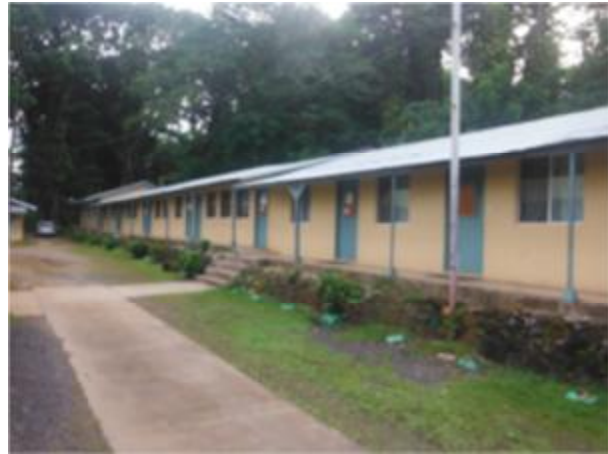
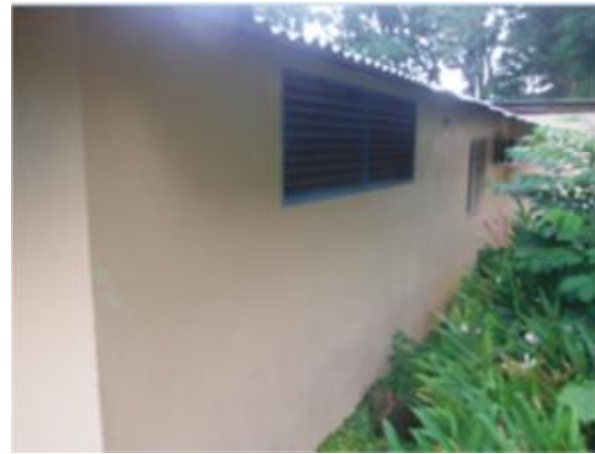
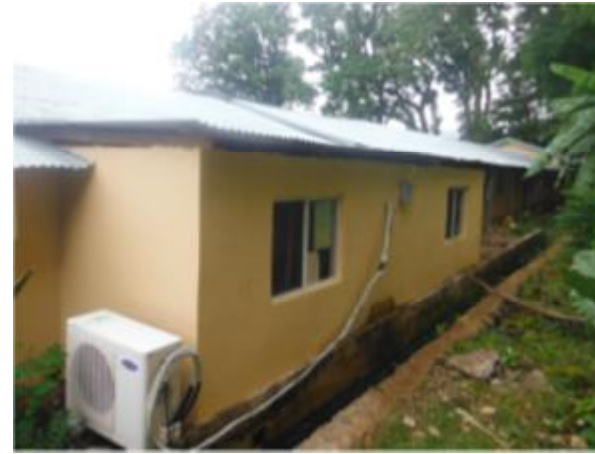
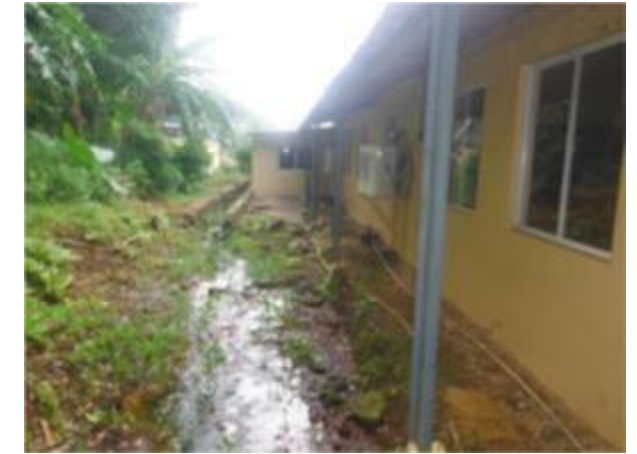
D - CLASSROOM BUILDING A

1.00	Total Sub-Structure	3	50%						0	0	0	0	210,729	0.0%	<p>TOP 5 MAJOR ELEMENTS REQUIRING URGENT MAINTENANCE, RENEWAL OR REPLACEMENT</p> <p>Element</p> <p>Profiled Metal Sheet Roof Cladding (Pre-Finished) Evidence of leaks, corrosion, flaking of protective paint and holes in sheets evident on walkway. Evidence of sag in one location</p> <p>Vinyl Floor Finishes Staining, lifting, marks, impact damage, tear and missing vinyl parts</p> <p>Tiled Floor Finishes Impact damage, loose grout, marks and lifting tiles</p> <p>WC Out of order toilet to male WC</p> <p>Solid Plaster Wall Lining with Painted Finishes Evidence of cracking especially along top of walls and around window and door openings evident. Impact damage, water damage and marks also evident</p> <p>Overall Recommendation/Action Targeted regular maintenance and cleaning. Repair roof, wall and window leaks and male WC immediately. Replace roof by 2023. Refurbish floor and wall finishes by 2023. Regularly maintain and replace sanitary plumbing, mechanical and special services by 2023</p>
