College of Micronesia - FSM Space Utilization and Facilities Master Plan Study, Part 3 - Detailed Report for the Yap Campus

Prepared for the College of Micronesia - FSM

Prepared by Beca International Consultants Ltd (Beca)

28 February 2014

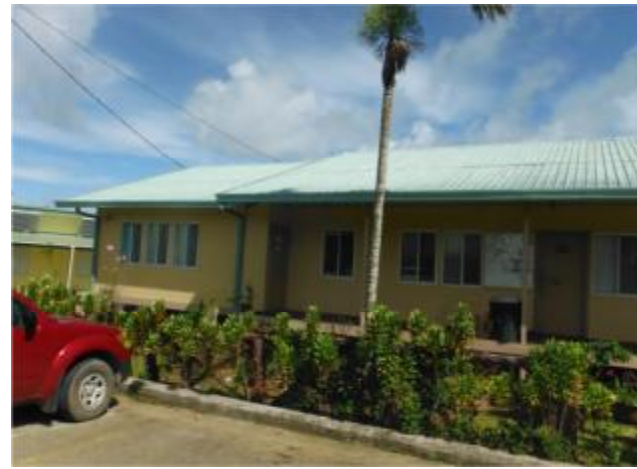
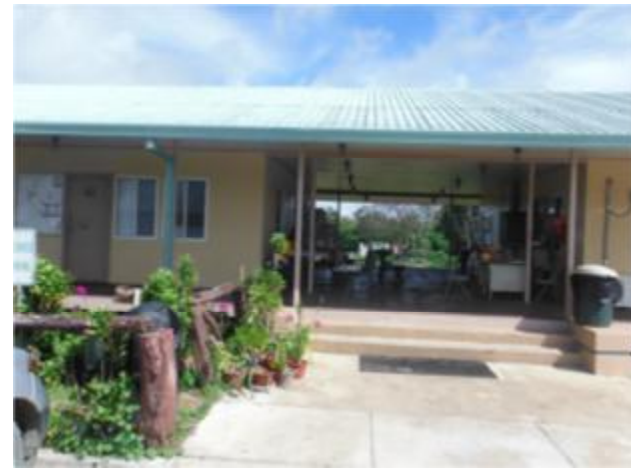
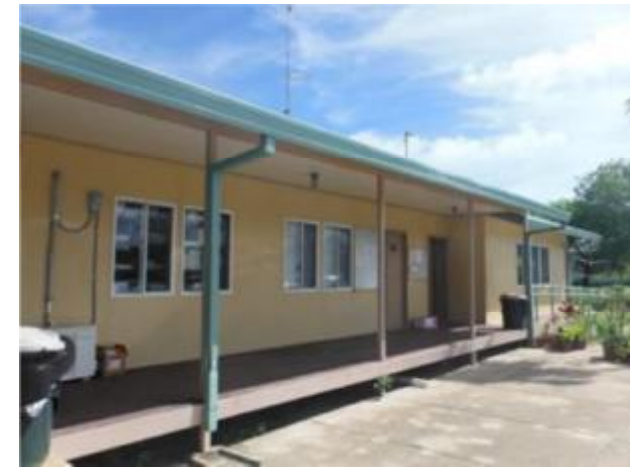
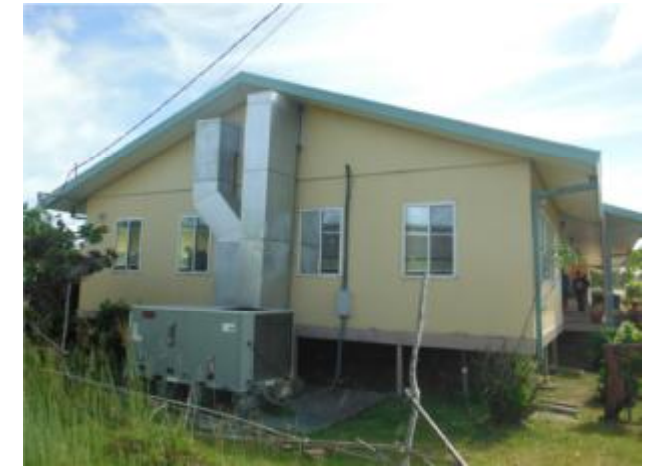
A – ADMINISTRATION BUILDING

1. Building A – Administration Building. The severe corrosion of the steel substructure and decay in the timber flooring makes this building, in our opinion, uneconomic to renew and maintain. We consider that minimum operational costs should be spent on this asset (i.e. carry out protection /health and safety remedial works only) and that the asset should be run-down and replaced in 2018 or before.

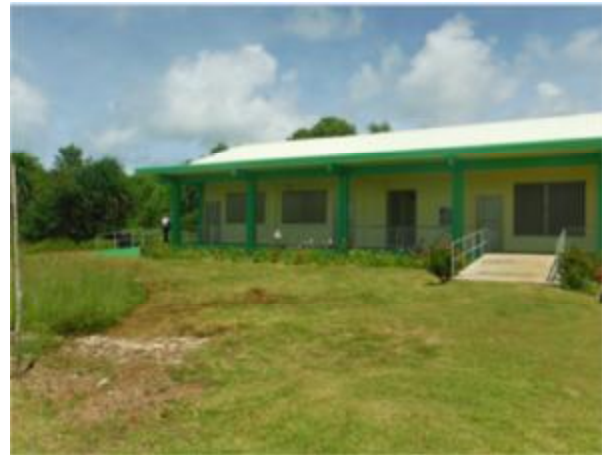
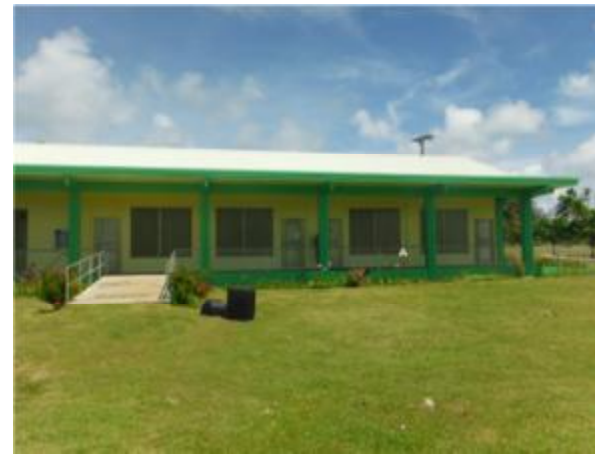
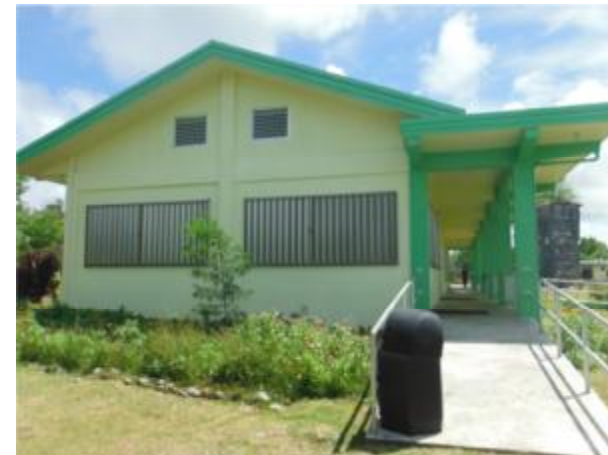
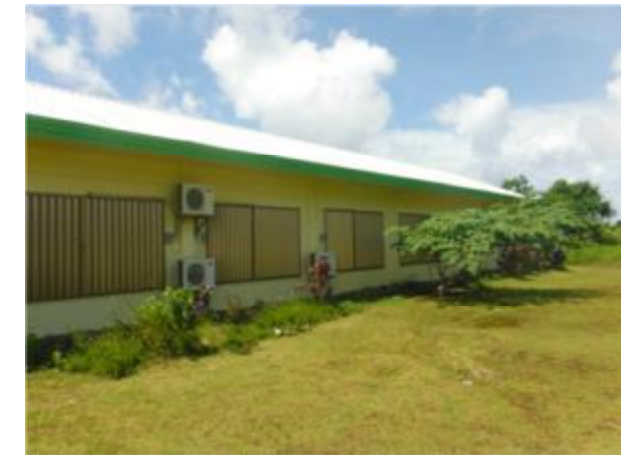
D - SCIENCE LABORATORY

1.00	Total Sub-Structure	1	10%						0	0	0	0	90,492	0.0%	Element Metal Doors (Security Gate) Reinforced Concrete Slab on Grade Insitu Reinforced Concrete Ramp Metal Framed Balustrades Tiled Floor Finishes Overall Recommendation/Action	Observed Deterioration/Recommendations Evidence of corrosion on hinge and lock. Evidence of crazed/shrinkage cracking on walkway Evidence of crazed/shrinkage cracking on walkway Evidence of flaking protective coating or corrosion Evidence of lifting, marks, tears, worn through Targeted regular maintenance and cleaning. Review paint on metal balustrades and repaint if corroded. Regularly maintain and replace mechanical and fire services by 2023.

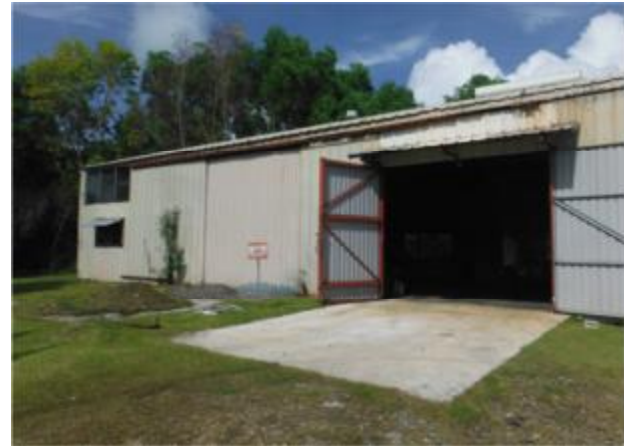
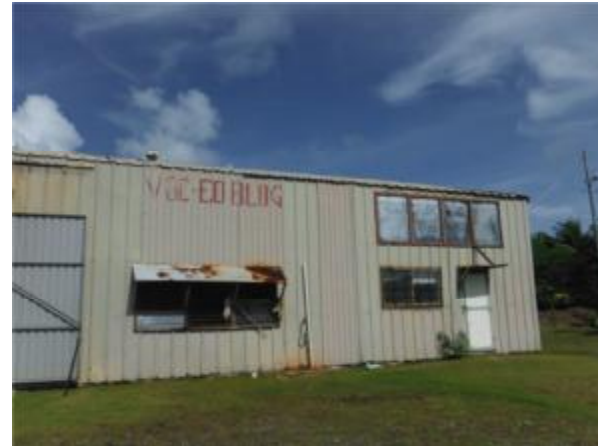
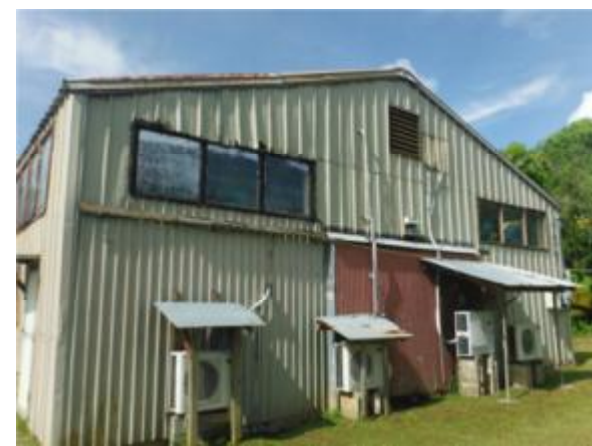
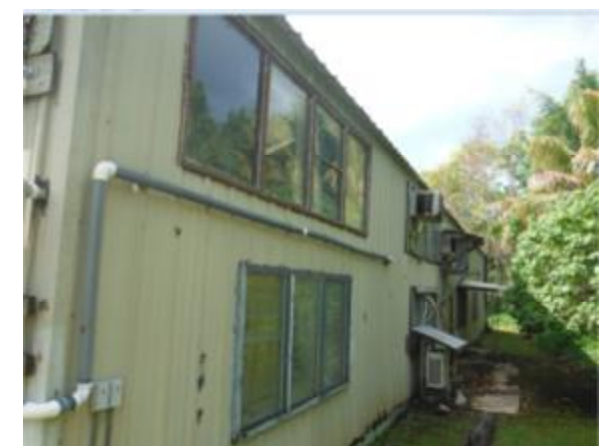
G - VOCATIONAL BUILDING

2. Building G – Vocational Building has very high renewal and maintenance costs over the next 30 years (40% of Yap Year 1-10 renewal budget and 96% of full replacement cost over 30 years). In our view this building is uneconomic to renew and maintain. We consider that minimum operational costs should be spent on this asset (with the exception of any protection /health and safety remedial works) and that the asset should be run-down and replaced in 2018 or before.
