College of Micronesia - FSM Space Utilization and Facilities Master Plan Study, Part 3 - Detailed Report for the Kosrae Campus

Prepared for the College of Micronesia - FSM

Prepared by Beca International Consultants Ltd (Beca)

28 November 2013

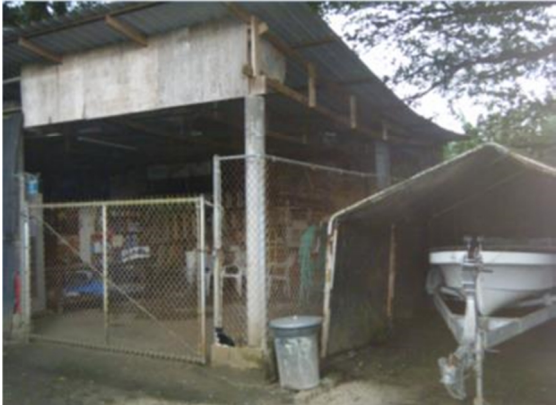
Building	Outline
<p>F – Maintenance Shop</p>

<p>Points to consider for future planning – Consider a similar location in the long term, potentially further towards the entry and combined with security</p>	<p>Building F is an open area maintenance shop</p> <p>Location for its function – Located on the boundary behind the KSDBC, good location away from the academic zone</p> <p>Quality and suitability of spaces for its function -</p> <p>Building condition points - Asset is run-down but is functioning as intended. We are uncertain about the condition of the substructure and this needs monitoring. Consider strengthening/propping to roof trusses. Maintain as necessary for building to function. Review in 2018</p> <p>Building age -2004 , 8 years, partially repainted in 2007</p>
<p>G – Maintenance Office</p>

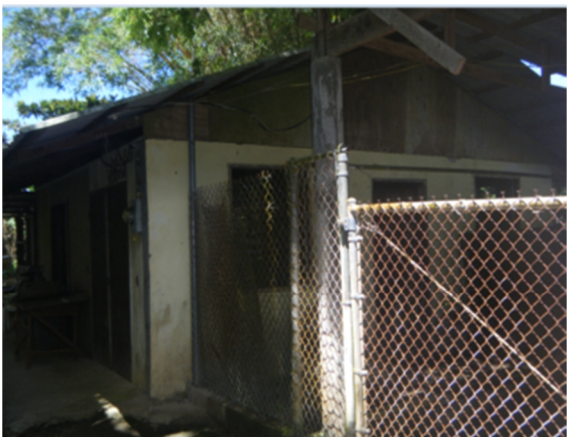
<p>Points to consider for future planning – Consider a similar location in the long term, potentially further towards the entry and combined with security</p>	<p>Building G is the maintenance office</p> <p>Location for its function - Located on the boundary behind the KSDBC, good location away from the academic zone</p> <p>Quality and suitability of spaces for its function – Adequate spatially but could have more permanent structure</p> <p>Building condition points - Targeted regular maintenance and cleaning. Repair exposed reinforcing and concrete spalling immediately</p> <p>Building age – 2004 , 8 years old, partially repainted 2007</p>

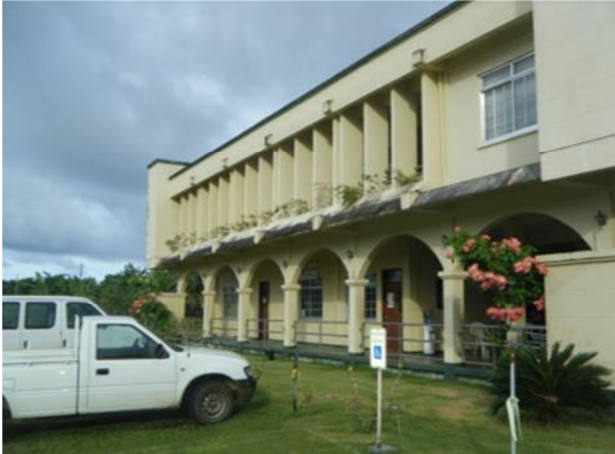
Building	Outline
<p>H – KSBDC Building</p>

<p>Points to consider for future planning – Consider space around the building - formalise car parking paths to entries</p>	<p>Building H is the Kosrae Small Business Development Centre. COM-FSM occupies the second floor with two classrooms, a meeting room seating up to 10 people and the instructional coordinator. Toilets are provided on the ground floor.</p> <p>Location for its function – Community facilities on one edge of the campus co located with CRE - Extension</p> <p>Quality and suitability of spaces for its function - Adequate</p> <p>Disabled access - No lift provided</p> <p>Teaching spaces – Two teaching spaces</p> <p>Amenities, toilets - Toilets on the ground floor, 2 male, 2 female</p> <p>Building condition points - Targeted regular maintenance and cleaning. Review waterproofing (some leaks observed) and repair immediately. Replace roof by 2023.</p> <p>Building age – 2007, 5 years, not yet repainted</p>

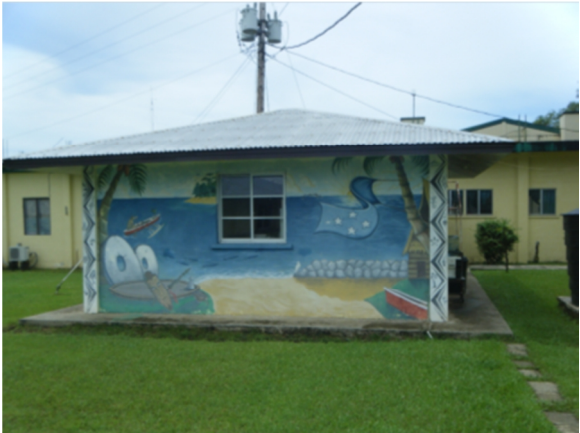
<p>I - Bookstore</p>

<p>Points to consider for future planning – Remove building in the medium term (within 10 years) or consider a retrofit into an open sided computer recharge station and study area</p>	<p>Building I is the Bookstore</p> <p>Location for its function – Located in the academic zone</p> <p>Quality and suitability of spaces for its function – More storage is a requirement as well as space for both fiscal office and bookstore functions</p> <p>Disabled access - nil</p> <p>Teaching spaces - nil</p> <p>Amenities, toilets -nil</p> <p>Building condition points - Generally cladding and linings require repair</p> <p>Building age -2007, 5 years old, repainted 2010 and 2012</p>

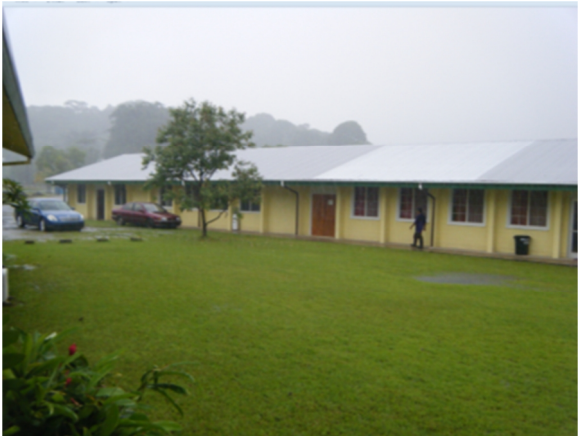
Building	Outline
<p>J - Learning Resources and Career Development</p>

<p>Points to consider for future planning – Building can be retrofitted for a range of functions including offices</p>	<p>Building J is has the following rooms – carpentry shop, maths/ electronic classroom, electronic repair shop, electronics classroom, computer lab, library study area. Three further rooms at the eastern end of the block are a Dept. of Ed Dressmaking classroom, agricultural and food tech classroom and an AHEC office</p> <p>Location for its function – In the centre of the academic zone</p> <p>Quality and suitability of spaces for its function – Teaching spaces are a good size/ shape. The Learning Resource Centre layout is a good configuration with access to the library off the computer lab area</p> <p>Disabled access - Level access, narrow walkway with uncovered drain and edge drop off is not ideal for accessible access</p> <p>Teaching spaces – 2 classrooms, 2 seminar sized spaces</p> <p>Amenities, toilets - adjacent toilet building</p> <p>Building condition points - No significant issues</p> <p>Building age - Built 1980 - 32 years old, renovated 2010 and 2012</p>

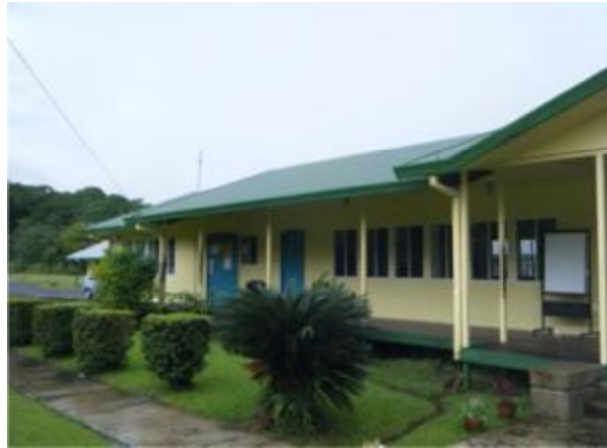
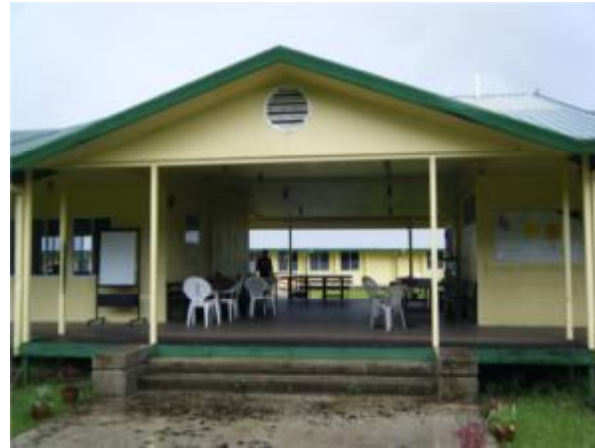
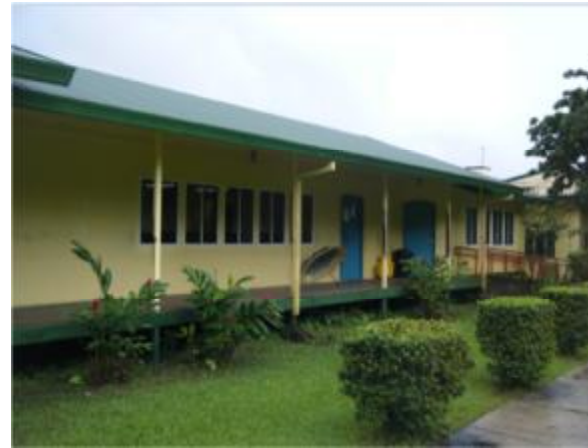
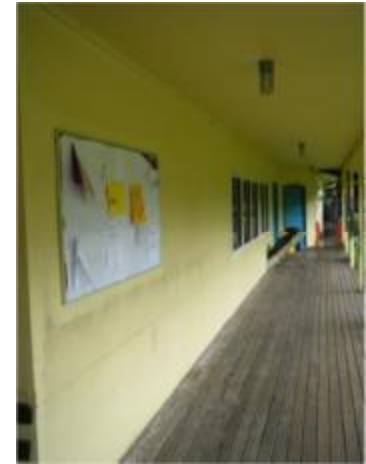
A – ADMINISTRATION BUILDING/CLASSROOMS

1.00	Total Sub-Structure	4	70%						33,990	0	56,038	90,028	119,517	75.3%		
2.00	Total Frame	3	50%						0	0	0	0	107,409	0.0%	Steel Framed Floor on Steel Pile Foundations	Severe corrosion present and virtually disconnected at base as rusted through

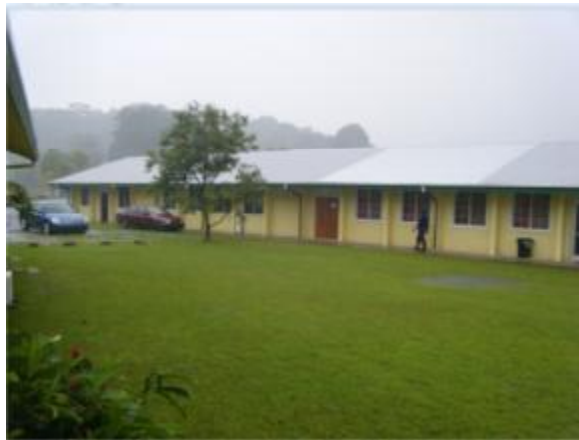
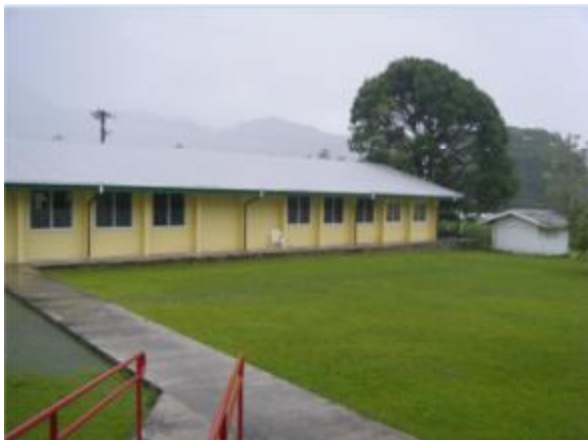
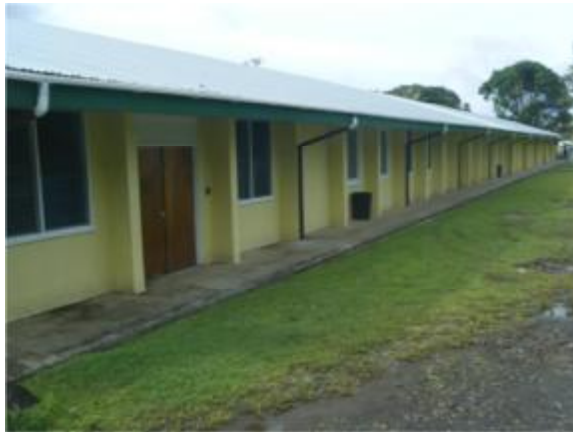
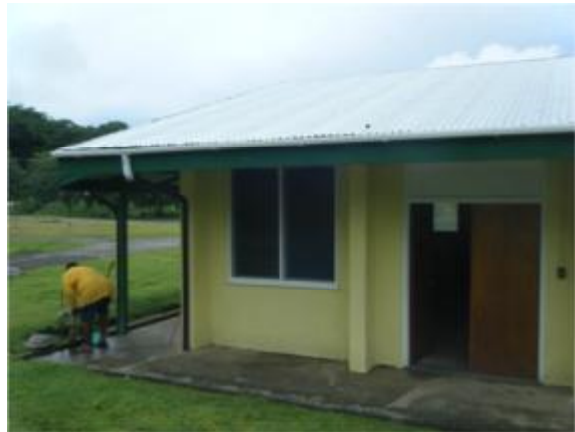
J – LEARNING RESOURCES AND CAREER DEVELOPMENT

1.00	Total Sub-Structure	2	30%						0	0	0	0	254,389	0.0%
2.00	Total Frame	2	30%						0	0	0	0	11,696	0.0%
3.00	Total Structural Walls	2	30%						0	0	0	0	175,454	0.0%

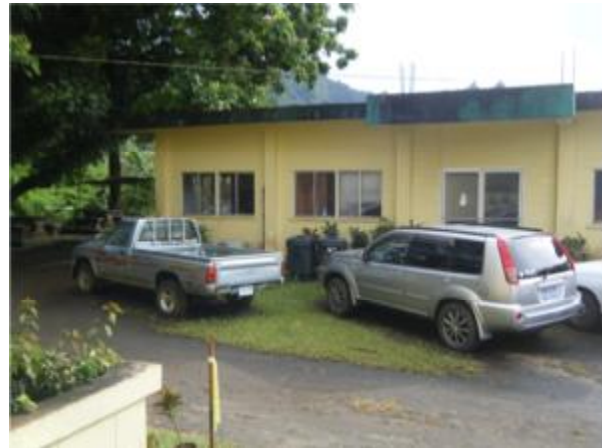
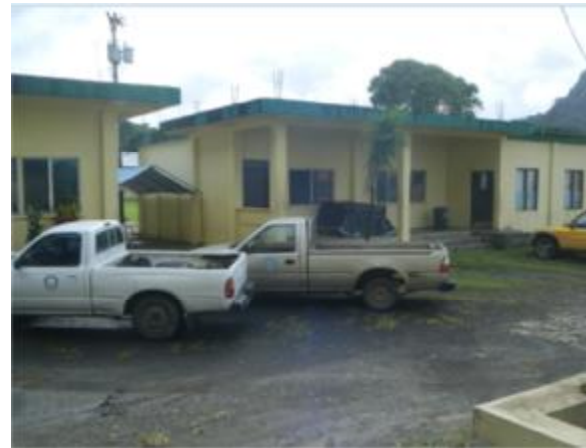
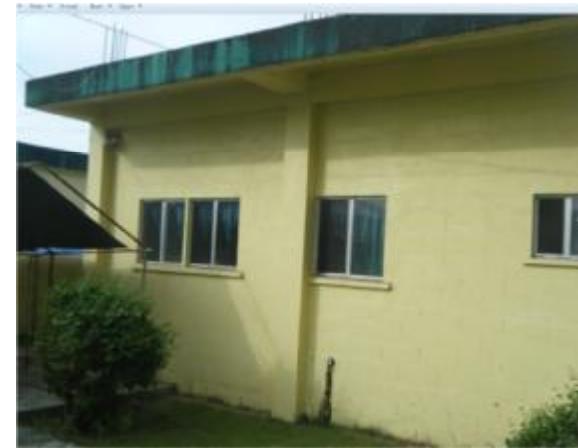
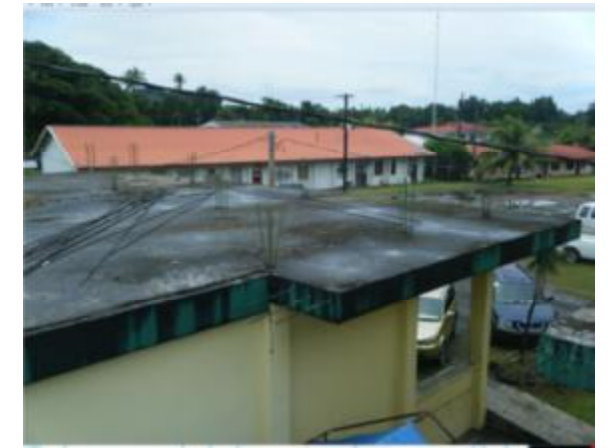
B - LAND GRANT BUILDING

1.00	Total Sub-Structure	3	50%						0	0	0	0	69,634	Element	Observed Deterioration/Recommendations
2.00	Total Frame	3	50%						0	0	0	0	73,488		
3.00	Total Structural Walls	3	50%						0	0	0	0	45,000	Reinforced Concrete Roof	Evidence of cracking, ponding of water and unprotected reinforcing
