# College of Micronesia - FSM Facilities Master Plan, Part 3 - Detailed Report for the Pohnpei Career and Technical Education Center

Prepared for the College of Micronesia - FSM

Prepared by Beca International Consultants Ltd (Beca)

28 November 2013

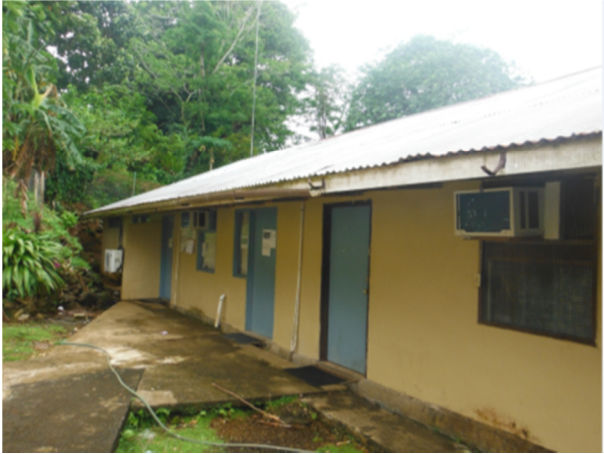
Building	Outline
<p><b>C – I.C. Building/ Electronics Classrooms</b></p>

<p><b>Points to consider for future planning –</b> Consider removal.</p>	<p>Building C is the electronics classrooms and faculty rooms</p> <p>Location for its function – better closer to technology area</p> <p>Quality and suitability of spaces for its function – mezzanine area for faculty compromises cross ventilation</p> <p>Disabled access – needs to be reviewed for adequacy</p> <p>Teaching spaces - 2</p> <p>Amenities, toilets - nil</p> <p>Building condition points - Due to sub-standard foundations and evidence of structural cracking recommend building is demolished and replaced by 2018. In the interim carry out minimal maintenance (address any health and safety issues e.g. missing beam) only. Run asset down and demolish.</p> <p>Building age – not available</p>
<p><b>D – Classroom Building A</b></p>

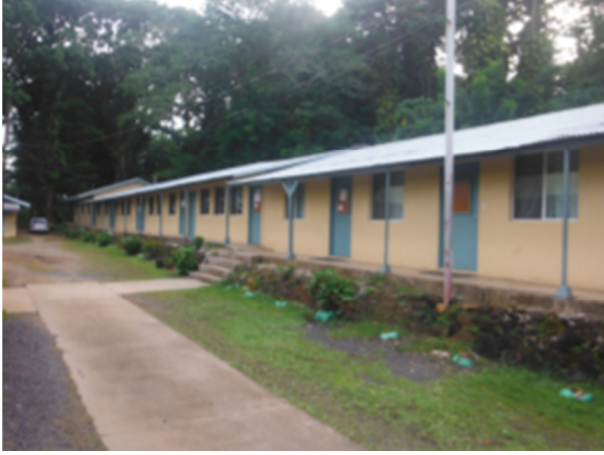
<p><b>Points to consider for future planning –</b> Consider widening the walkway for pedestrian access and removal of the end of the building for through site vehicle access.</p>	<p>Building D is a long classroom block</p> <p>Location for its function – good location in the lower area</p> <p>Quality and suitability of spaces for its function – noise from the walkway is an issue as it is the main access way</p> <p>Disabled access - nil</p> <p>Teaching spaces - 5</p> <p>Amenities, toilets -2 urinals and 2 mens wc, 2 womens wc</p> <p>Building condition points - Targeted regular maintenance and cleaning. Repair roof, wall and window leaks and male WC immediately.</p> <p>Building age – not available</p>

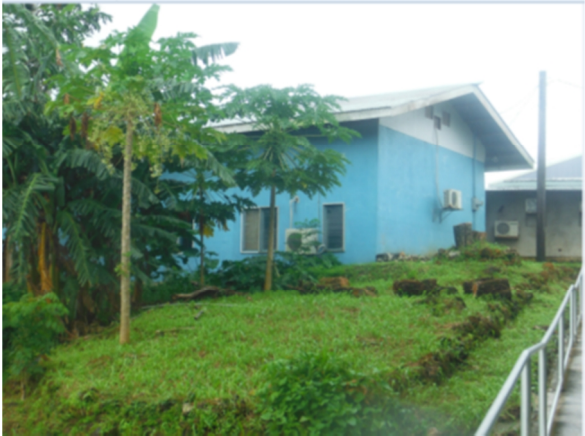
Building	Outline
<p><b>E – Electrical Building</b></p>

<p><b>Points to consider for future planning –</b> Consider removal to provide through site access.</p>	<p>Building E is used for electrical instruction.</p> <p>Location for its function – located close to the other instructional facilities</p> <p>Quality and suitability of spaces for its function -</p> <p>Disabled access - nil</p> <p>Teaching spaces - one</p> <p>Amenities, toilets - nil</p> <p>Building condition points – Targeted regular maintenance and cleaning. Localised repairs to foundation walls, solid plaster walls and vinyl flooring required. Localised electrical maintenance required.</p> <p>Building age – not available</p>
<p><b>F – Carpentry Shop</b></p>

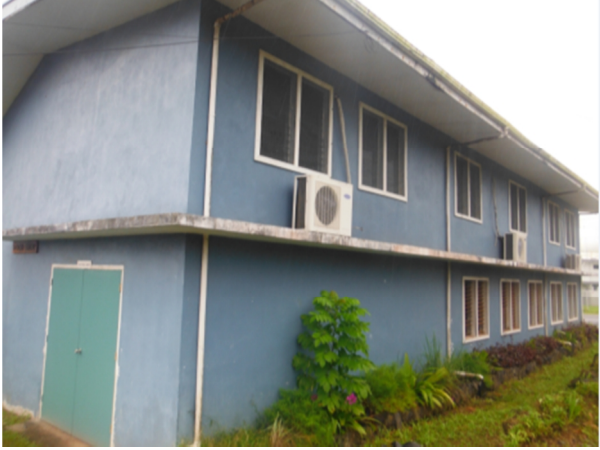
<p><b>Points to consider for future planning –</b> Consider removal to release land for a specifically designed building.</p>	<p>Building F is the carpentry shop with a mezzanine carpentry classroom and workshop below</p> <p>Location for its function – well located next to the main road, more could be made of this location</p> <p>Quality and suitability of spaces for its function – needs to be larger in size for workshop space and storage</p> <p>Disabled access - nil</p> <p>Teaching spaces - 1</p> <p>Amenities, toilets - 2 wc</p> <p>Building condition points – Targeted regular maintenance and cleaning. Repair leaks and rot in soffits/ceilings and replace sections of gutter immediately.</p> <p>Building age – not available</p>

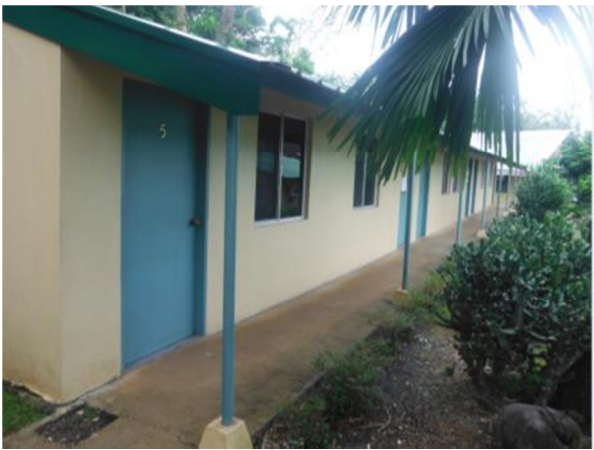
<p>Building J is the second dedicated classroom block on the site</p> <p>Location for its function – well located in the lower campus</p> <p>Quality and suitability of spaces for its function – adequate sized rooms</p> <p>Disabled access – difficult changes in level, no external ramps</p> <p>Teaching spaces - 3</p> <p>Amenities, toilets - nil</p> <p>Building condition points - Targeted regular maintenance and cleaning. Localised roof and frame repairs due to tree damage required.</p> <p>Building age – not available</p>

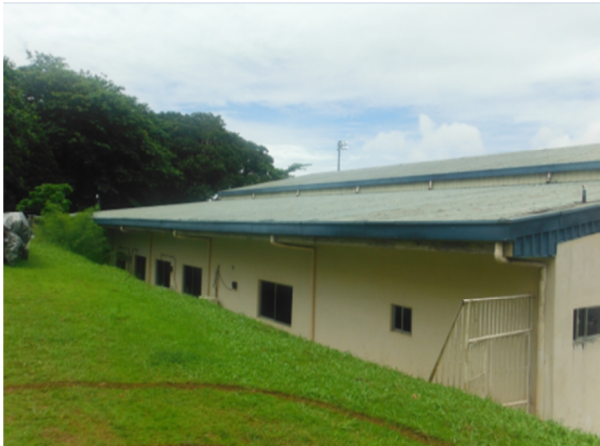
Building	Outline
	Building age – not available
<p><b>L – Student Services Center</b></p>

<p>Building L is the student services centre on the side of the gymnasium</p> <p>Location for its function –well located in close proximity to other student services</p> <p>Quality and suitability of spaces for its function – proximity to gymnasium limits space required for quiet study</p> <p>Disabled access – level access</p> <p>Teaching spaces - 1</p> <p>Amenities, toilets - 1 mens wc and 1 womens wc</p> <p>Building condition points – Targeted regular maintenance and cleaning. Repair leaks to Multipurpose room and treat/repair termite damage to doors.</p> <p>Building age – not available</p>
<p><b>M – Mechanic Shop</b></p>

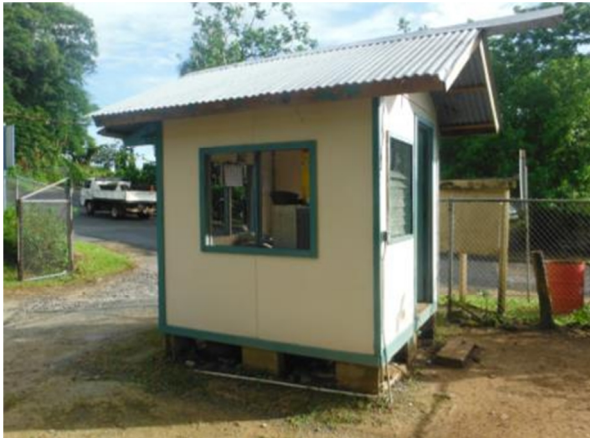
Building	Outline
<p><b>P – Security Shed</b></p>

<p>Building P is a security hut</p> <p>Location for its function – well located on site entry</p> <p>Quality and suitability of spaces for its function – acceptable size</p> <p>Disabled access - nil</p> <p>Teaching spaces - nil</p> <p>Amenities, toilets - nil</p> <p>Building condition points – Targeted regular maintenance and cleaning. Tie building to adequate foundations prior to next typhoon season. Repair water damage/decaying plywood linings immediately.</p> <p>Building age – not available</p>
<p><b>R – Maintenance Building</b></p>

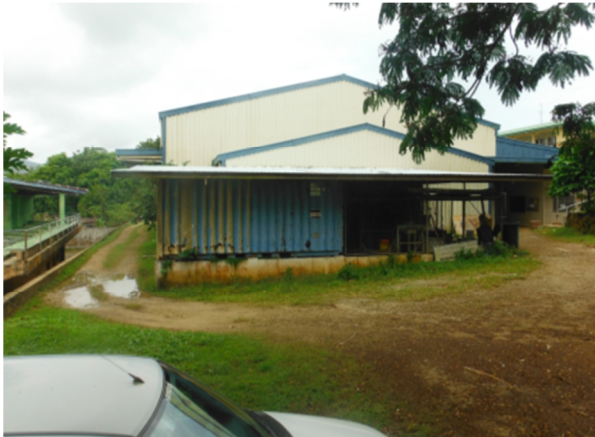
<p><b>Points to consider for future planning –</b> Relocate maintenance to open up the gymnasium to viewing area out to the trees.</p>	<p>Building R is a container facility for the maintenance</p> <p>Location for its function – well located on the edge of the campus but adjacent to what could become a public area</p> <p>Quality and suitability of spaces for its function – adequate, location of function limits view for gymnasium adjacent</p> <p>Disabled access - nil</p> <p>Teaching spaces - nil</p> <p>Amenities, toilets - nil</p> <p>Building condition points – Targeted regular maintenance and cleaning. Localised repairs to metal roof and wall cladding and plywood cladding required immediately.</p> <p>Building age – not available</p>

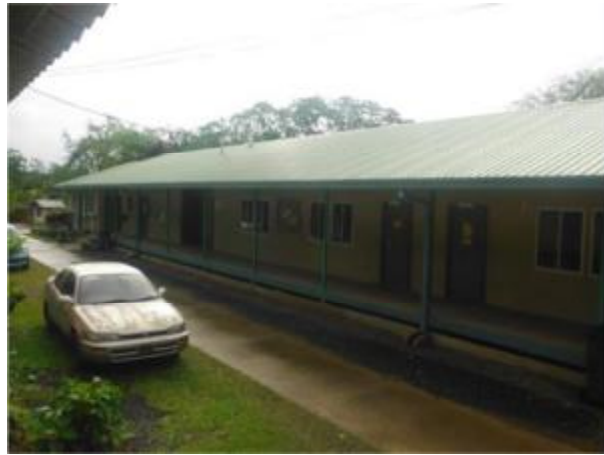
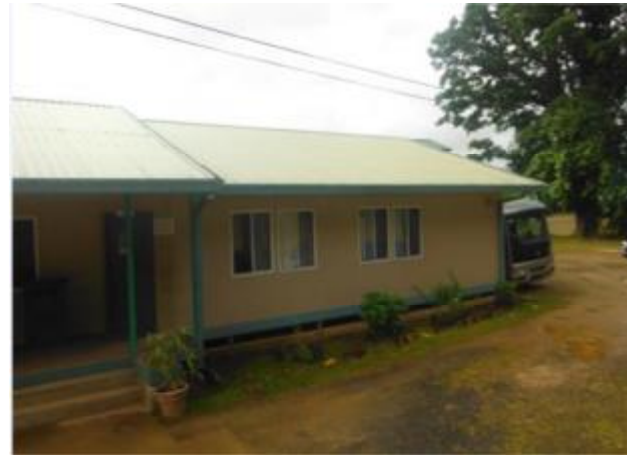
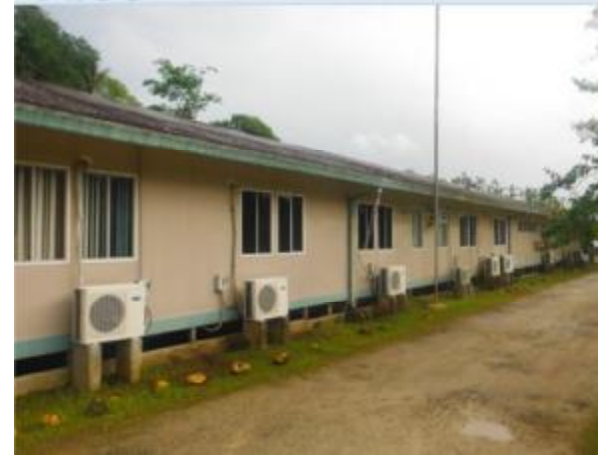
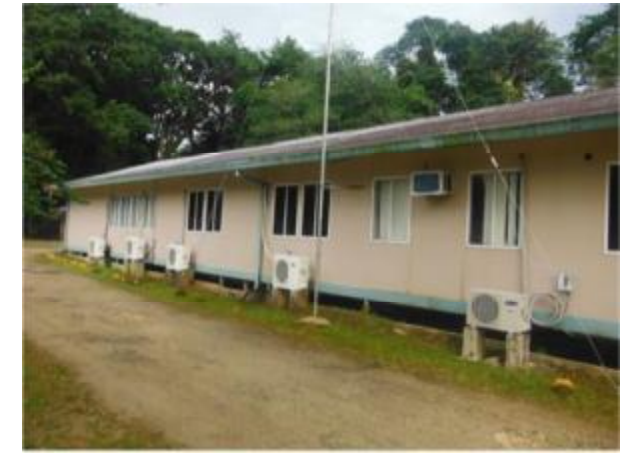
**POHNPEI CAMPUS, KOLONIA, POHNPEI STATE**
**A - ADMINISTRATION BUILDING**

1.00	Total Sub-Structure	3	50%						1,892	0	121,304	123,196	142,772	86.3%	Element	Observed Deterioration/Recommendations
2.00	Total Frame	4	70%						15,442	0	0	15,442	154,419	10.0%

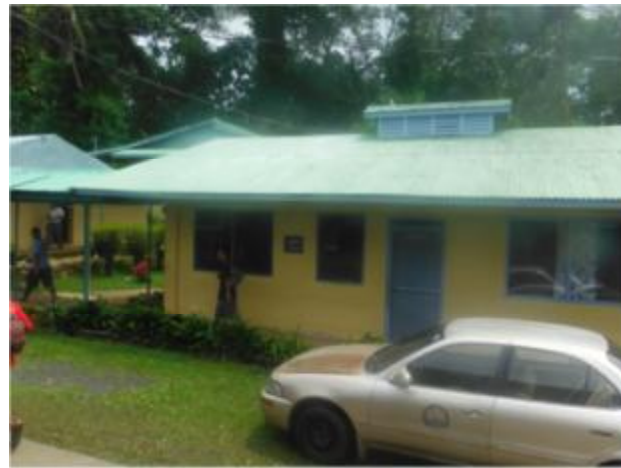
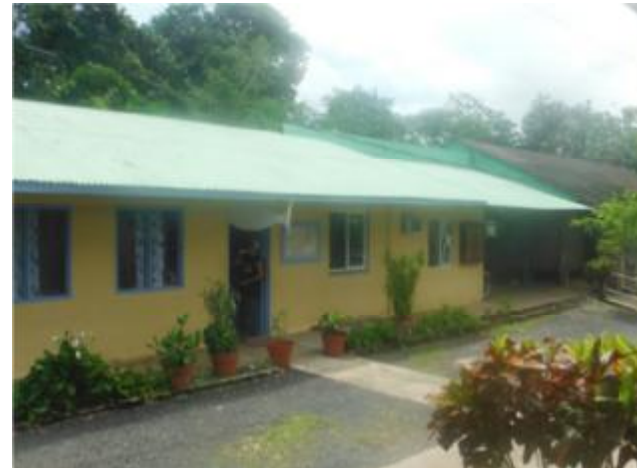
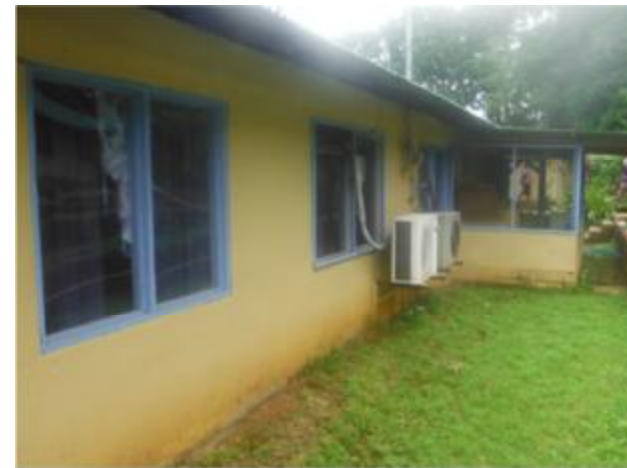
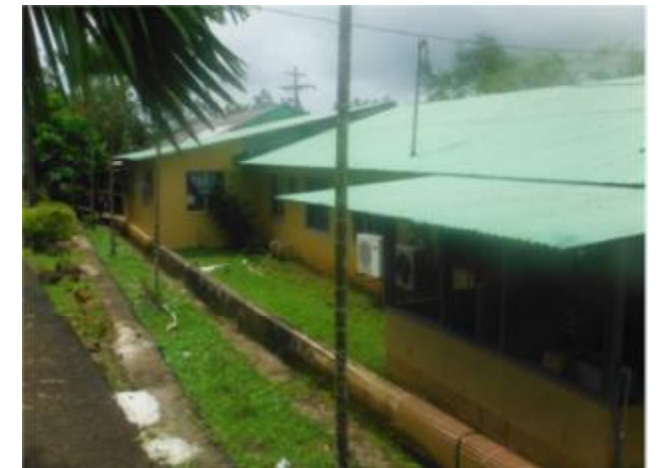
**POHNPEI CAMPUS, KOLONIA, POHNPEI STATE**
**H – HOTEL AND TOURISM BUILDING**

1.00	Total Sub-Structure	3	50%						0	0	0	0	95,720	0.0%		
2.00	Total Frame	3	50%						0	7,827	126,569	134,396	157,446	85.4%		
3.00	Total Structural Walls	3	50%						0	0	0	0	73,487	0.0%

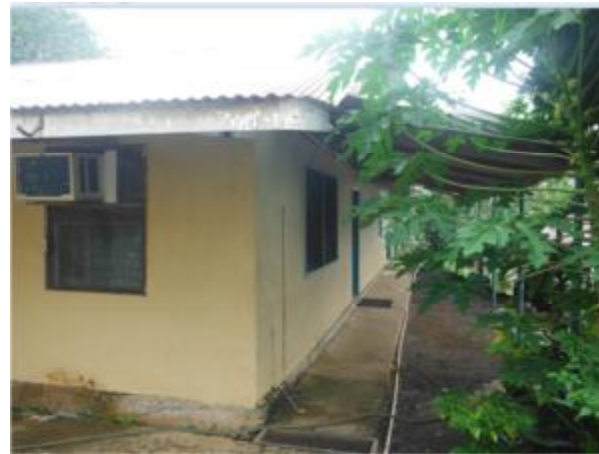
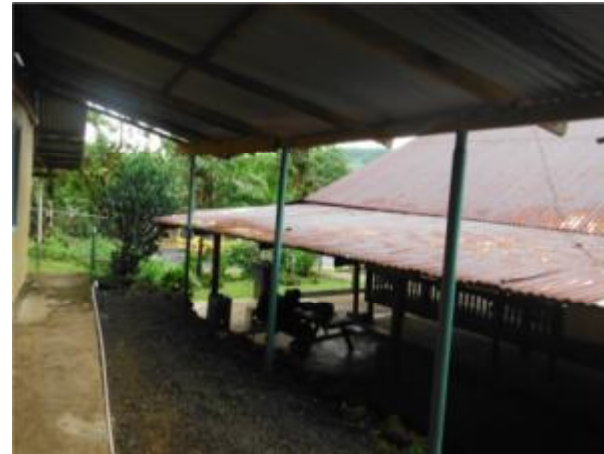
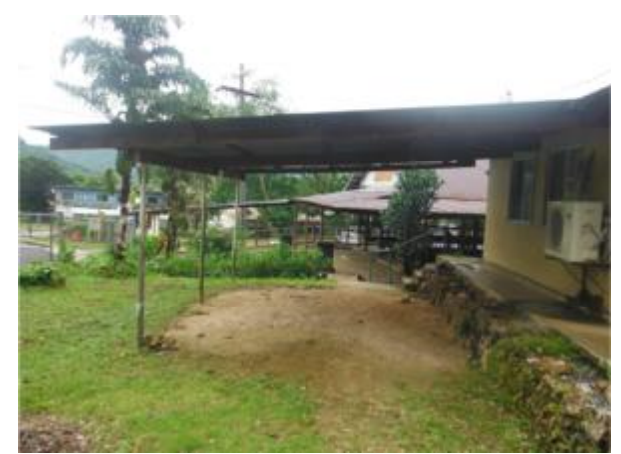
**POHNPEI CAMPUS, KOLONIA, POHNPEI STATE**
**C – I.C BUILDING**

1.00	Total Sub-Structure	5	90%						86,844	0	0	86,844	86,844	100.0%		
2.00	Total Frame	4	70%						0	161,773	12,517	174,290	174,290	100.0%	Substructure, Foundations and Structural Walls	No proper foundation has been constructed (bricks laid over an old foundation). A beam is missing, cracking in walls. Provide temporary support (health & safety issue). Demolish and replace asset.

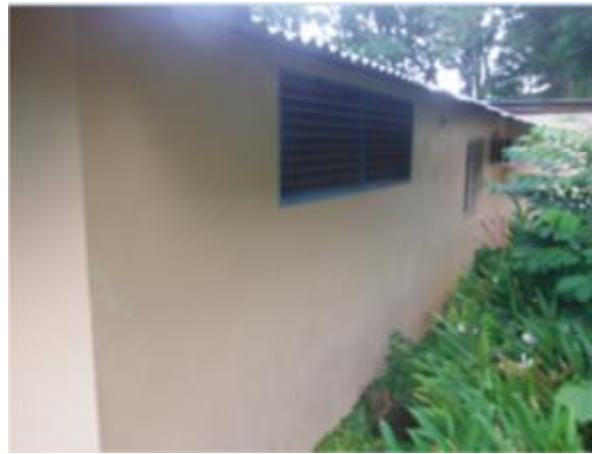
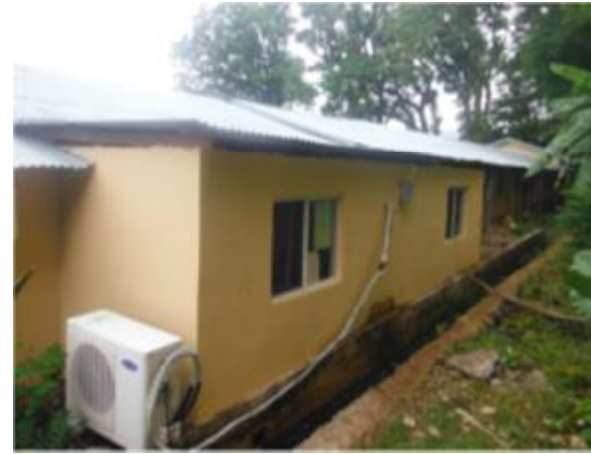
**POHNPEI CAMPUS, KOLONIA, POHNPEI STATE**
**D - CLASSROOM BUILDING A**

1.00	Total Sub-Structure	3	50%						0	0	0	0	210,729	0.0%			
2.00	Total Frame	3	50%						0	0	284,329	284,329	309,623	91.8%	Profiled Metal Sheet Roof Cladding (Pre-Finished)	Evidence of leaks, corrosion, flaking of protective paint and holes in sheets evident on walkway. Evidence of sag in one location

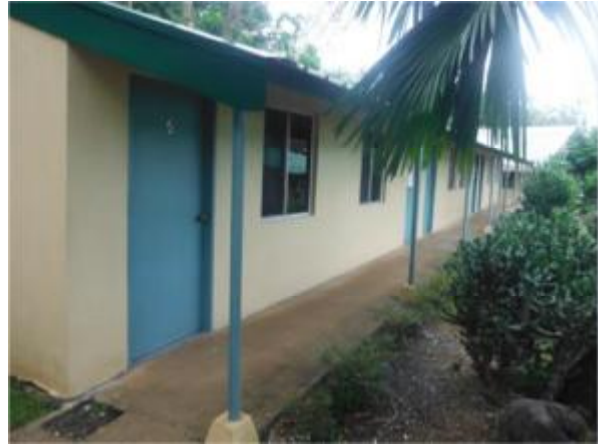
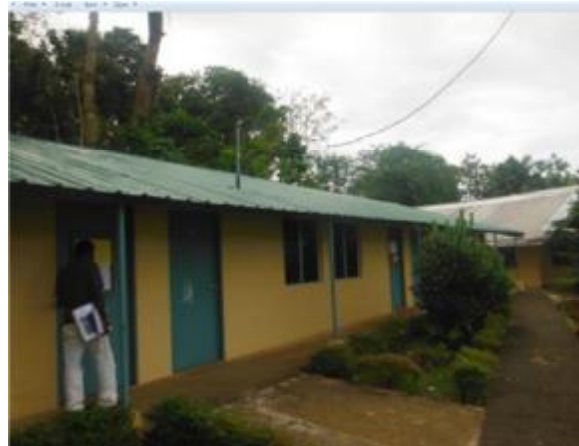
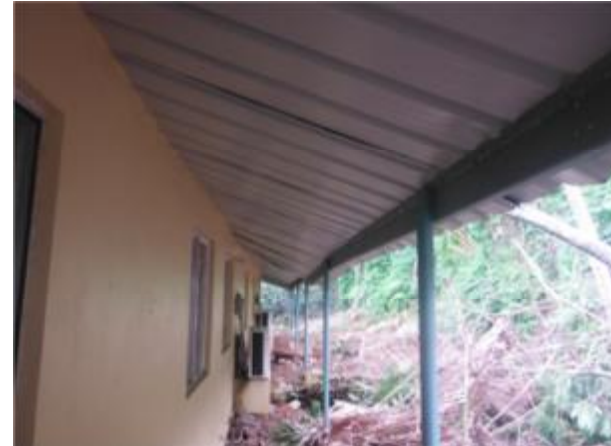
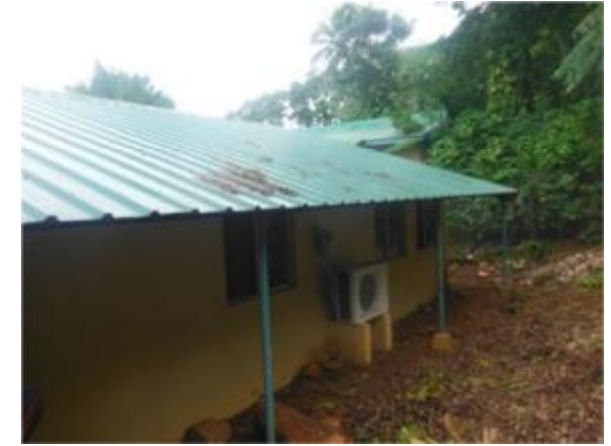
**POHNPEI CAMPUS, KOLONIA, POHNPEI STATE**
**J - CLASSROOM BUILDING B**

1.00	Total Sub-Structure	2	30%						0	0	0	0	68,126	0.0%		
2.00	Total Frame	4	70%						4,800	0	17,280	22,080	98,881	22.3%	Structural Steel Frame (Portal/Truss/Columns/Beams, etc.)	Part damaged by previously fallen tree (say 5% of roof area)

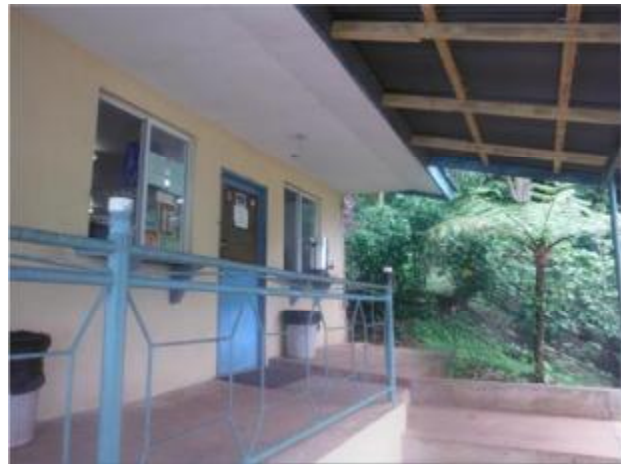
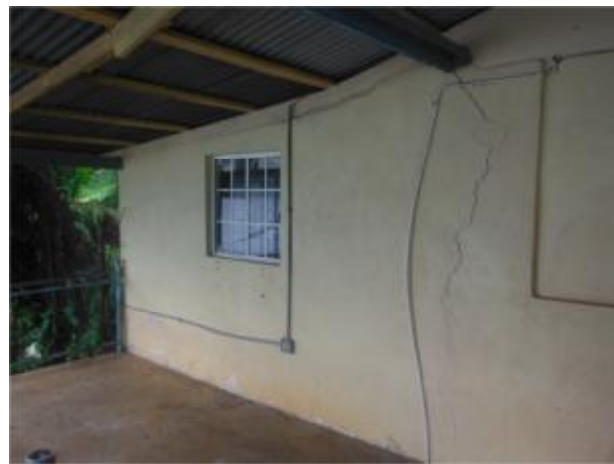
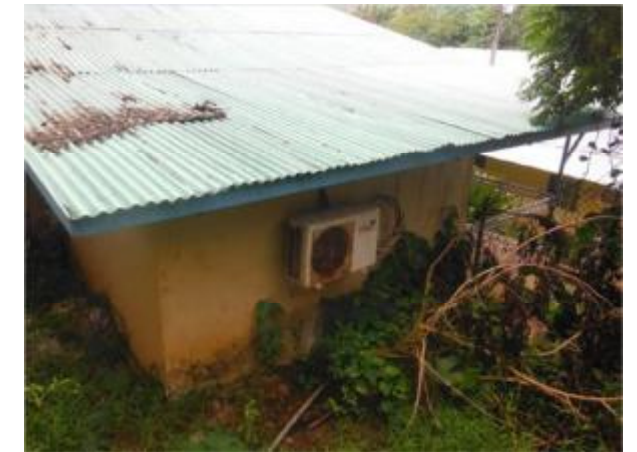
**POHNPEI CAMPUS, KOLONIA, POHNPEI STATE**
**B – BOOKSTORE**

1.00	Total Sub-Structure	4	70%						0	0	44,019	44,019	67,778	64.9%		
2.00	Total Frame	4	70%						0	0	49,849	49,849	66,977	74.4%	Reinforced Concrete Brick/Block Masonry Walls and Reinforced Concrete Frame	Evidence of settlement and structural cracking
