College of Micronesia - FSM Space Utilization and Facilities Master Plan Study, Part 3 - Detailed Report for the FSM-FMI Campus

Prepared by Beca International Consultants Ltd (Beca)

28 November 2013

Building Condition Assessments

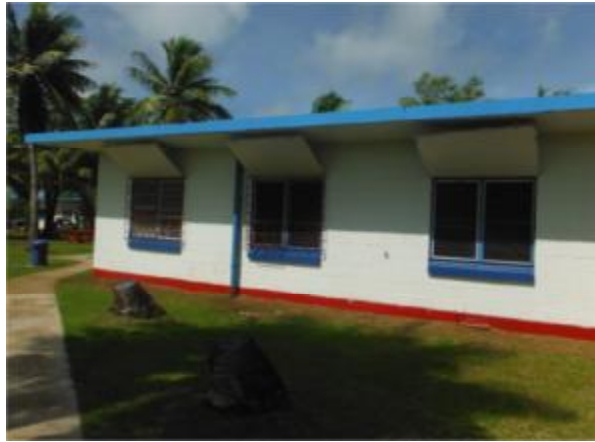
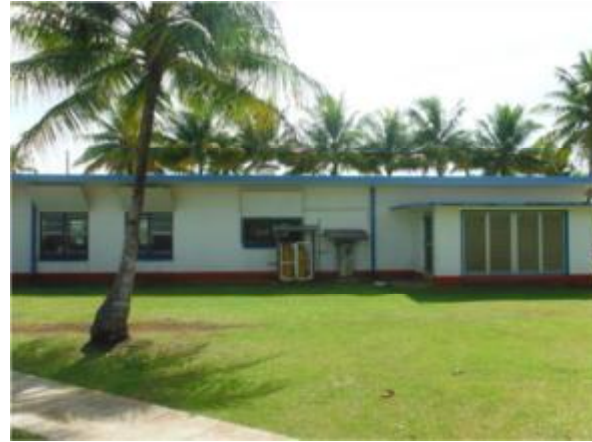
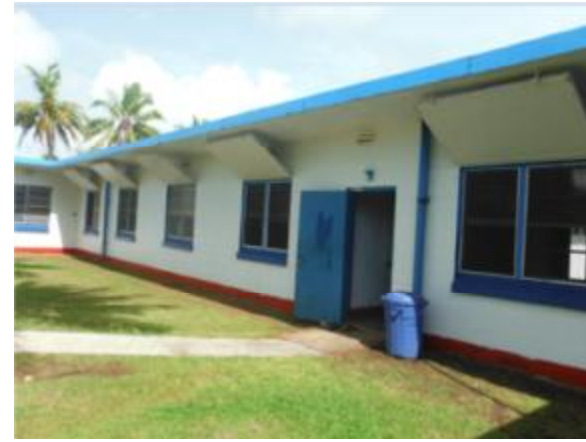
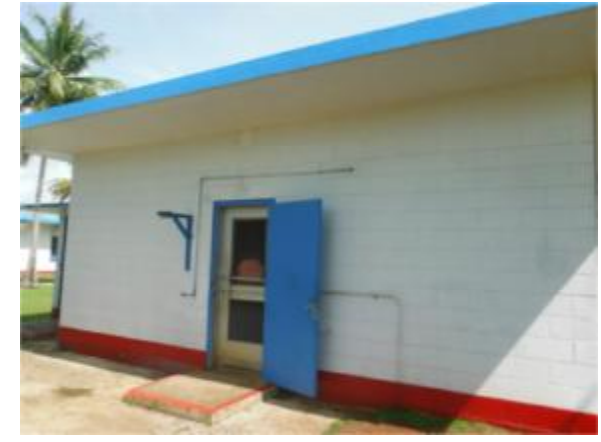
A - ADMINISTRATION/STUDENT SERVICES, LIVING QUARTERS/MESS HALL

Condition Gauge											TOP 5 MAJOR ELEMENTS REQUIRING URGENT MAINTENANCE, RENEWAL OR REPLACEMENT	
				Condition Grading		VG	G	A	P	VP	Asset Renewal Cost					
ID Code	Element	Condition Grade	% Deterioration	0-20 %	20-40 %	40-60 %	60-80 %	80-100 %	Year 1-10 Total	Year 11-20 Total	Year 21-30 Total	Grand Renewal Total	Full Replace	% Full Replace	Element	Observed Deterioration/Recommendations

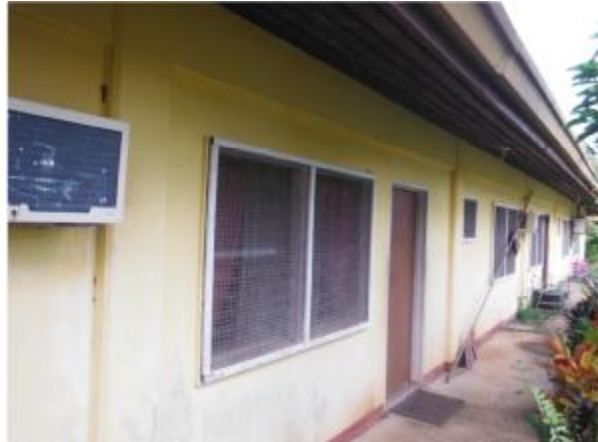
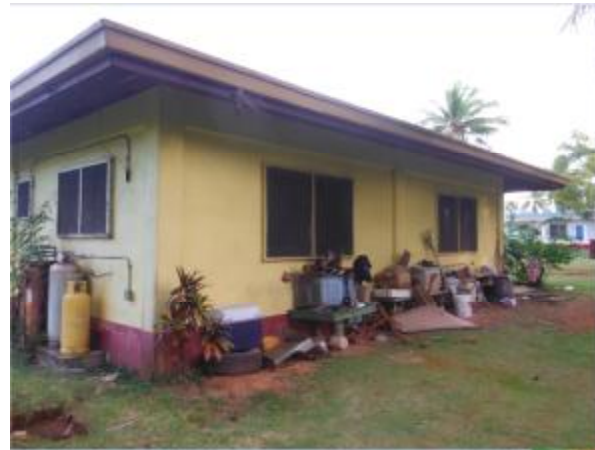
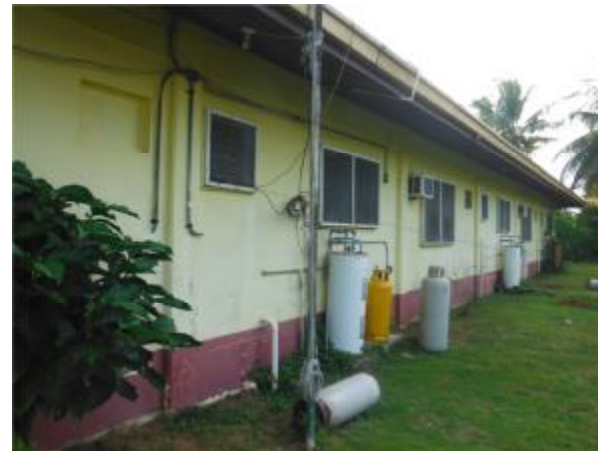
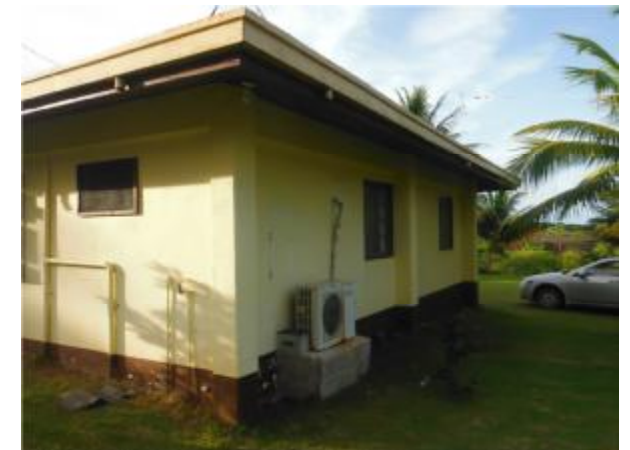
B - STAFF HOUSING

Condition Grading		Condition Gauge					Asset Renewal Cost						Element	Observed Deterioration/Recommendations
ID Code	Element	Condition Grade	% Deterioration	VG 0-20 %	G 20-40 %	A 40-60 %	P 60-80 %	VP 80-100 %	Year 1-10 Total	Year 11-20 Total	Year 21-30 Total	Grand Renewal Total	Full Replace	% Full Replace

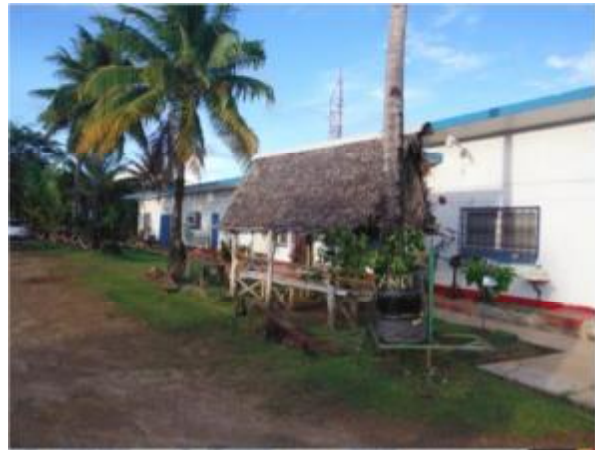
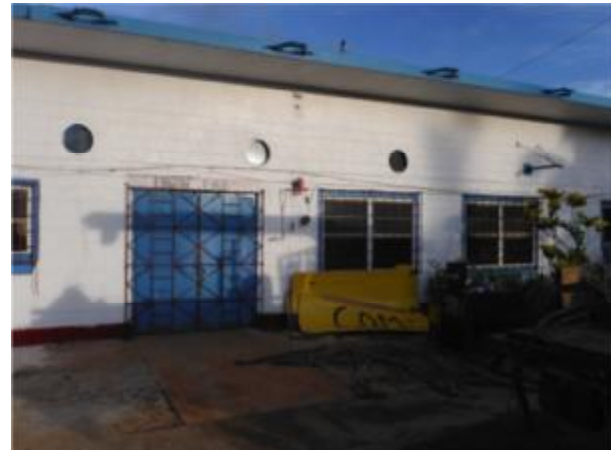
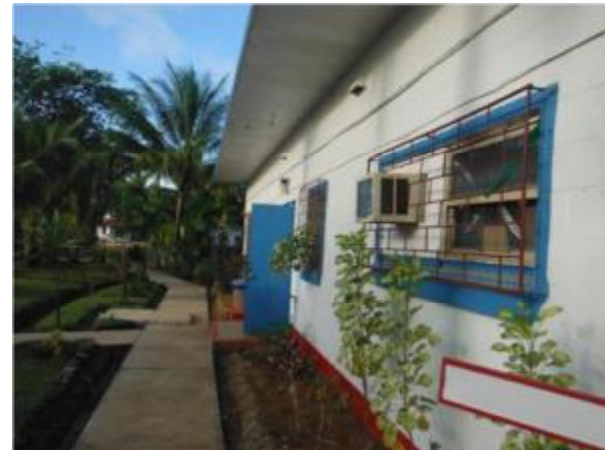
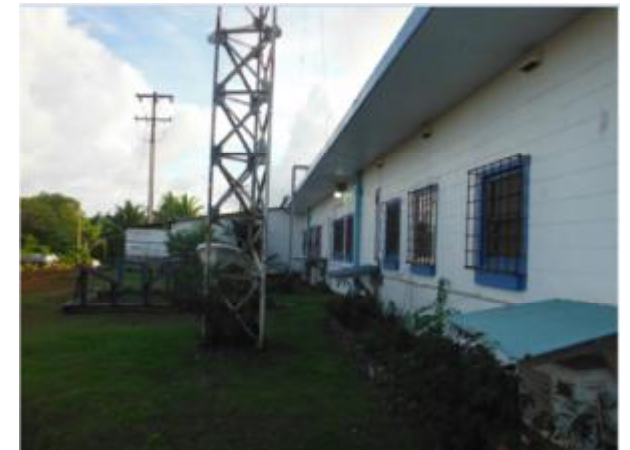
C - CLASSROOMS, LIBRARY & SHOPS

Condition Gauge										TOP 5 MAJOR ELEMENTS REQUIRING URGENT MAINTENANCE, RENEWAL OR REPLACEMENT	
				Condition Grading		VG	G	A	P	VP	Asset Renewal Cost				
ID Code	Element	Condition Grade	% Deterioration	0-20 %	20-40 %	40-60 %	60-80 %	80-100 %	Year 1-10 Total	Year 11-20 Total	Year 21-30 Total	Grand Renewal Total	Full Replace	% Full Replace

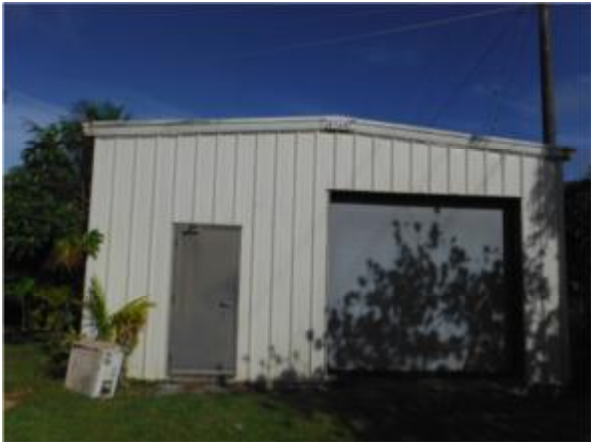
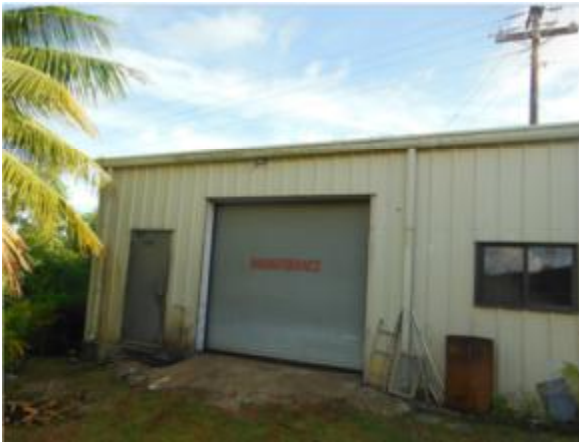
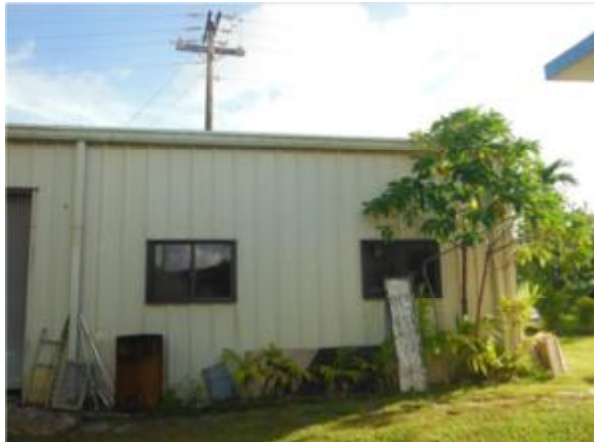
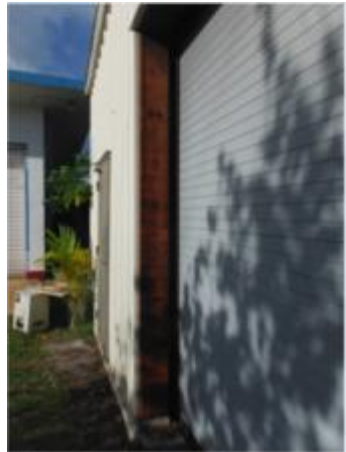
D - MAINTENANCE

Condition Gauge										
				Condition Grading		VG	G	A						
D Code	Element	Condition Grade	% Deterioration	0-20 %	20-40 %	40-60 %	60-80 %	80-100 %	Year 1-10 Total	Year 11-20 Total	Year 21-30 Total	Grand Renewal Total	Full Replace	% Full Replace

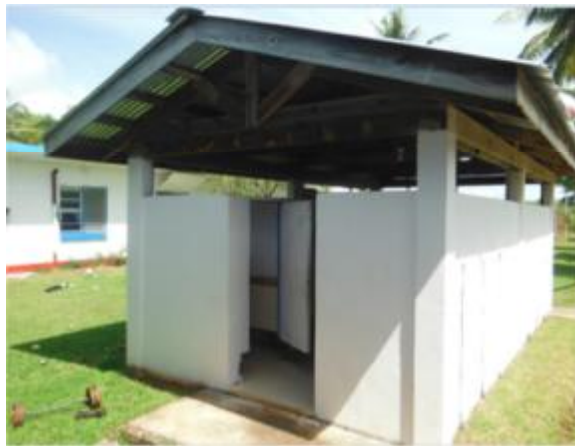
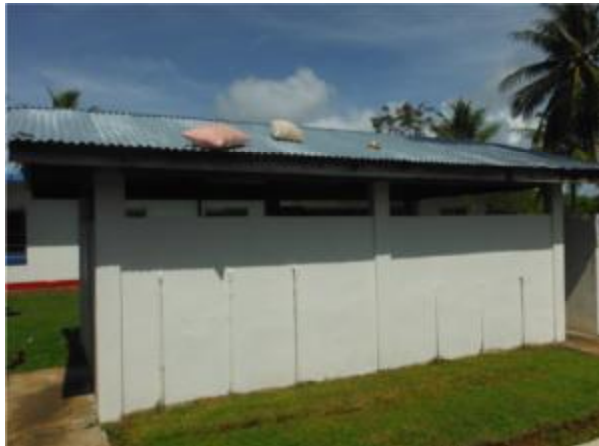
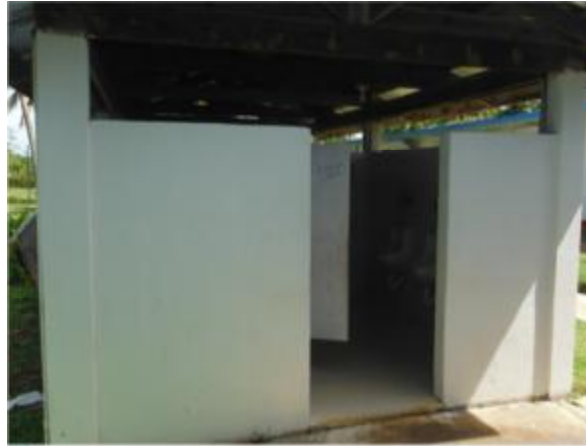
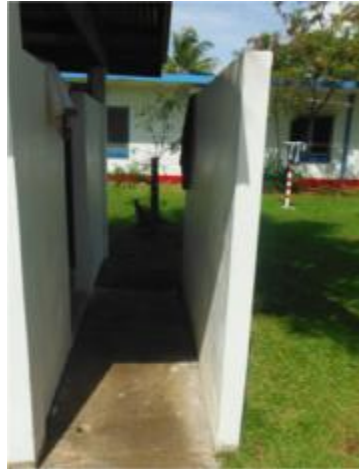
E - SHOWER HOUSE

Condition Gauge										
		Condition Grading		VG	G	A	P	VP	Asset Renewal Cost					
D Code	Element	Condition Grade	% Deterioration	0-20 %	20-40 %	40-60 %	60-80 %	80-100 %	Year 1-10 Total	Year 11-20 Total	Year 21-30 Total	Grand Renewal Total	Full Replace	% Full Replace

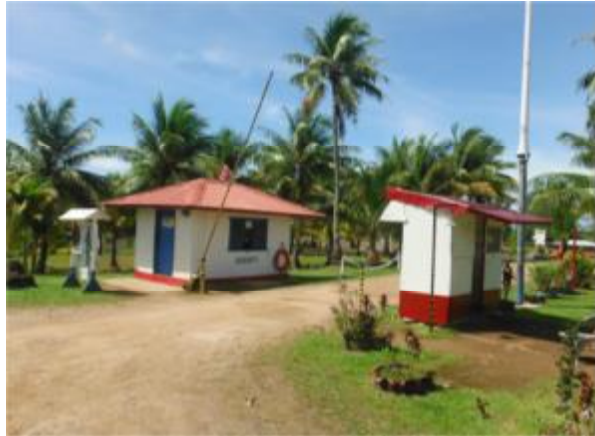
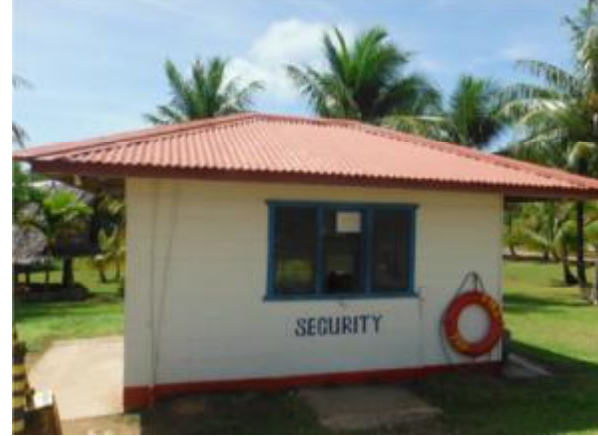
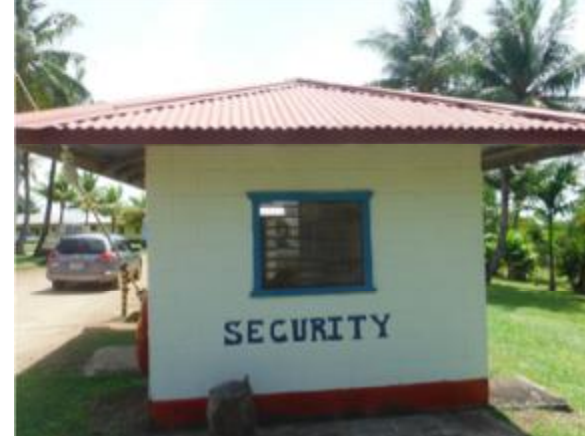
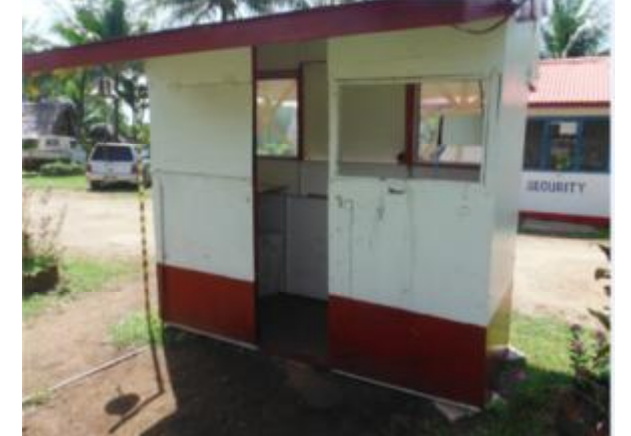
F - SECURITY POST

Condition Gauge											TOP 5 MAJOR ELEMENTS REQUIRING URGENT MAINTENANCE, RENEWAL OR REPLACEMENT	
				Condition Grading		VG	G	A								
ID Code	Element	Condition Grade	% Deterioration	0-20 %	20-40 %	40-60 %	60-80 %	80-100 %	Year 1-10 Total	Year 11-20 Total	Year 21-30 Total	Grand Renewal Total	Full Replace	% Full Replace	Element	Observed Deterioration/Recommendations
