College of Micronesia - FSM Space Utilization and Facilities Master Plan Study, Part 3 - Detailed Report for the Chuuk Campus

Prepared by Beca International Consultants Ltd (Beca)

28 February 2014

CHUUK CAMPUS, NEPUKOS WENO, CHUUK STATE

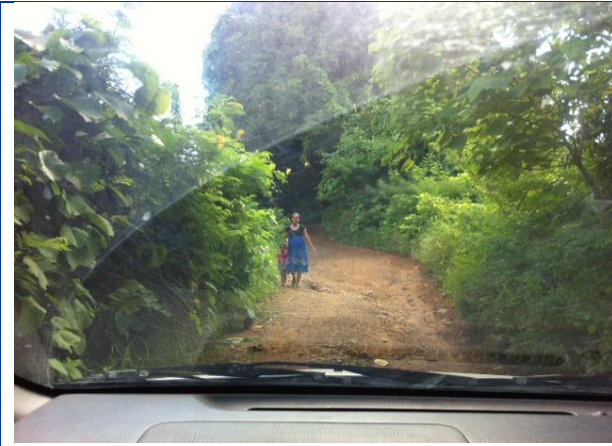
Access on a slope on leaving Pou to reach the Nantaku site – single lane unsealed road, susceptible to rutting due to lack of drainage

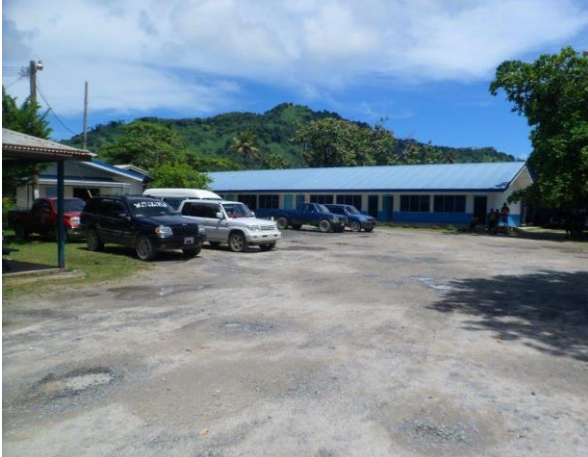
<p>B – Classroom Building B</p>

<p>Building B is a classroom block with four large classrooms</p> <p>Location for its function – well located but due to its proximity to other buildings limits cross ventilation through the site</p> <p>Quality and suitability of spaces for its function – Adequate. Increased ventilation is required.</p> <p>Disabled access - Ramp access</p> <p>Teaching spaces – Four classrooms 670sqft</p> <p>Amenities, toilets - Two toilets</p> <p>Building condition points - Targeted regular maintenance and cleaning. Treat and spot prime rusted gutters immediately. Review roof and consider re-painting. Treat and repair termite damage to doors.</p> <p>Building age – 7 years (mid 2000's)</p>
--	--

Building condition points - Targeted regular maintenance and cleaning. Treat and spot prime rusted roofing immediately. Review roof and consider re-painting. Treat and repair termite damage to windows.

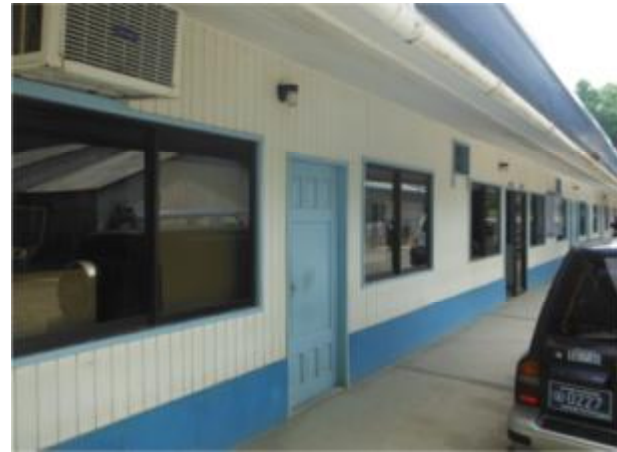
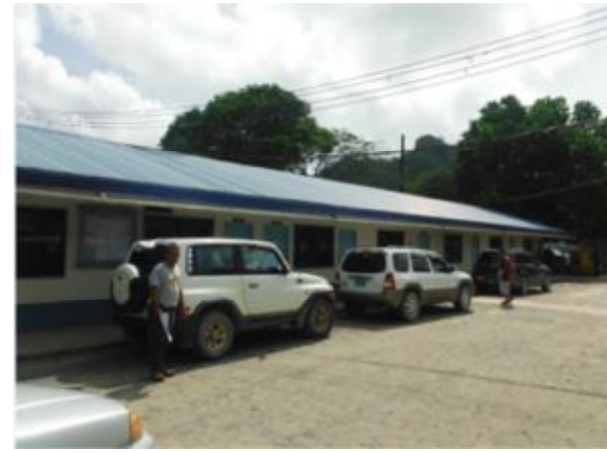
A – ADMINISTRATION/FACULTY OFFICES

1.00	Total Sub-Structure	2	30%						0	0	0	0	89,053	0.0%	Metal Rain Water Heads	Rusted out in parts
2.00	Total Frame	2	30%						0	0	0	0	94,762	0.0%		
3.00	Total Structural Walls	2	30%						0	0	0	0	53,452	0.0%	Profiled Metal Sheet Roof Cladding (Pre-Finished)	Faded paint to roof

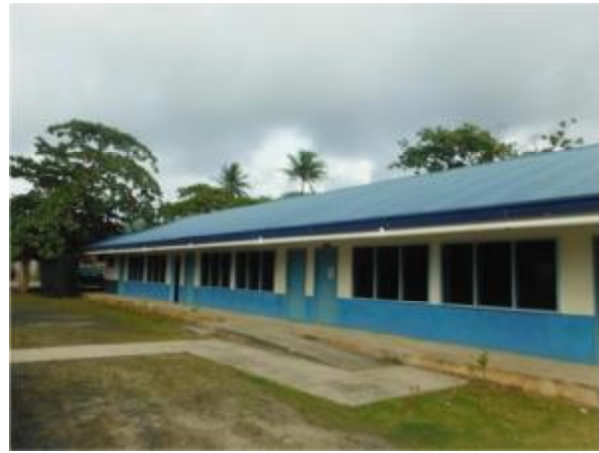
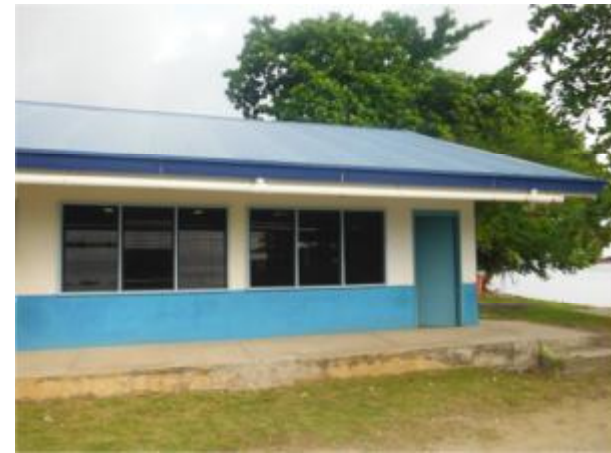
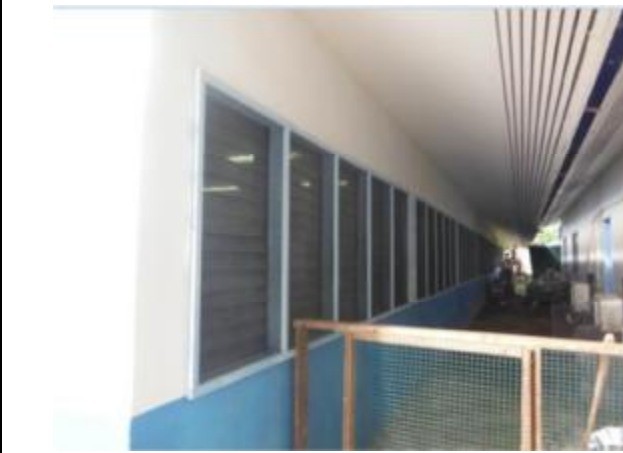
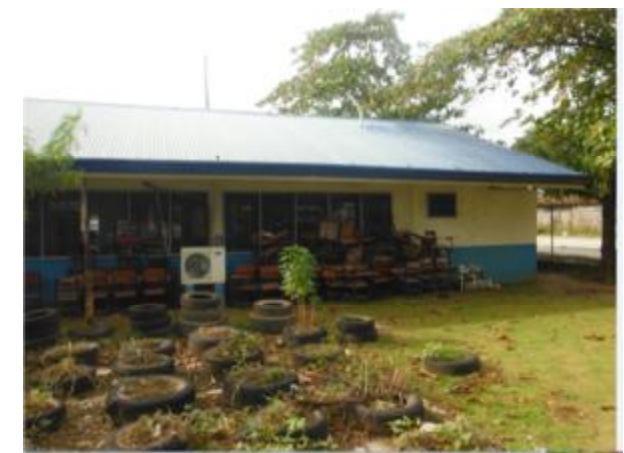
B – CLASSROOM BUILDING B

1.00	Total Sub-Structure	2	30%						0	0	0	0	72,321	0.0%	
2.00	Total Frame	2	30%						0	0	0	0	136,612	0.0%	
3.00	Total Structural Walls	2	30%						0	0	0	0	49,302	0.0%

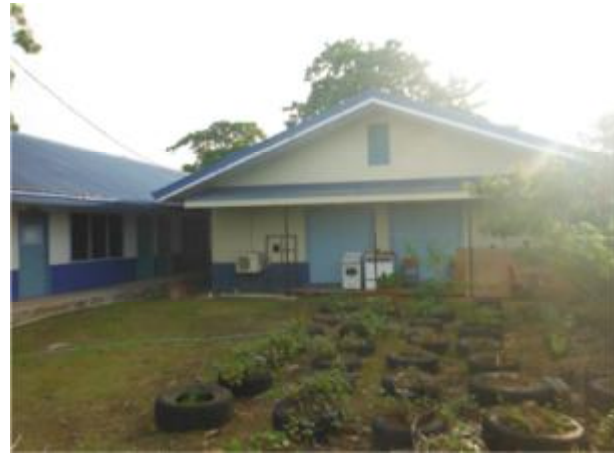
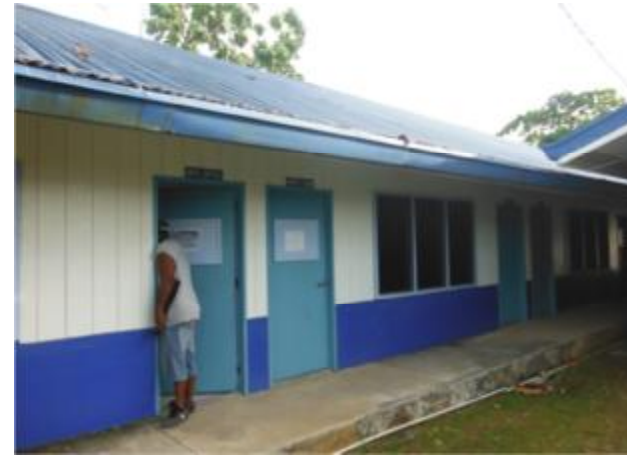
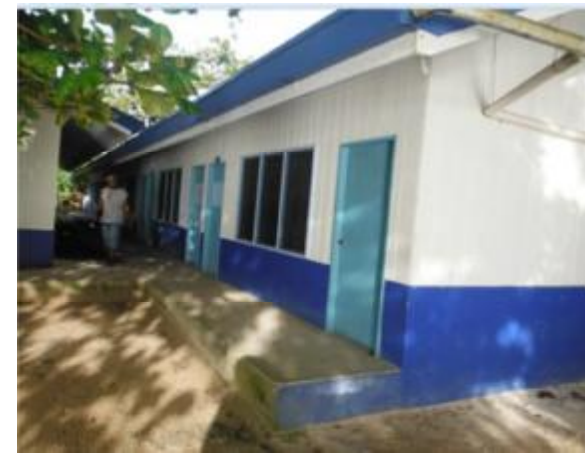
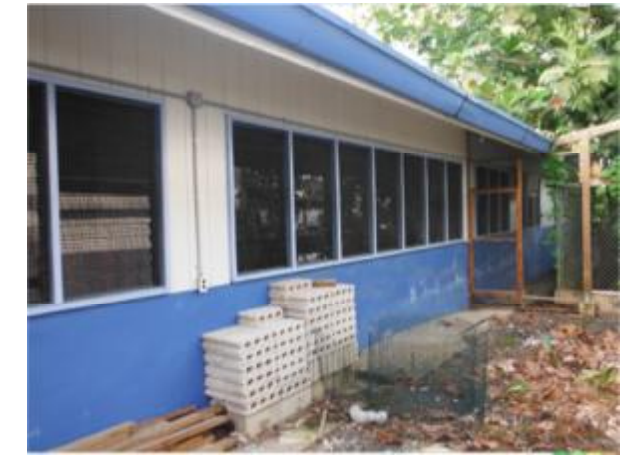
C – CLASSROOM BUILDING C

1.00	Total Sub-Structure	2	30%						0	0	0	0	68,377	0.0%
2.00	Total Frame	2	30%						0	0	0	0	74,553	0.0%
3.00	Total Structural Walls	2	30%						0	0	0	0	41,792	0.0%

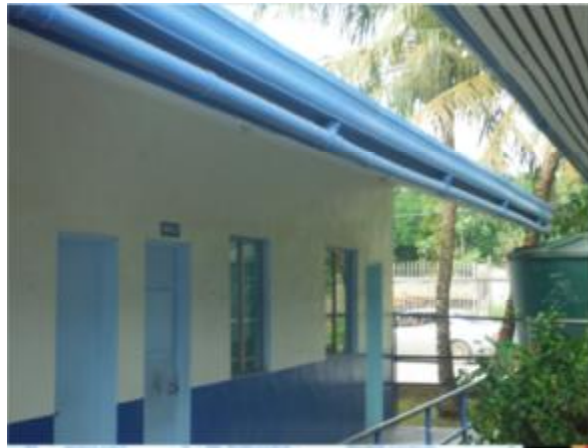
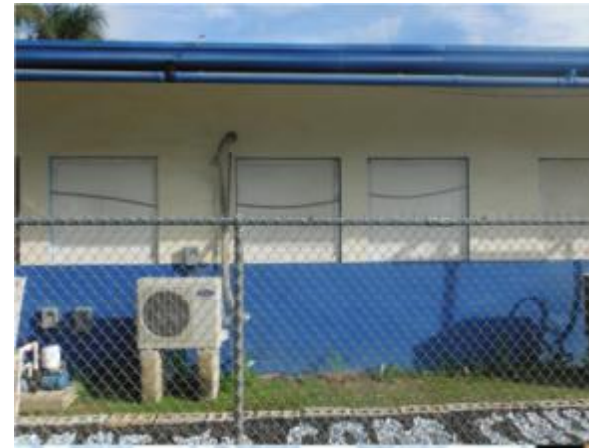
I - COMPUTER LAB

1.00	Total Sub-Structure	2	30%						0	0	0	0	44,851	0.0%	Element	Observed Deterioration/Recommendations
2.00	Total Frame	2	30%						0	0	0	0	83,010	0.0%

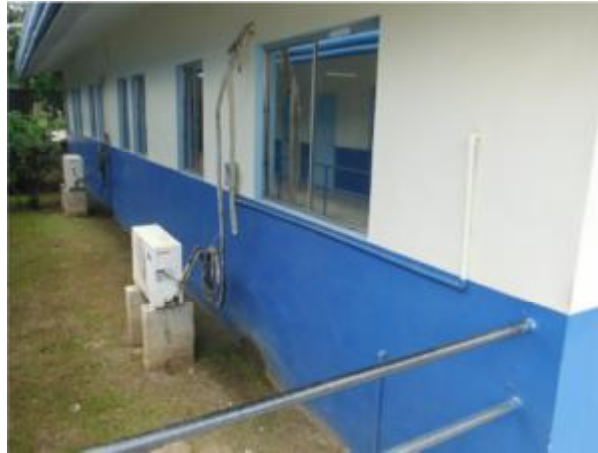
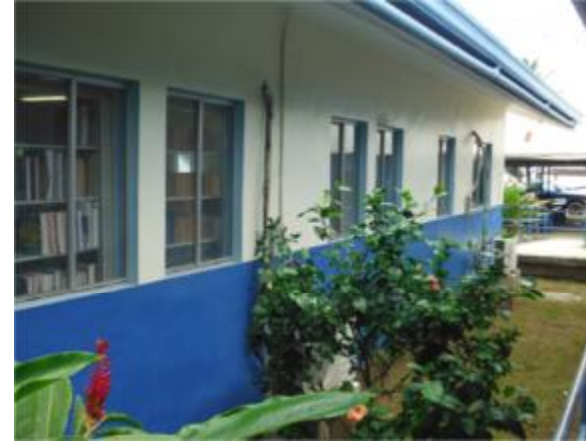
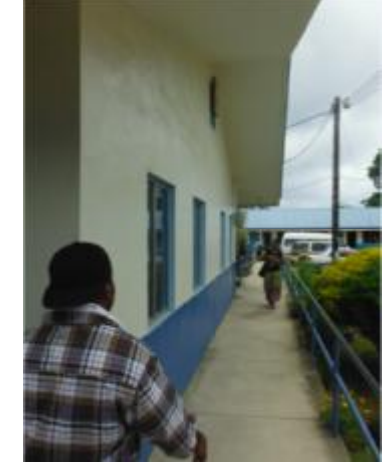
K – LEARNING RESOURCES CENTER

ID Code	Element	Condition Grading		Condition Gauge					Asset Renewal Cost					TOP 5 MAJOR ELEMENTS REQUIRING URGENT MAINTENANCE, RENEWAL OR REPLACEMENT															
		Condition Grade	% Deterioration	VG	G	A	P	VP	Year 1-10 Total	Year 11-20 Total	Year 21-30 Total	Grand Renewal Total	Full Replace			% Full Replace													
				0-20 %	20-40 %	40-60 %	60-80 %	80-100 %																					
1.00	Total Sub-Structure	2	30%						0	0	0	0	45,747	0.0%

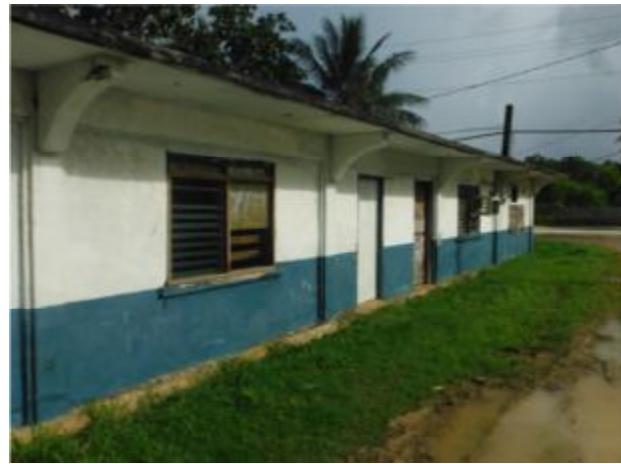
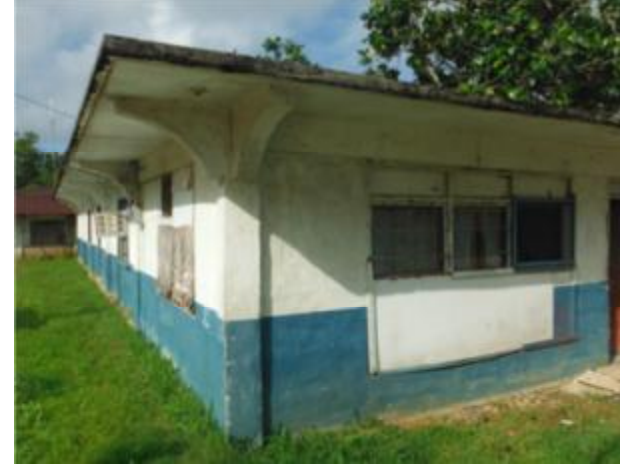
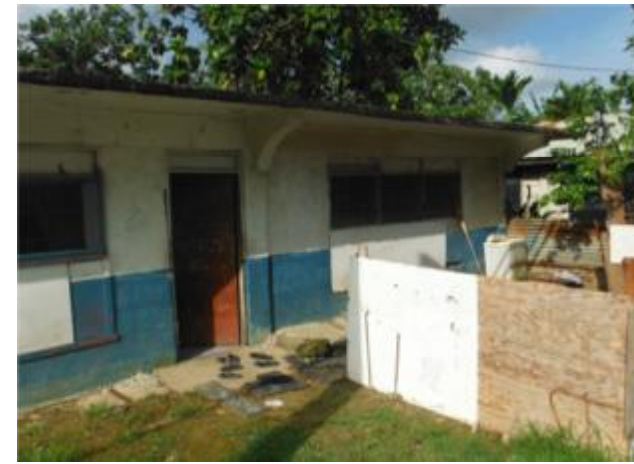
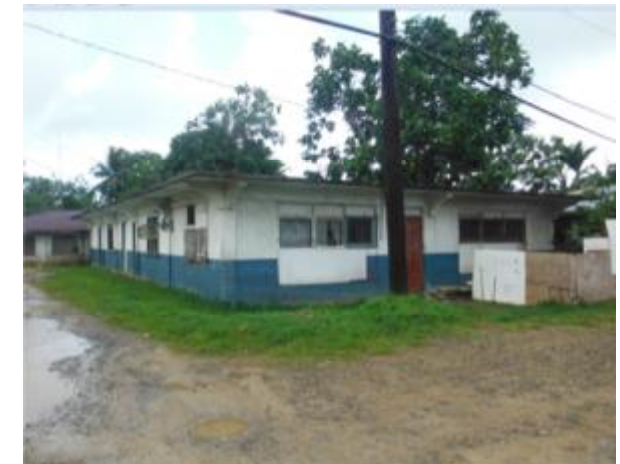
M - MIDTOWN (OFF CAMPUS)

1. Midtown (off-campus) Building. 20% of the operational cost is dedicated to this off-campus building that is not owned by COM-FSM and is showing signs of significant structural and elemental failure. The use of this asset must be considered and if it is no longer required then operational costs could be reduced by diverting them to other facilities.

1.00	Total Sub-Structure	4	70%						0	0	48,699	48,699	48,699	100.0%
2.00	Total Frame	0	0%						0	0	0	0	0	0.0%
3.00	Total Structural Walls	5	90%						61,763	0	0	61,763	61,763	100.0%
