# College of Micronesia - FSM Space Utilization and Facilities Master Plan Study, Part 3 - Detailed Report for the Chuuk Campus

Prepared for the College of Micronesia - FSM

Prepared by Beca International Consultants Ltd (Beca)

28 November 2013

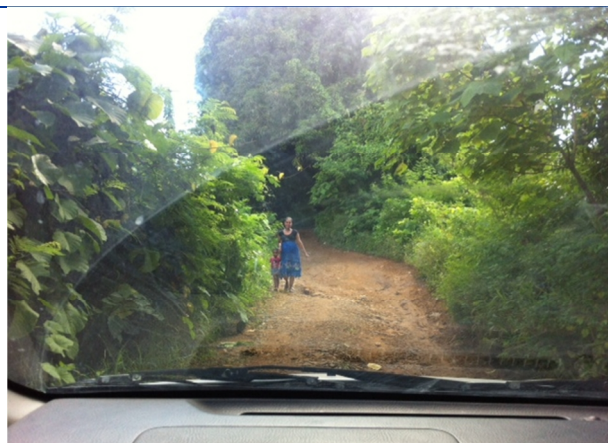
Access on a slope on leaving Pou to reach the Nantaku site – single lane unsealed road, susceptible to rutting due to lack of drainage

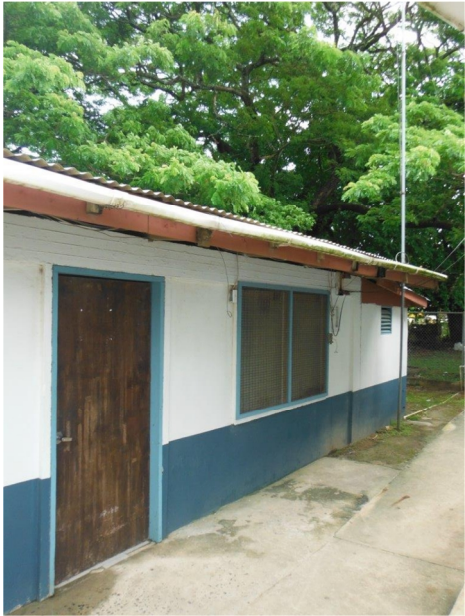
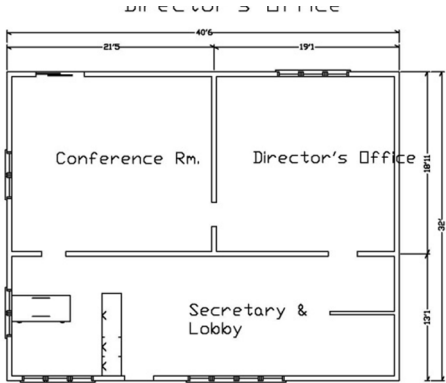
Building	Outline
<p><b>D – Dean's office</b></p>

<p>Building D is the director's office with lobby and conference room</p> <p>Location for its function – Located in a good position with regard to function , however , affected by storm surges due to its proximity to the coastal edge</p> <p>Quality and suitability of spaces for its function – Issues with flooding</p> <p>Disabled access – ramp access</p> <p>Teaching spaces - nil</p> <p>Amenities, toilets - nil</p> <p>Building condition points – Targeted regular maintenance and cleaning. Rust treat, repaint and clean roof, or replace corroded roof immediately.</p> <p>Building age – not available</p>

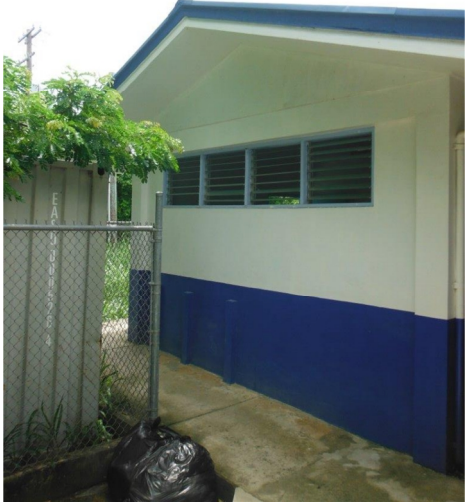
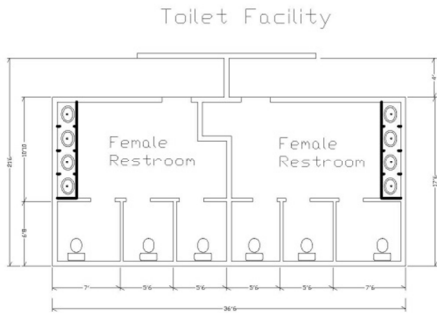
<p><b>E – Restrooms</b></p>

<p>Building E is the toilet block with male and female facilities</p> <p>Location for its function – well located on the edge of the site away from the classrooms, however were comments on distance from classrooms</p> <p>Quality and suitability of spaces for its function – well laid out and designed</p> <p>Disabled access – ramp access</p> <p>Amenities, toilets - 6 toilets; 3 male and 3 female</p> <p>Building condition points – Targeted regular maintenance and cleaning to extend asset life.</p> <p>Building age – 8 years (mid 2000's)</p>

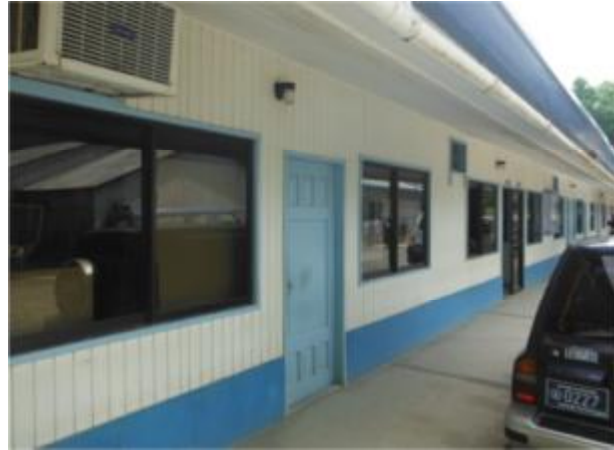
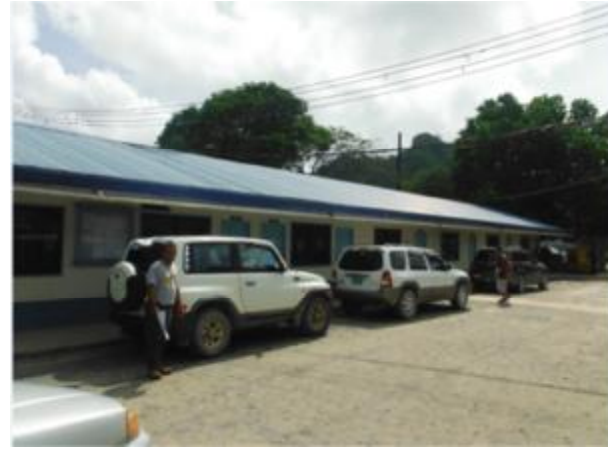
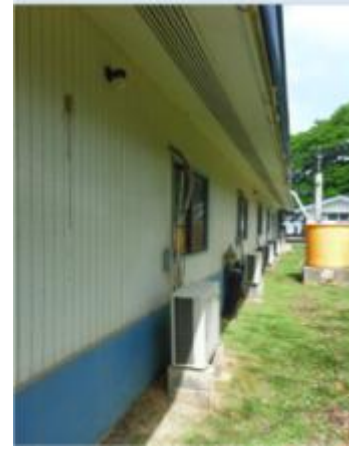
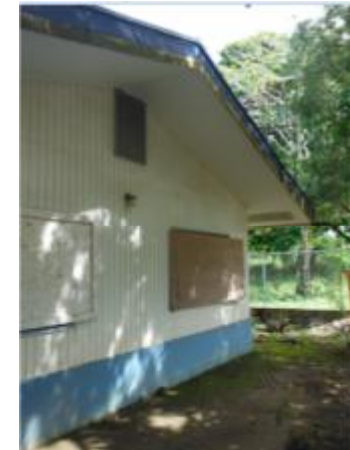
A – ADMINISTRATION/FACULTY OFFICES

1.00	Total Sub-Structure	2	30%						0	0	0	0	89,053	0.0%	<b>TOP 5 MAJOR ELEMENTS REQUIRING URGENT MAINTENANCE, RENEWAL OR REPLACEMENT</b>
2.00	Total Frame	2	30%						0	0	0	0	94,762	0.0%

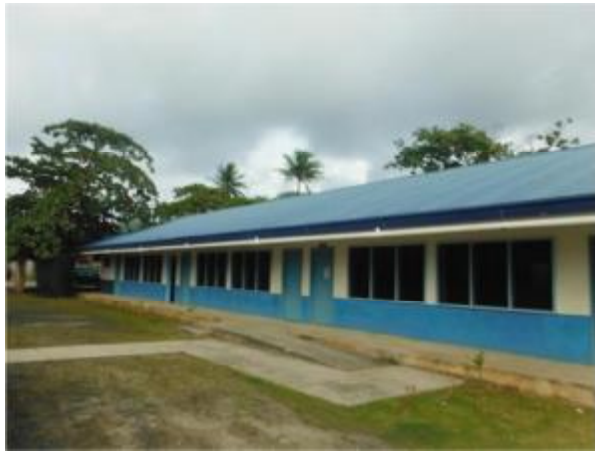
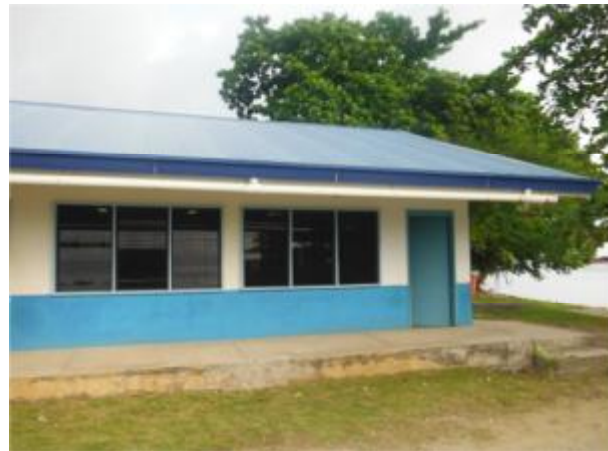
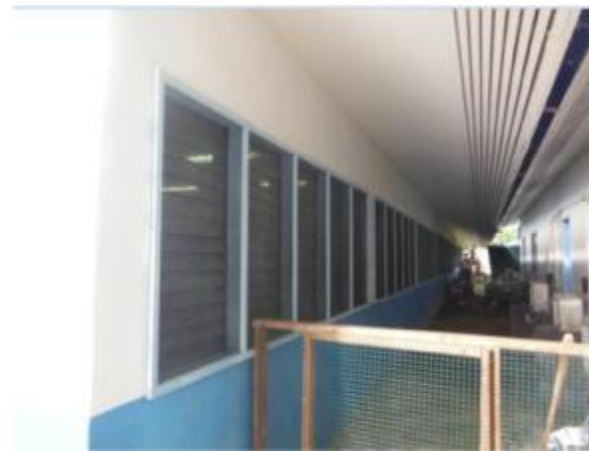
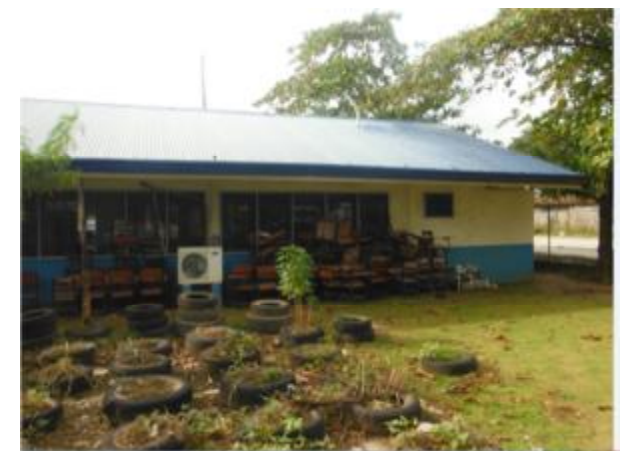
**CHUUK CAMPUS, NEPUKOS WENO, CHUUK STATE**
**B – CLASSROOM BUILDING B**

1.00	Total Sub-Structure	2	30%						0	0	0	0	72,321	0.0%			Element	Observed Deterioration/Recommendations
2.00	Total Frame	2	30%						0	0	0	0	136,612	0.0%

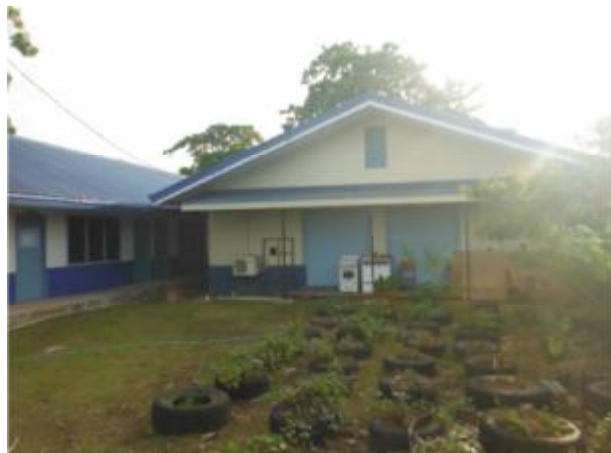
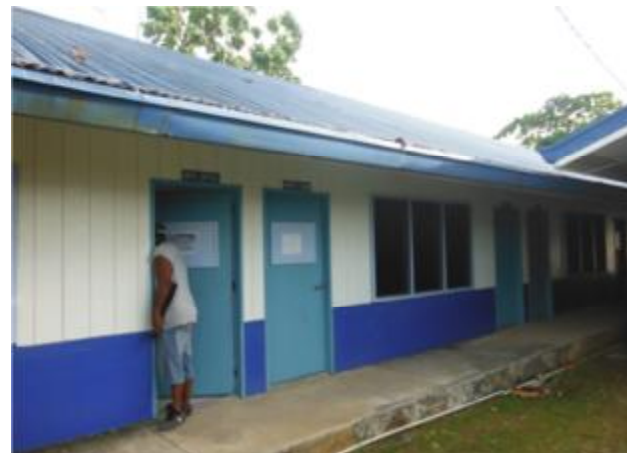
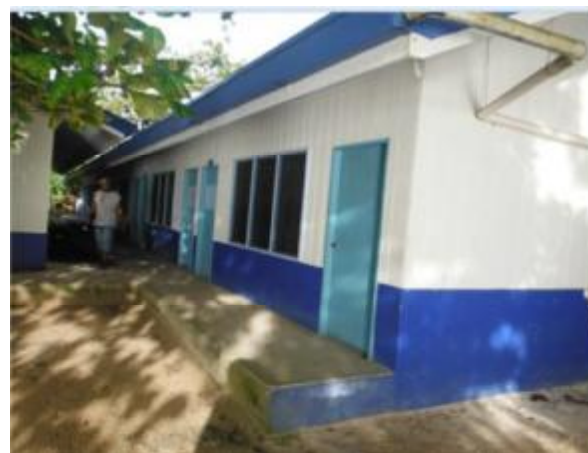
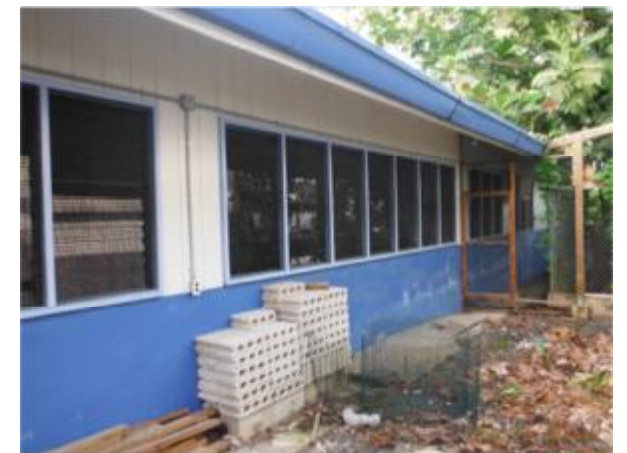
# C – CLASSROOM BUILDING C

1.00	Total Sub-Structure	2	30%						0	0	0	0	68,377	0.0%			
2.00	Total Frame	2	30%						0	0	0	0	74,553	0.0%	Profiled Metal Sheet Roof Cladding (Pre-Finished)	Faded paint to roof, rush patches occurring

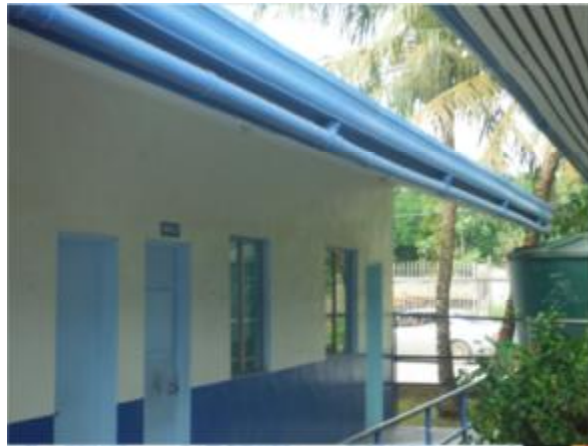
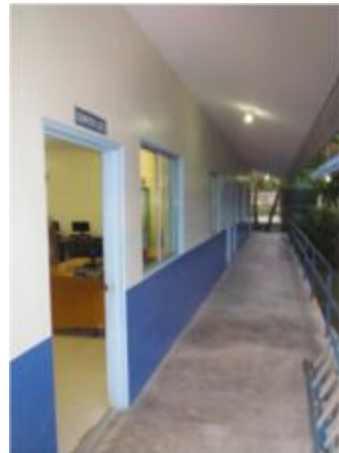
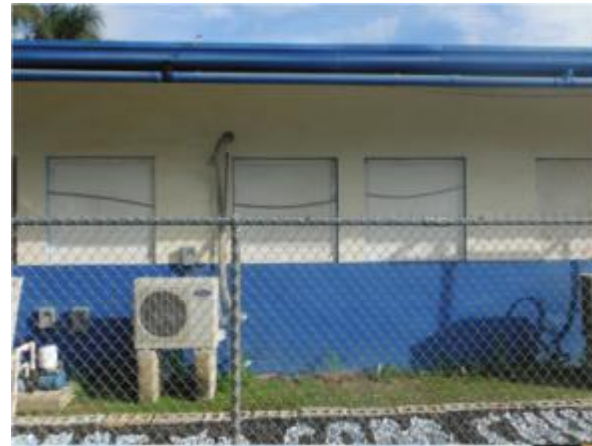
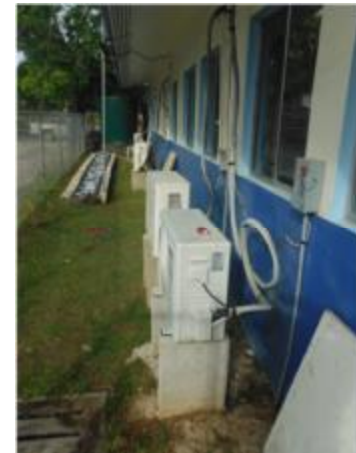
**I - COMPUTER LAB**

1.00	Total Sub-Structure	2	30%						0	0	0	0	44,851	0.0%
2.00	Total Frame	2	30%						0	0	0	0	83,010	0.0%
3.00	Total Structural Walls	2	30%						0	0	0	0	62,927	0.0%

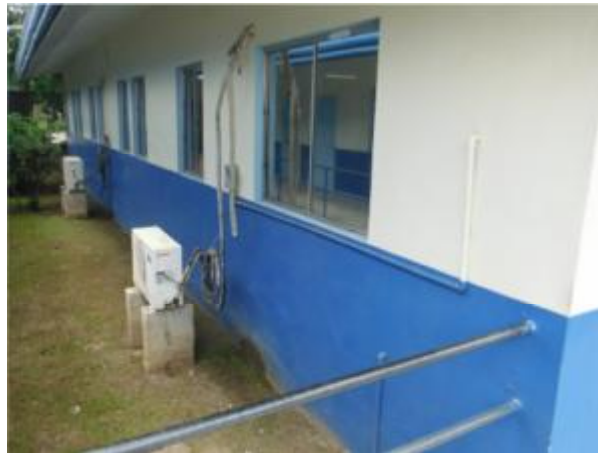
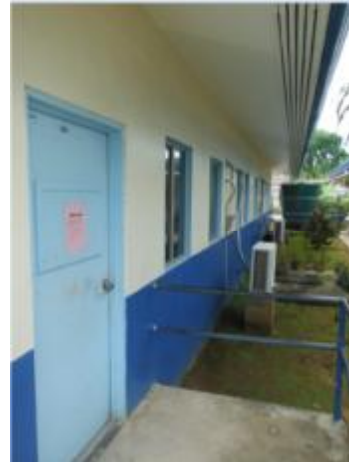
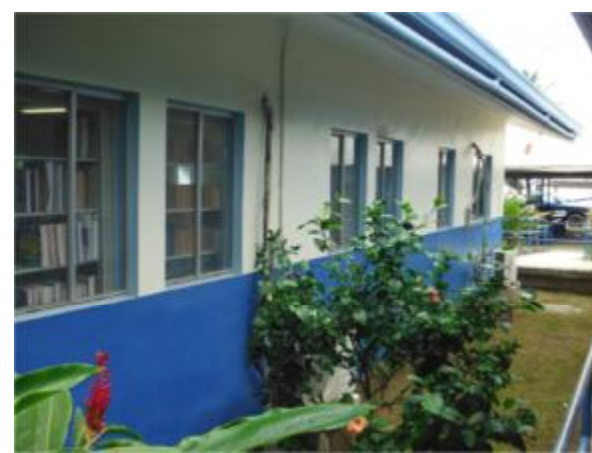
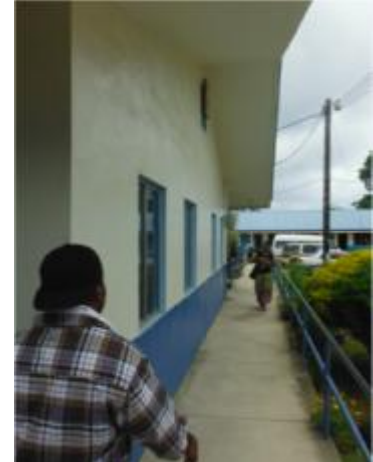
**CHUUK CAMPUS, NEPUKOS WENO, CHUUK STATE**
**K – LEARNING RESOURCES CENTER**

1.00	Total Sub-Structure	2	30%						0	0	0	0	45,747	0.0%		
2.00	Total Frame	2	30%						0	0	0	0	89,592	0.0%	Metal Gutters	Gutters corrosion around downpipes, minor impact damage

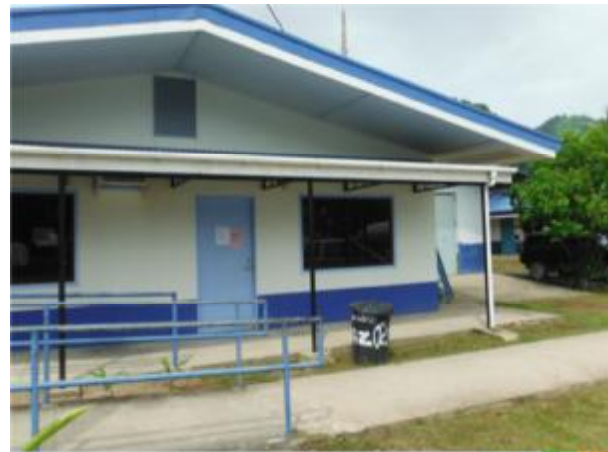
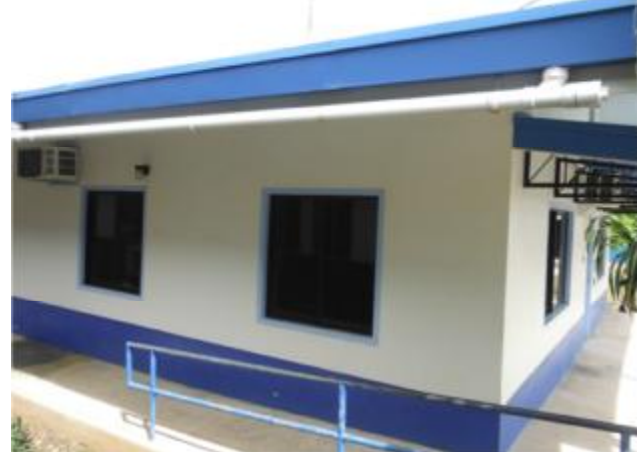
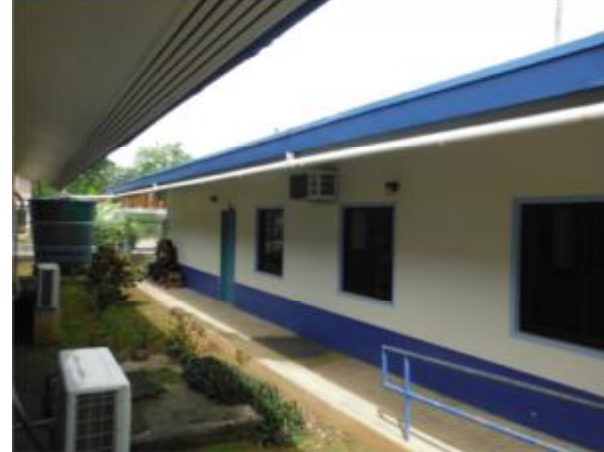
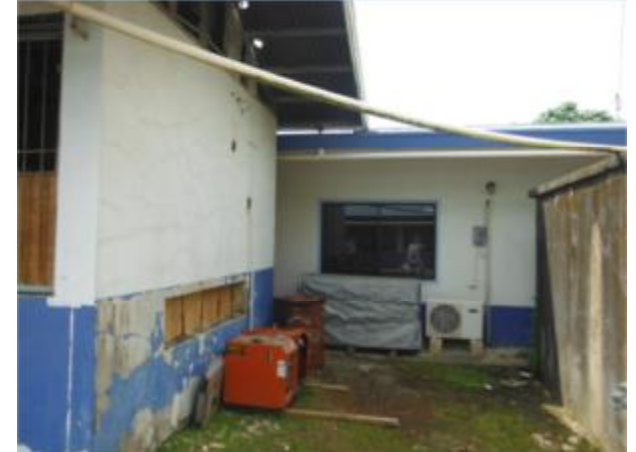
# H – STUDENT SERVICES BUILDING

1.00	Total Sub-Structure	3	50%						0	0	0	0	77,017	0.0%			Element	Observed Deterioration/Recommendations
2.00	Total Frame	4	70%						12,650	0	0	12,650	82,295	15.4%

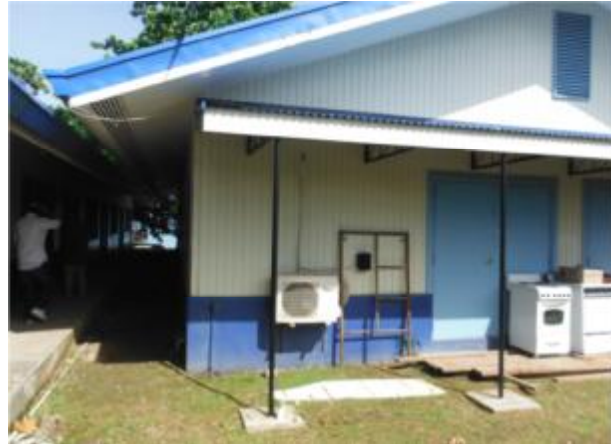
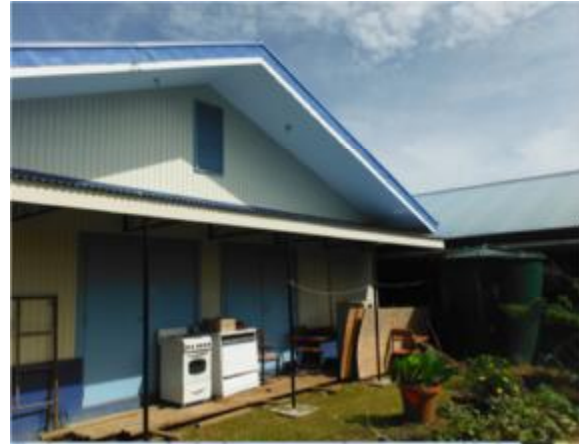
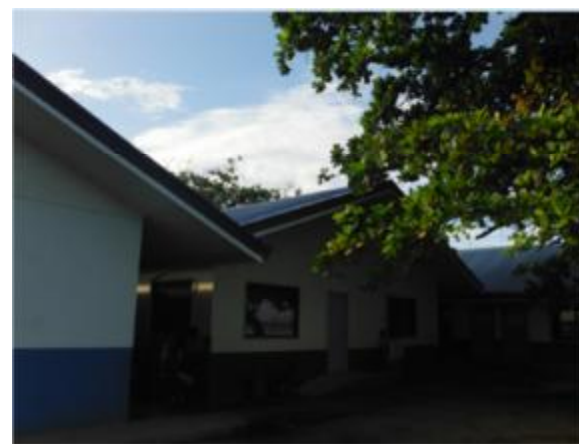
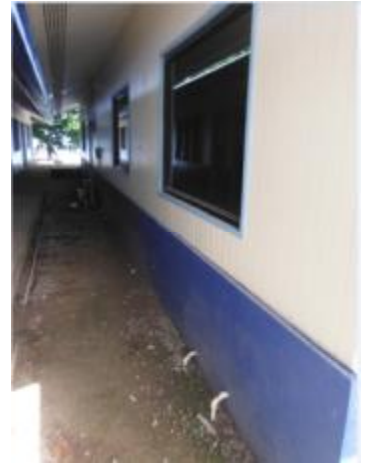
F – CRE BUILDING

1.00	Total Sub-Structure	2	30%						0	0	0	0	49,277	0.0%	Element	Observed Deterioration/Recommendations
2.00	Total Frame	3	50%						0	0	0	0	62,498	0.0%

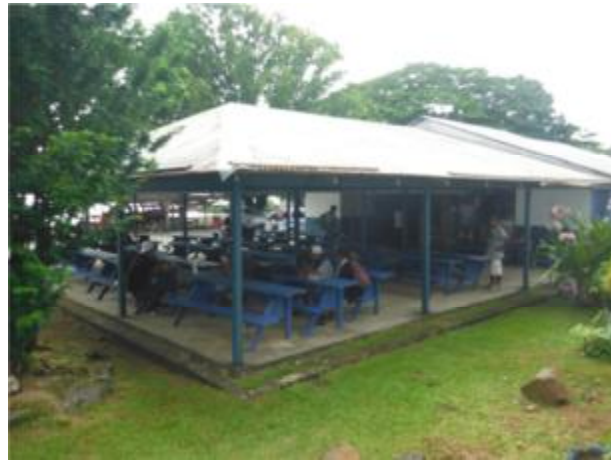
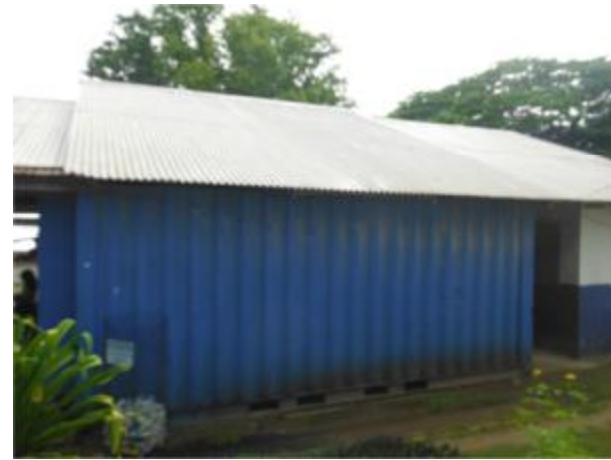
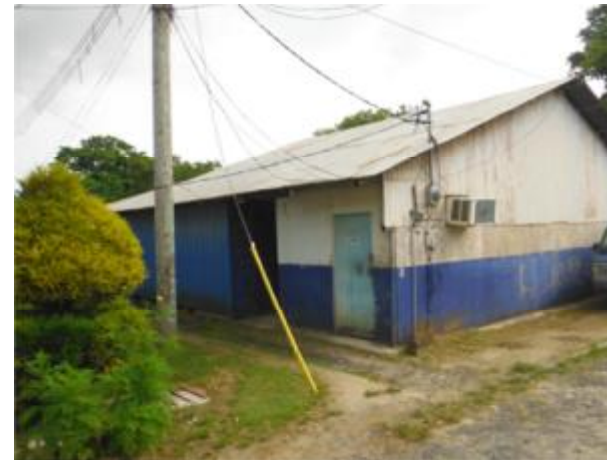
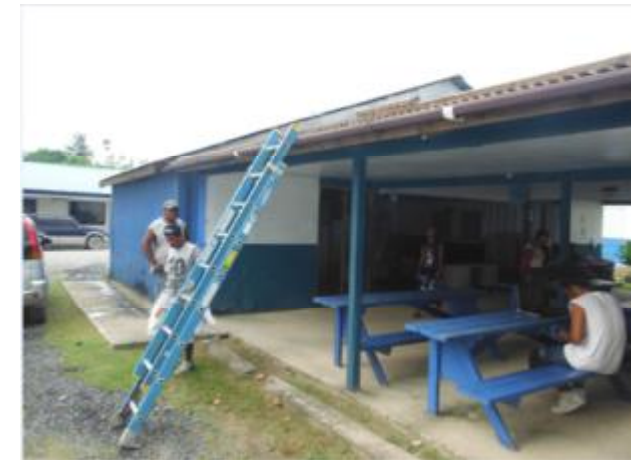
**CHUUK CAMPUS, NEPUKOS WENO, CHUUK STATE**
**J - STUDENT CENTER**

1.00	Total Sub-Structure	3	50%						0	0	0	0	77,017	0.0%	PVC Downpipes			Missing
2.00	Total Frame	4	70%						12,650	0	0	12,650	82,295	15.4%				
3.00	Total Structural Walls	4	70%						0	21,233	0	21,233	21,233	100.0%

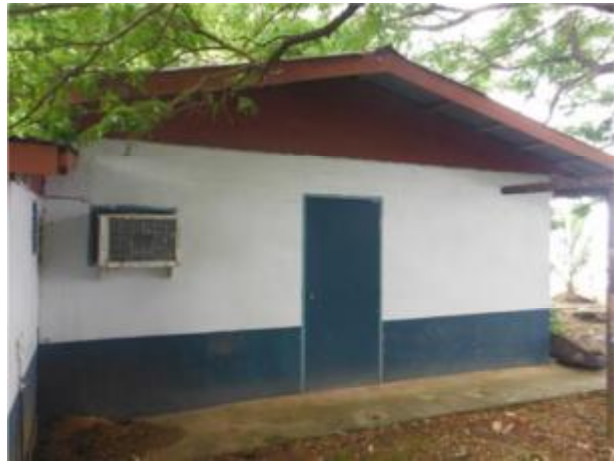
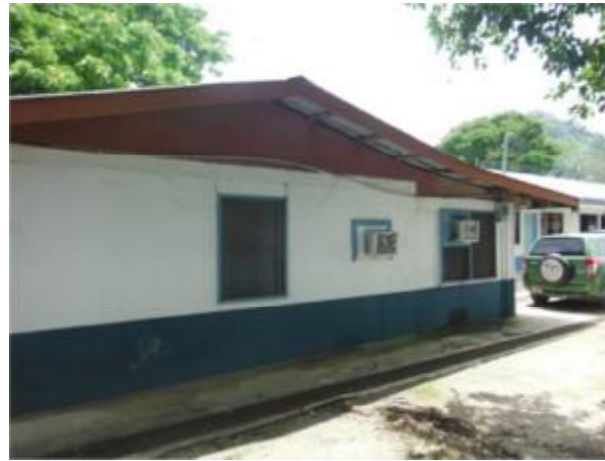
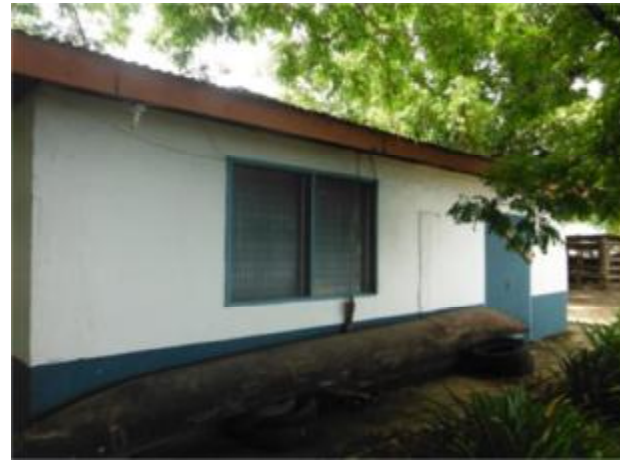
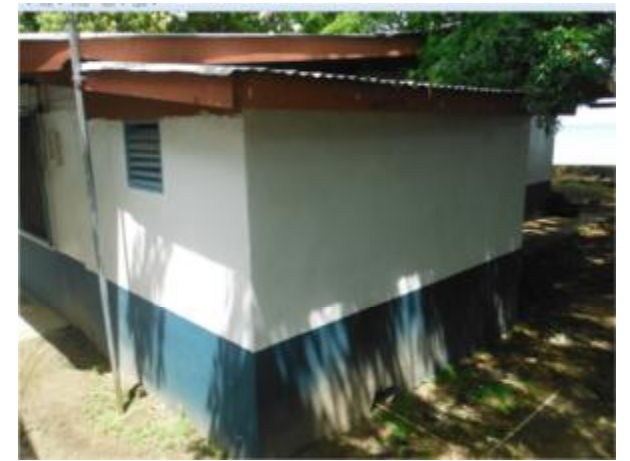
**CHUUK CAMPUS, NEPUKOS WENO, CHUUK STATE**
**D – CAMPUS DEAN’S OFFICE**

1.00	Total Sub-Structure	3	50%						0	0	0	0	35,886	0.0%		
2.00	Total Frame	3	50%						0	0	27,618	27,618	27,618	100.0%		
3.00	Total Structural Walls	4	70%						0	0	40,020	40,020	40,020	100.0%

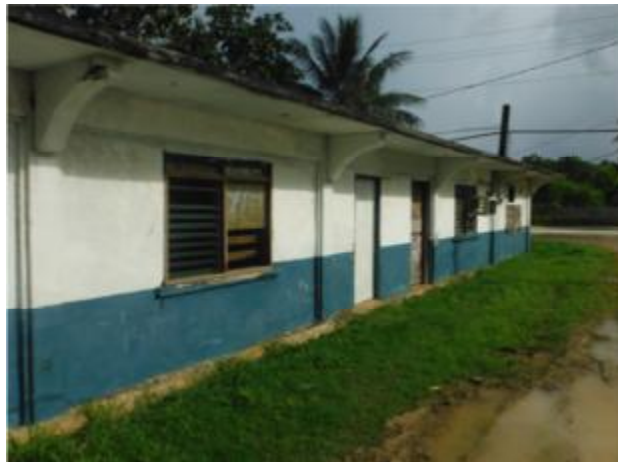
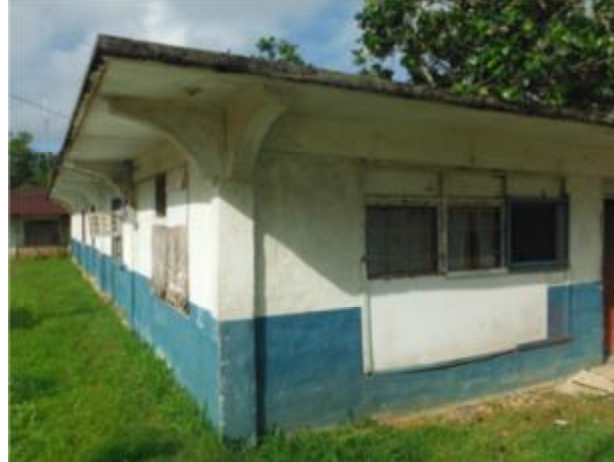
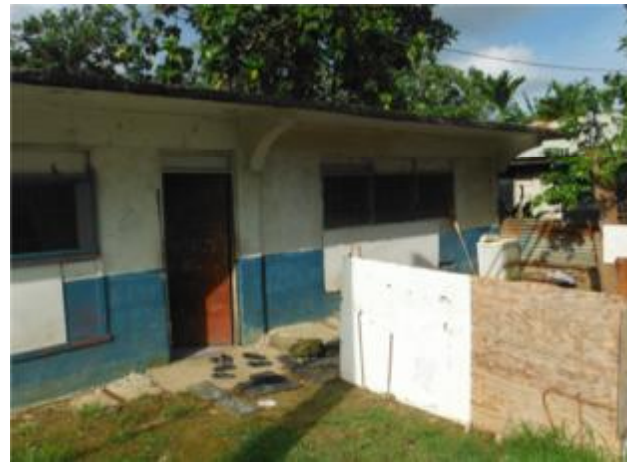
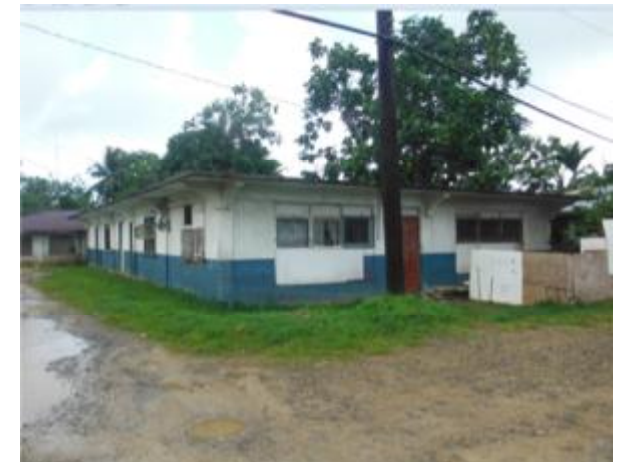
**CHUUK CAMPUS, NEPUKOS WENO, CHUUK STATE**
**M - MIDTOWN (OFF CAMPUS)**

1. Midtown (off-campus) Building. 20% of the operational cost is dedicated to this off-campus building that is not owned by COM-FSM and is showing signs of significant structural and elemental failure. The use of this asset must be considered and if it is no longer required then operational costs could be reduced by diverting them to other facilities.

1.00	Total Sub-Structure	4	70%						0	0	48,699	48,699	48,699	100.0%	Element	Observed Deterioration/Recommendations
2.00	Total Frame	0	0%						0	0	0	0	0	0.0%
