College of Micronesia - FSM Space Utilization and Facilities Master Plan Study, Part 3 - Detailed Report for the Yap Campus

Prepared for the College of Micronesia - FSM

Prepared by Beca International Consultants Ltd (Beca)

28 November 2013

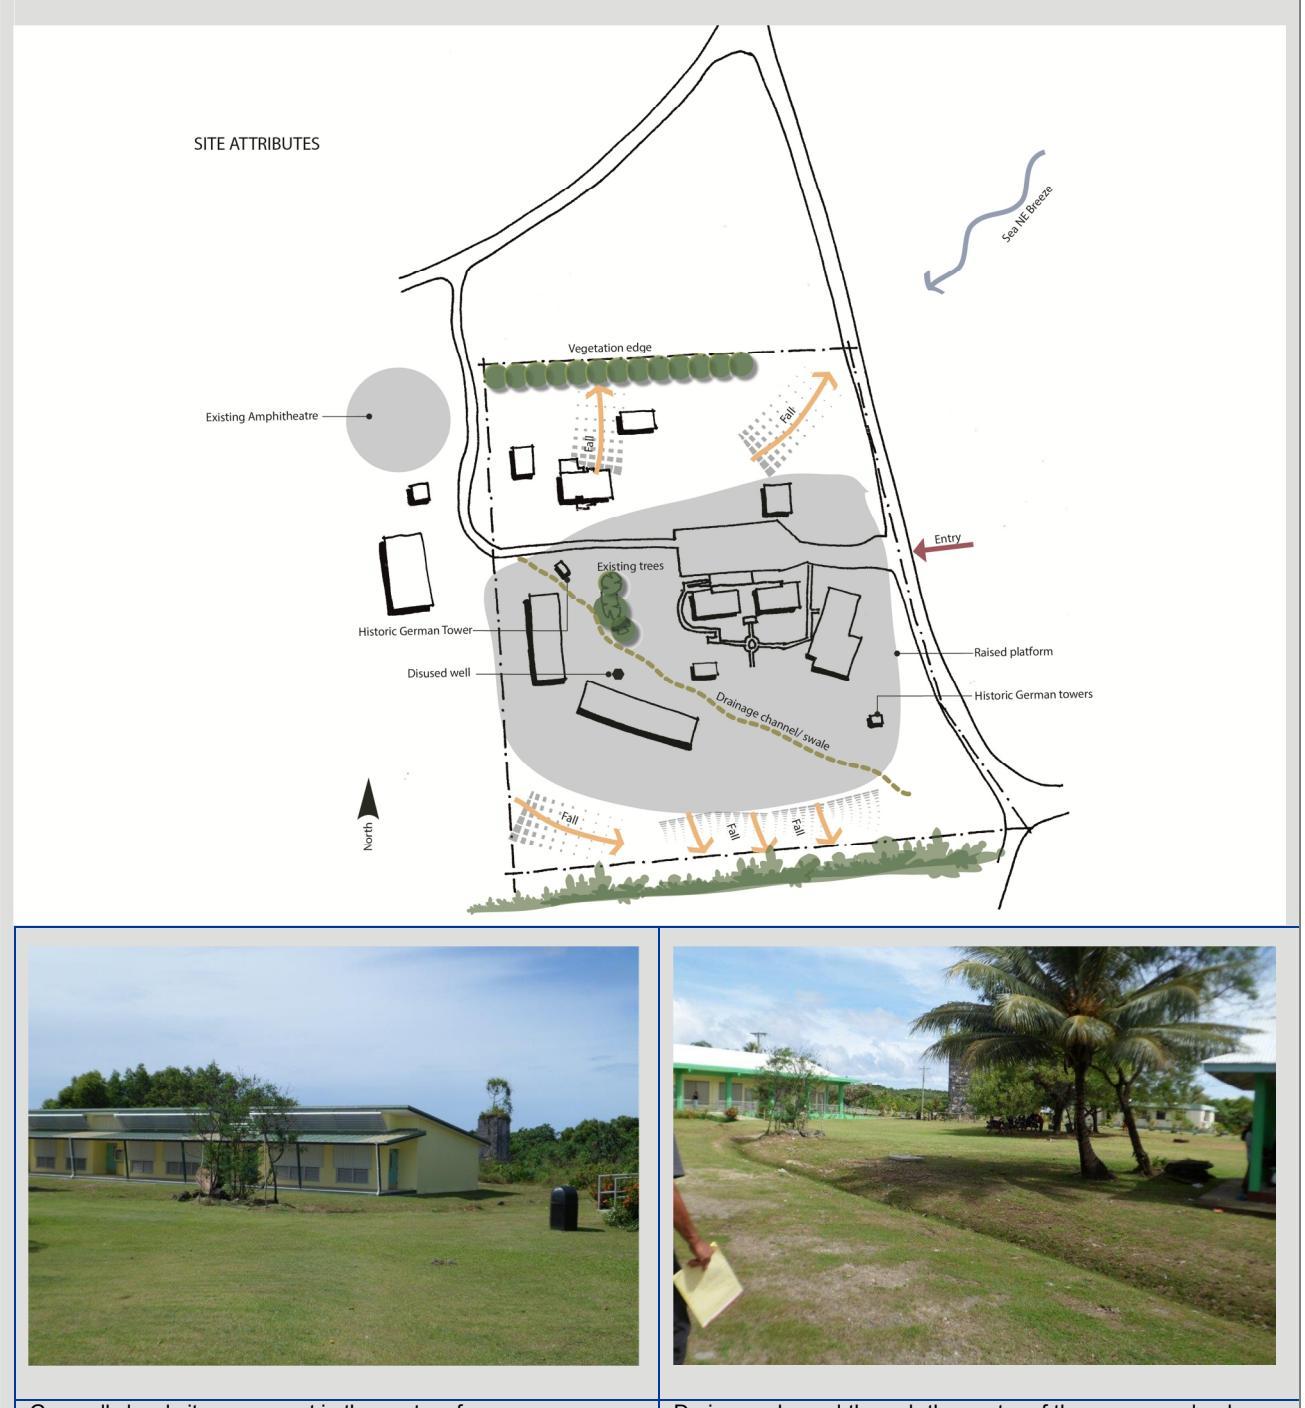
Generally level site - an asset in the centre of a campus

Drainage channel through the centre of the campus - landscape treatment and pedestrian access across needs to be considered

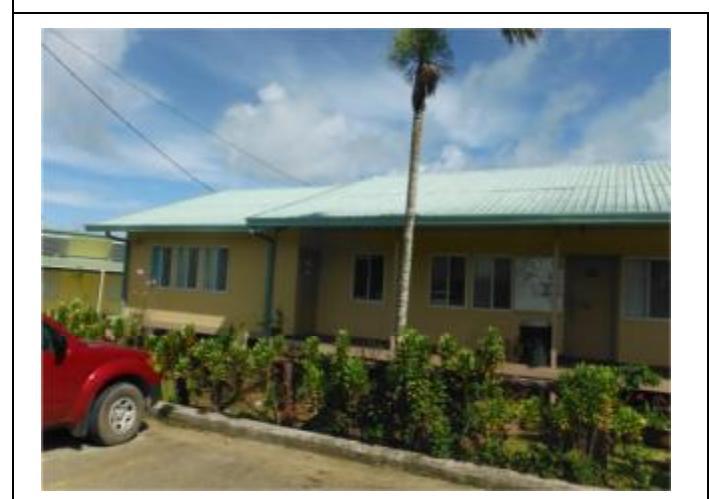
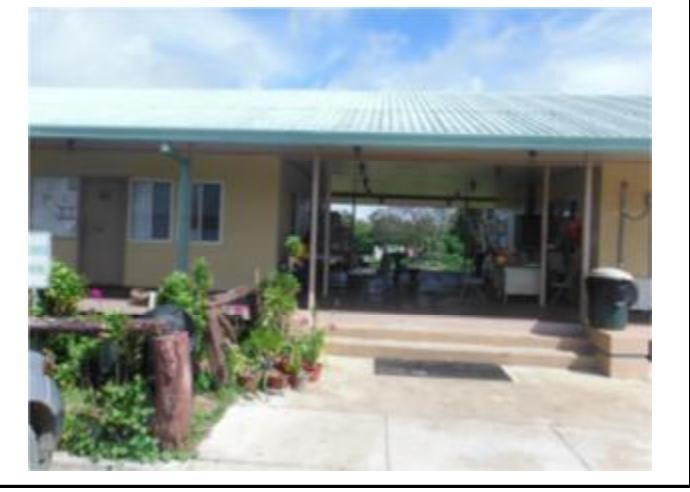
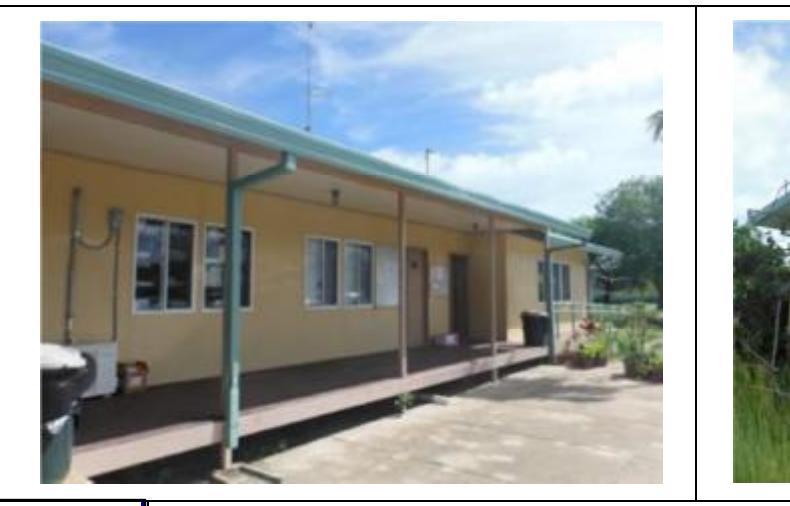
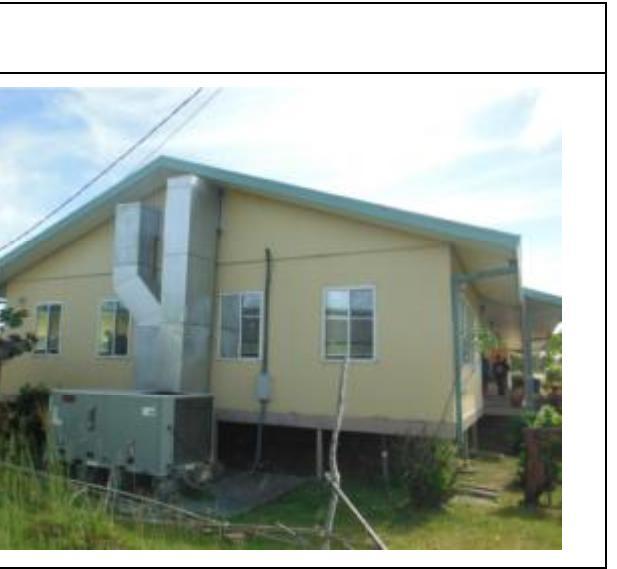
A – ADMINISTRATION BUILDING

- 1. Building A Administration Building. The severe corrosion of the steel substructure and decay ion the timber flooring makes this building, in our opinion, uneconomic to renew and maintain. We consider that minimum operational costs should be spent on this asset (i.e. carry out protection /health and safety remedial works only) and that the asset should be run-down and replaced in 2018 or before.

1.00	Total Sub-Structure	5	90%						75,110	0	40,628	115,738	115,738	100.0%	Element	C
2.00	Total Frame	3	50%						0	0	0	0	92,502	0.0%		_
3.00	Total Structural Walls	3	50%						0	0	23,920	23,920	23,920	100.0%	Steel Framed Floor on Steel Pile Foundations	S

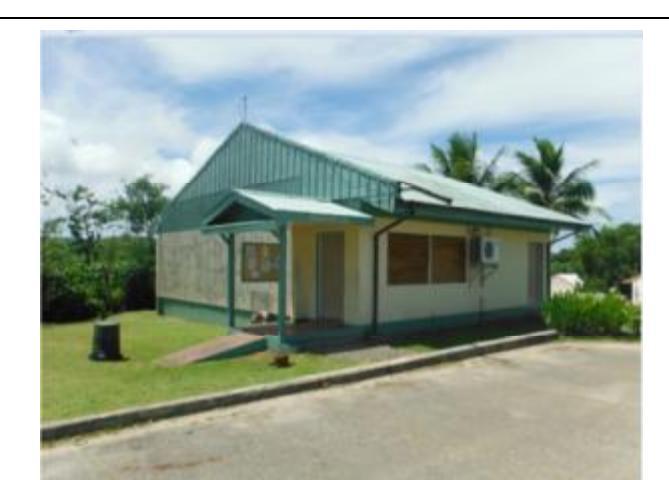
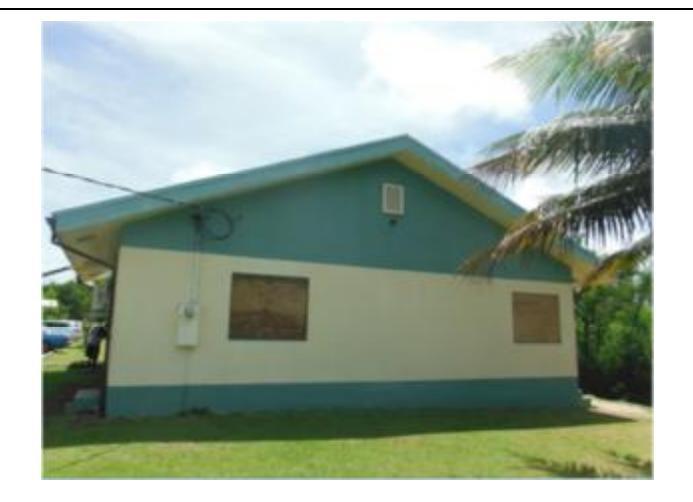
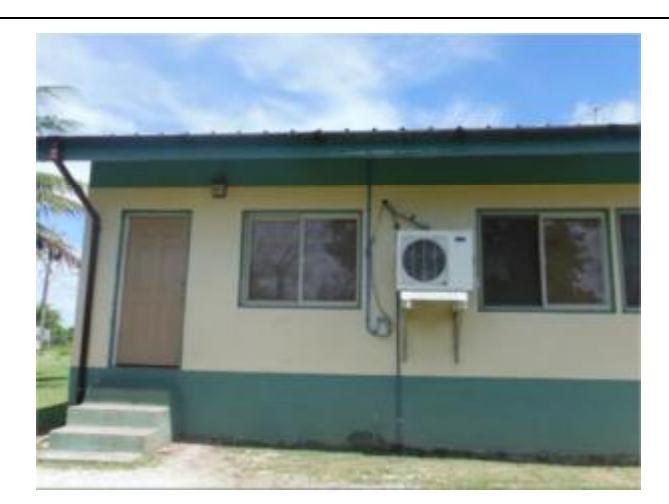
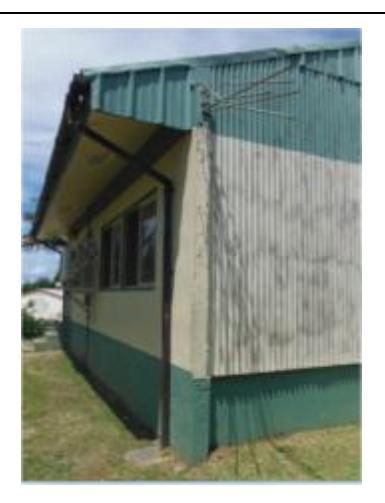
B - COMPUTER LAB

1.00	Total Sub-Structure	3	50%						0	0	0	0	36,875	0.0%		Τ
2.00	Total Frame	1	10%						0	0	0	0	28,211	0.0%	Element	
3.00	Total Structural Walls	3	50%						0	0	0	0	20,351	0.0%	1	_

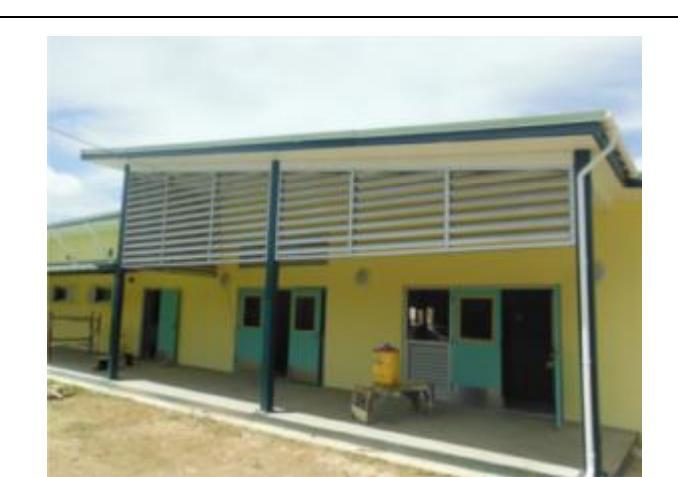
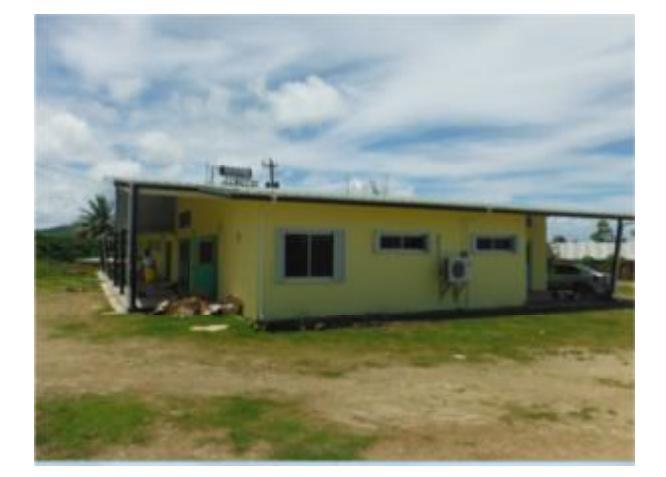
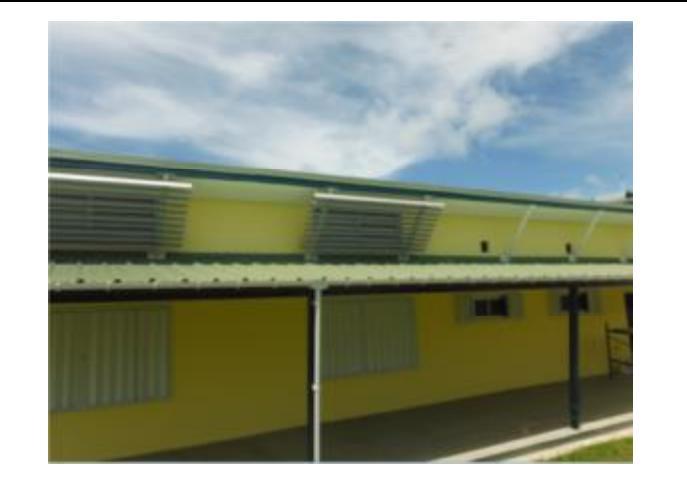
E - STUDENT CENTER BUILDING (NEW)

1.00	Total Sub-Structure	1	10%						0	0	0	0	115,097	0.0%		Τ
2.00	Total Frame	1	10%						0	0	0	0	71,633	0.0%	Element	
3.00	Total Structural Walls	1	10%						0	0	0	0	171,305	0.0%		T

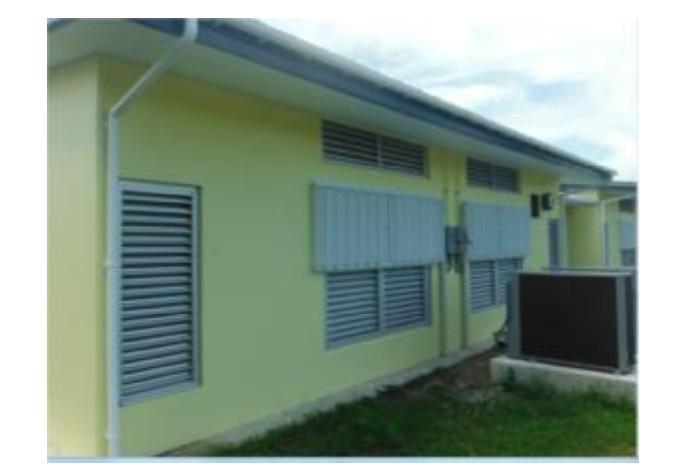
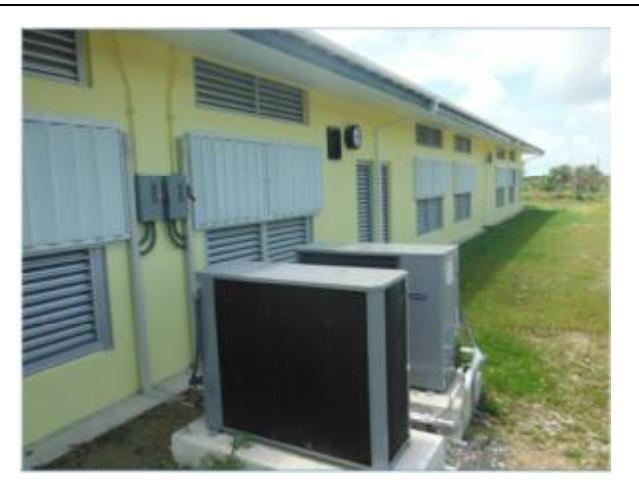
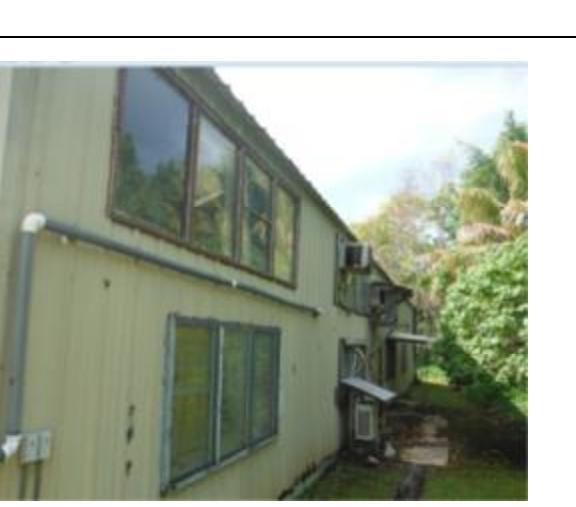
F - CLASSROOM BUILDING (NEW)

1.00	Total Sub-Structure	1	10%						0	0	0	0	145,983	0.0%		Γ
2.00	Total Frame	1	10%						0	0	0	0	113,836	0.0%	Element	0
3.00	Total Structural Walls	1	10%						0	0	0	0	185,837	0.0%	-	1

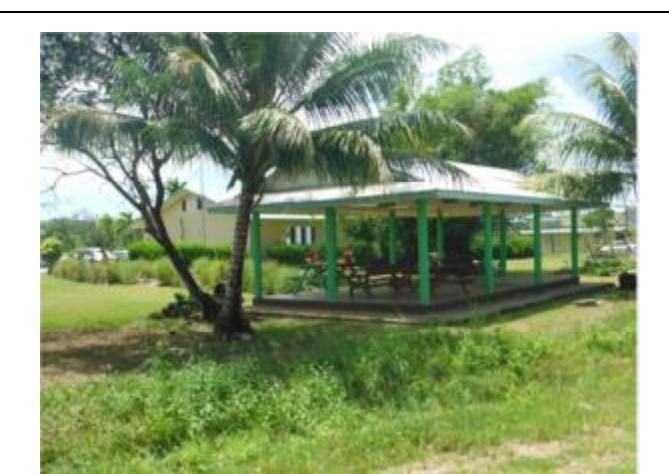
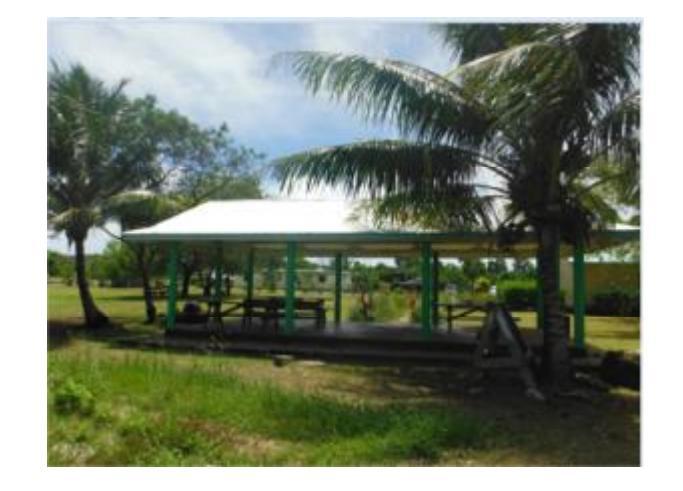
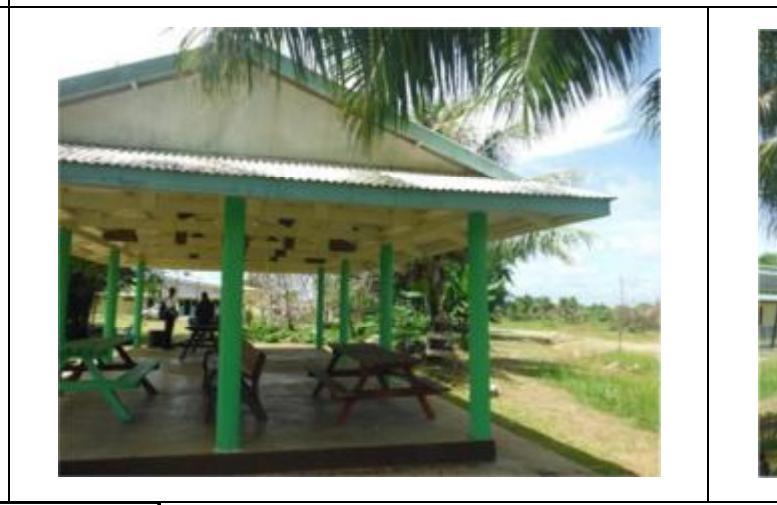
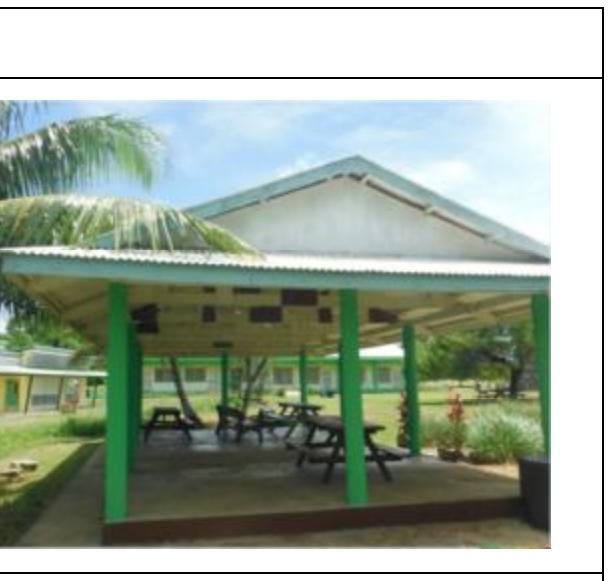
H - STUDENT OPEN LOUNGE

1.00	Total Sub-Structure	3	50%						0	0	0	0	19,309	0.0%		Τ
2.00	Total Frame	3	50%						0	0	0	0	28,999	0.0%	Element	C
3.00	Total Structural Walls	0	0%						0	0	0	0	0	0.0%
