College of Micronesia - FSM Space Utilization and Facilities Master Plan Study, Part 3 - Detailed Report for the Chuuk Campus

Prepared by Beca International Consultants Ltd (Beca)

28 February 2014

CHUUK CAMPUS, NEPUKOS WENO, CHUUK STATE

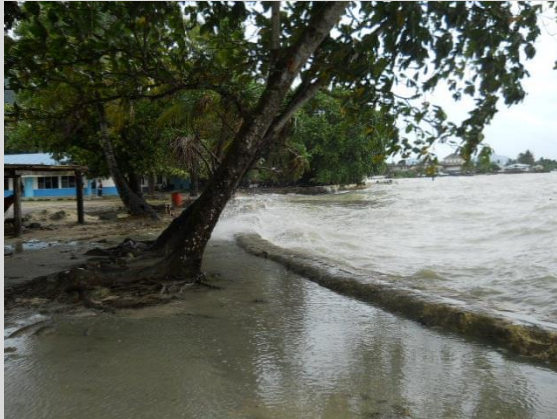
Exposure of the current site to storm surges with flooding of the buildings close to the sea frontage

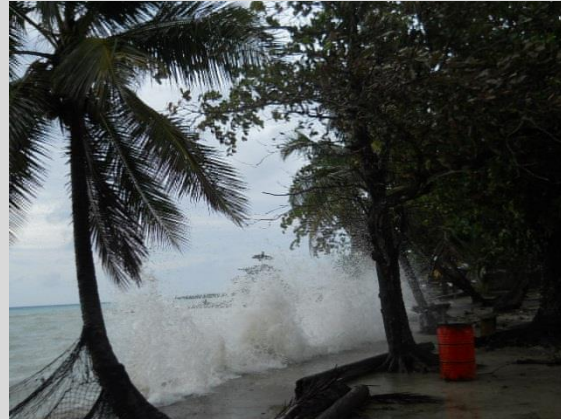
Exposure of the current site to storm surges with flooding of the buildings close to the sea frontage

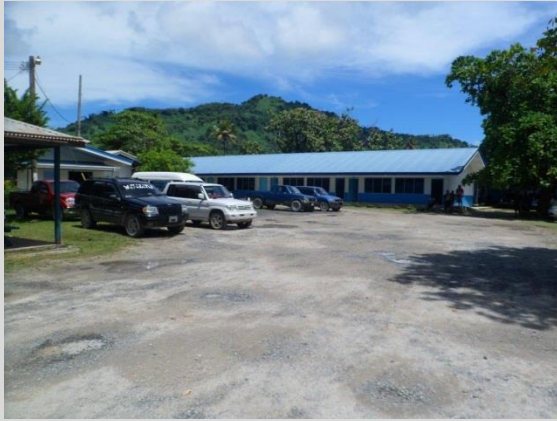
Cars park through the campus in a space that should be a pedestrian area

- Relocate the car parking zone from the center to the edge of the campus
- With the removal of cars from the campus provide seating and recreation spaces

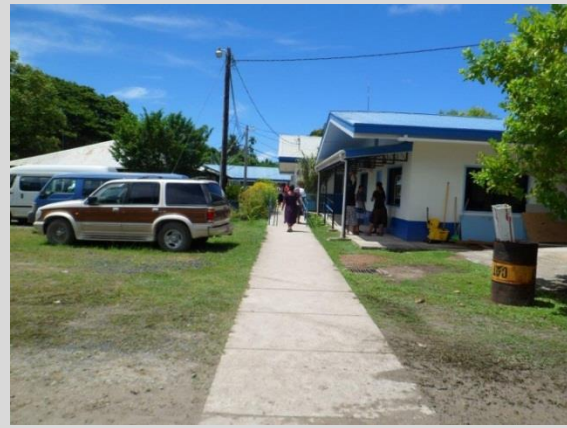
Space in front of buildings that could be used by students is occupied parked cars

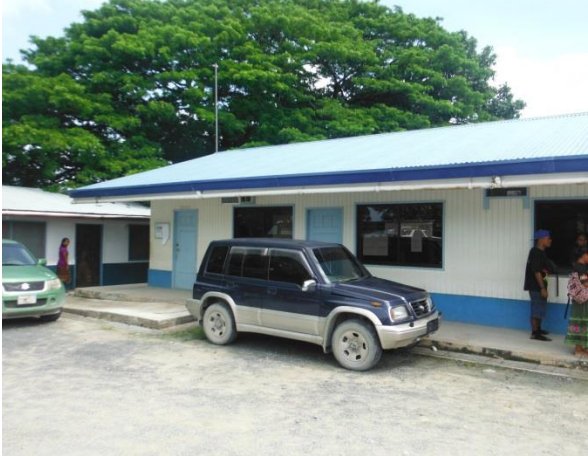
Building A - Faculty Offices

<p>Building A is the faculty offices with a mix of student service or administrative programs</p> <p>Location for its function – well located at the entry of the campus</p> <p>Quality and suitability of spaces for its function – The faculty rooms are a good size, additional space for storage of files would be beneficial. Considering using long desks instead of L shaped workstations to free up space</p> <p>Disabled access - Ramp access</p> <p>Teaching spaces - Nil</p> <p>Amenities, toilets - Single toilet for staff and a small kitchen bench. A lounge area attached to this space would enable staff to meet outside of the faculty rooms assisting collaborative work practices.</p> <p>Building condition points - Targeted regular maintenance and cleaning. Treat or replace rusted rainwater heads immediately. Repair decay (and any leaks) in soffit lining immediately.</p> <p>Building age – 7 years (mid 2000's)</p>

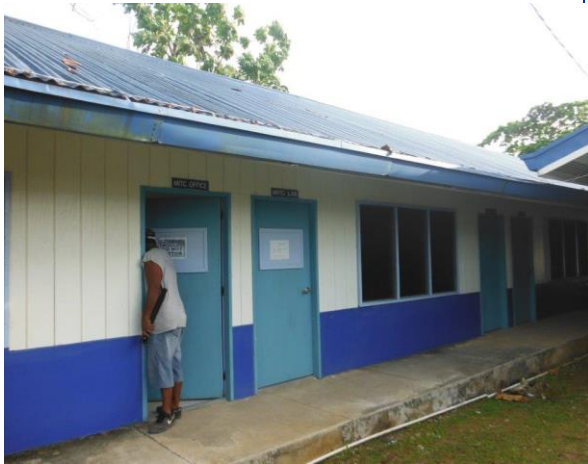
C – Classroom Building C

Building condition points - Targeted regular maintenance and cleaning. Treat and spot prime rusted roofing immediately. Review roof and consider re-painting. Treat and repair termite damage to windows.

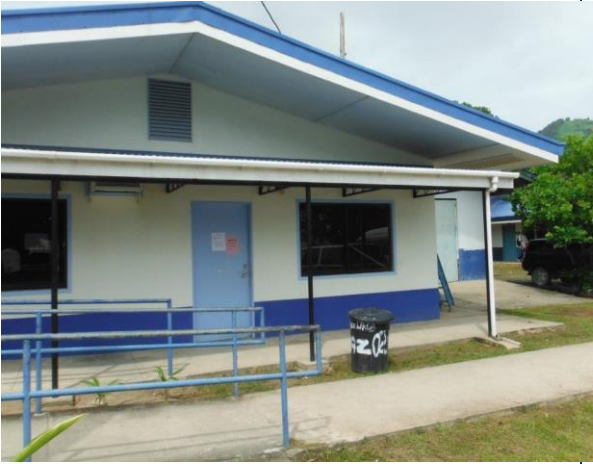
Building	Outline
<p>H – Student Services building</p>

<p>Building H is the student services building</p> <p>Location for its function – well located but proximity to other buildings limits cross ventilation on site</p> <p>Quality and suitability of spaces for its function – open area is a good size but there is compromised space for quiet and group study to occur at the structure</p> <p>Disabled access - ramp access</p> <p>Teaching spaces - nil</p> <p>Amenities, toilets - nil</p> <p>Building condition points – Targeted regular maintenance and cleaning. Rust treat, repaint and clean roof and structural steel frame immediately.</p> <p>Building age - 9 years (early 2000's)</p>
<p>I - Computer Lab</p>

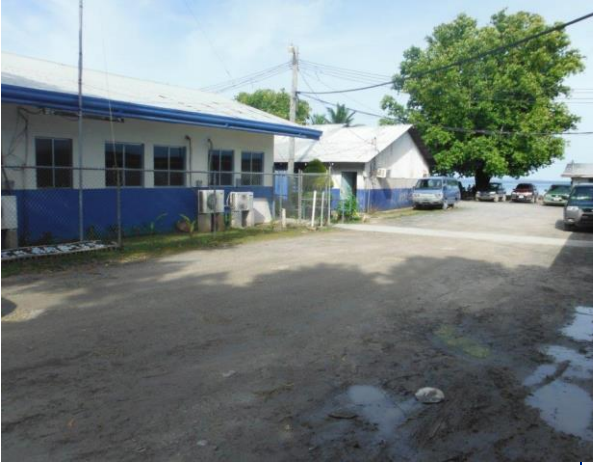
<p>Building I is a computer lab</p> <p>Location for its function – well located but its proximity to other buildings limits cross ventilation through the site</p> <p>Quality and suitability of spaces for its function – more space is required for the services provided; repair/the office/storage</p> <p>Disabled access - ramp access, hand rails</p> <p>Teaching spaces – computer lab, 750 sqft</p> <p>Amenities, toilets - nil</p> <p>Building condition points - Targeted regular maintenance and cleaning. Rust treat, repaint and clean roof and gutters immediately, or review replacement of roof and gutters. Repair boarded up windows and install security louvers.</p> <p>Building age – 5 years (late 2000's)</p> <div style="text-align: center;"> <p>Computer Lab</p>

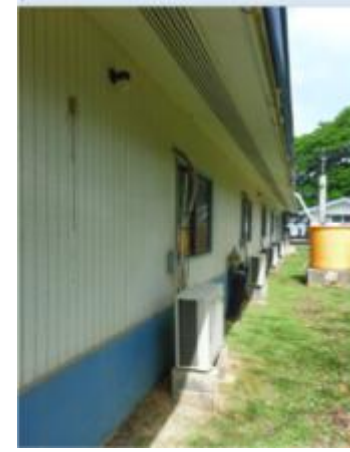
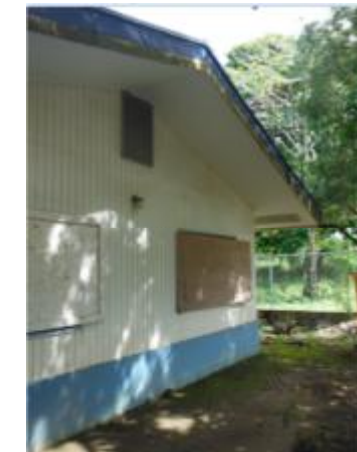
A – ADMINISTRATION/FACULTY OFFICES

1.00	Total Sub-Structure	2	30%						0	0	0	0	89,053	0.0%	Metal Rain Water Heads	Rusted out in parts
2.00	Total Frame	2	30%						0	0	0	0	94,762	0.0%		
3.00	Total Structural Walls	2	30%						0	0	0	0	53,452	0.0%	Profiled Metal Sheet Roof Cladding (Pre-Finished)	Faded paint to roof

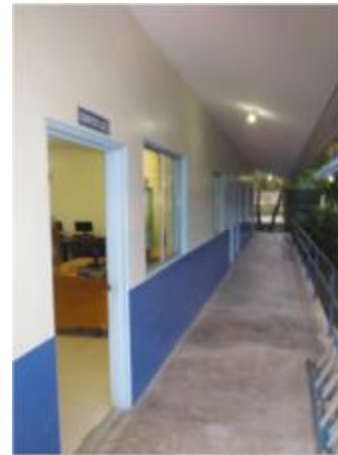
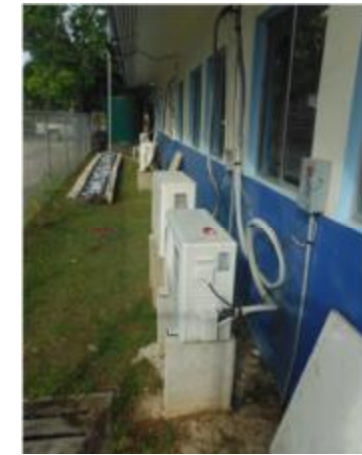
I - COMPUTER LAB

1.00	Total Sub-Structure	2	30%						0	0	0	0	44,851	0.0%	Element	Observed Deterioration/Recommendations
2.00	Total Frame	2	30%						0	0	0	0	83,010	0.0%

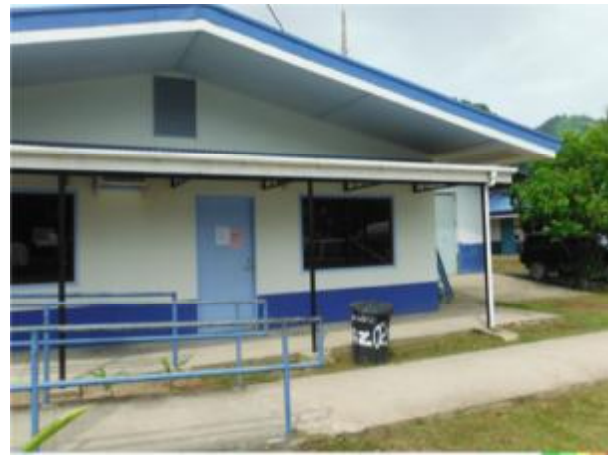
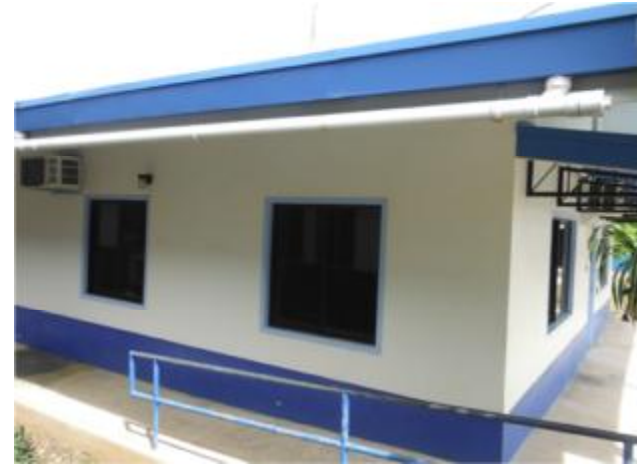
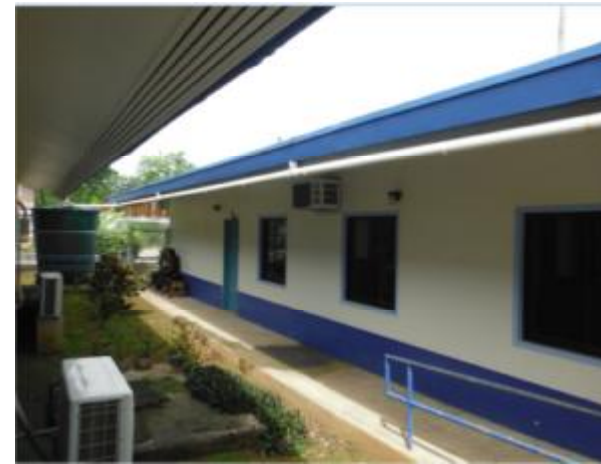
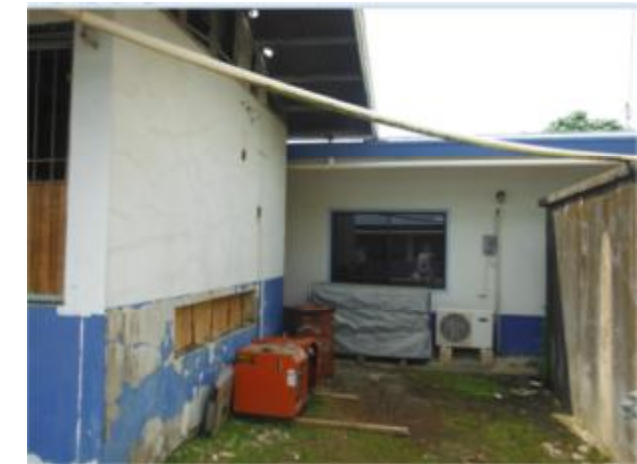
H – STUDENT SERVICES BUILDING

1.00	Total Sub-Structure	3	50%						0	0	0	0	77,017	0.0%
2.00	Total Frame	4	70%						12,650	0	0	12,650	82,295	15.4%
3.00	Total Structural Walls	4	70%						0	21,233	0	21,233	21,233	100.0%

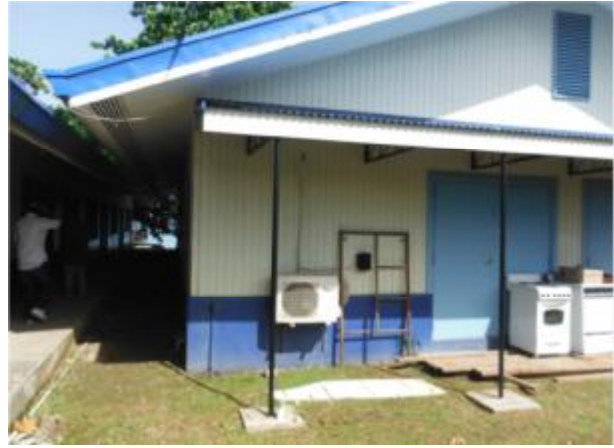
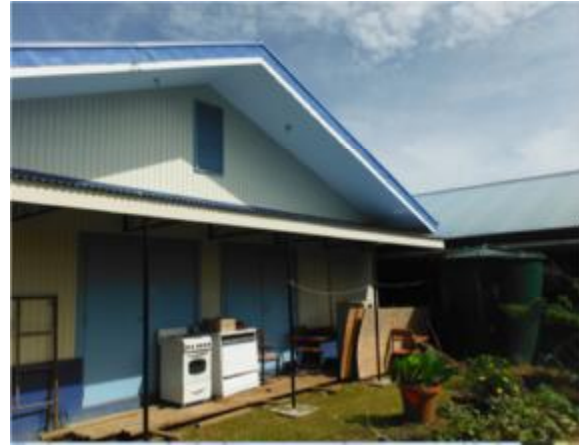
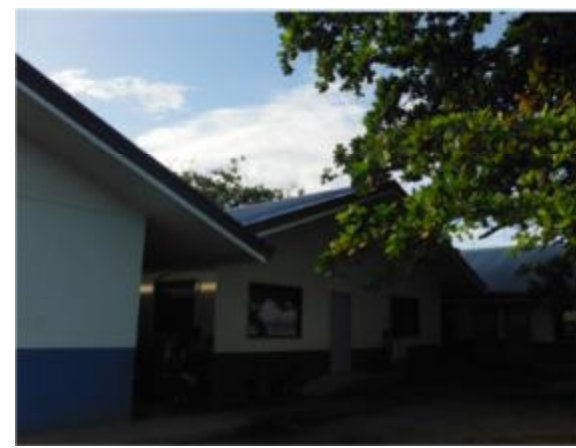
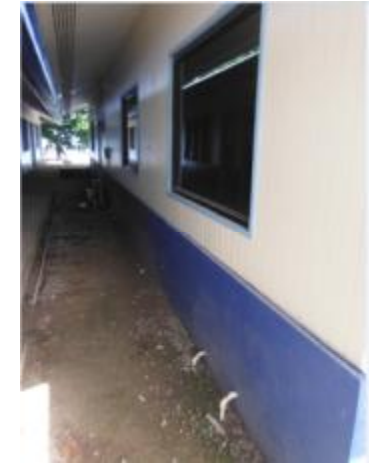
F – CRE BUILDING

1.00	Total Sub-Structure	2	30%						0	0	0	0	49,277	0.0%	TOP 5 MAJOR ELEMENTS REQUIRING URGENT MAINTENANCE, RENEWAL OR REPLACEMENT Element Observed Deterioration/Recommendations Metal Rain Water Heads Corrosion at top. Some steel not protected Metal Gutters Corrosion to gutters Plywood Shadowclad with Painted Finishes Ok condition. Rusted flashings apparent and joints at front gable end needs attention Vinyl Floor Finishes - Tiled Minor damage to tiles around exterior doors due to high traffic area, gaps between tiles, dust build-up Fibre Cement Soffit Lining with Painted Finishes Damage to some corners Overall Recommendation/Action Targeted regular maintenance and cleaning. Rust treat, repaint and clean roof, gutters and wall flashings immediately. Refurbish floor, wall and ceiling finishes by 2023. Regularly maintain and replace mechanical, fire and special services by 2023

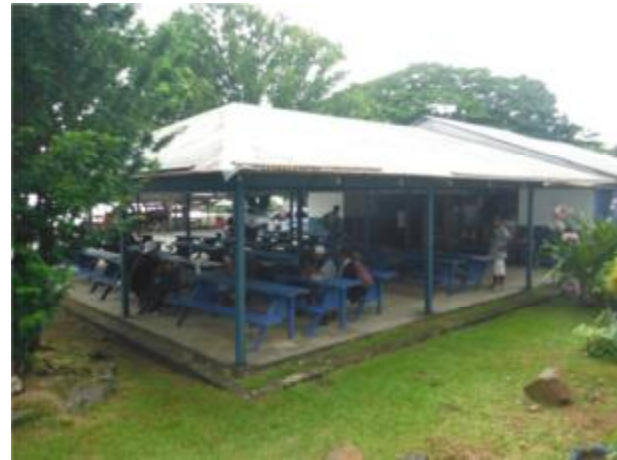
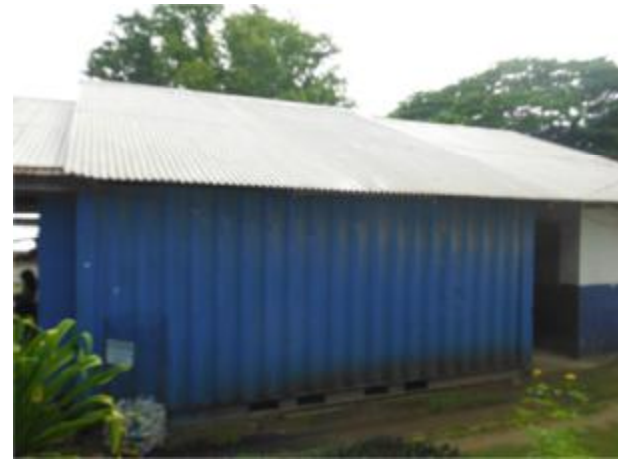
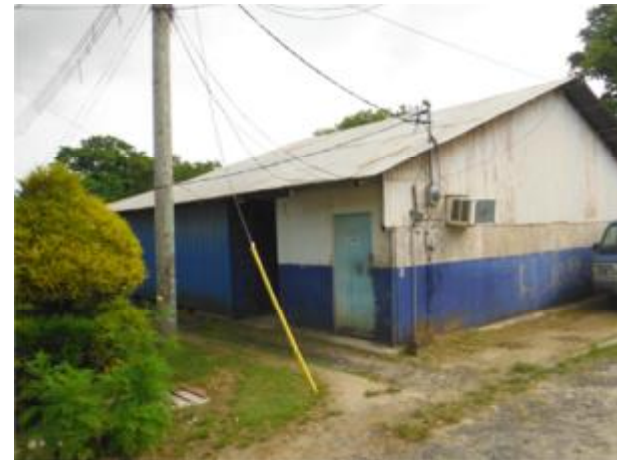
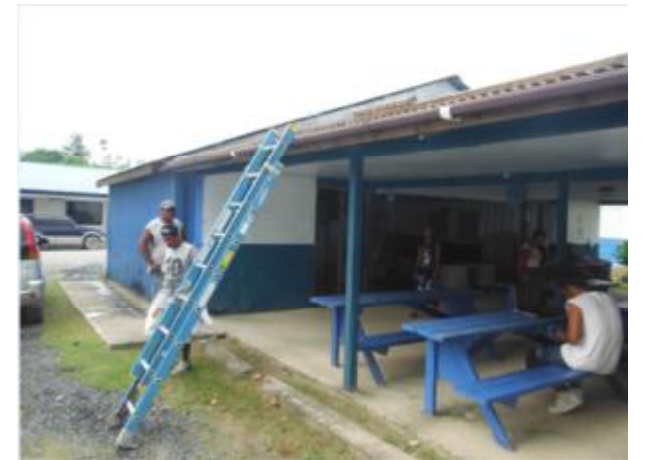
J - STUDENT CENTER

1.00	Total Sub-Structure	3	50%						0	0	0	0	77,017	0.0%	PVC Downpipes	Missing	
2.00	Total Frame	4	70%						12,650	0	0	12,650	82,295	15.4%			
3.00	Total Structural Walls	4	70%						0	21,233	0	21,233	21,233	100.0%	Metal Gutters	To unenclosed area only, No end on gutters, missing portions

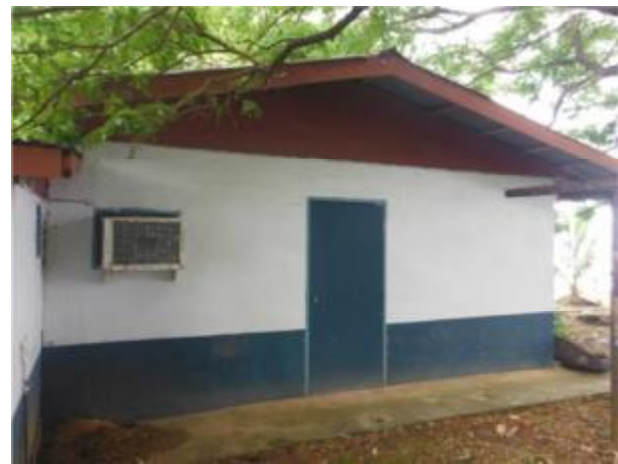
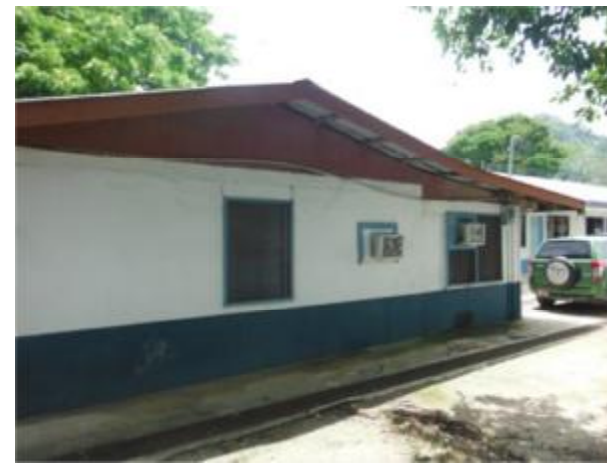
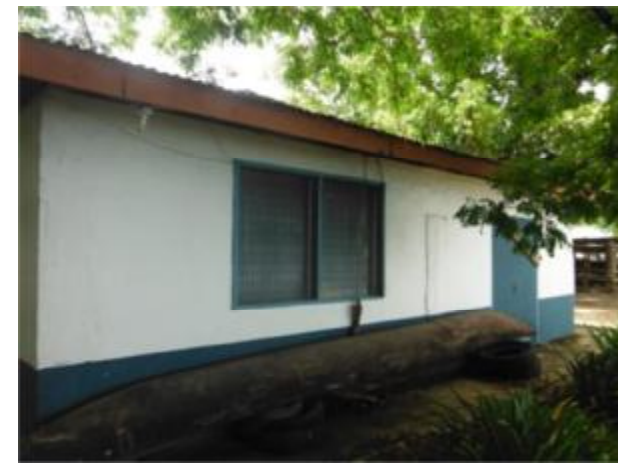
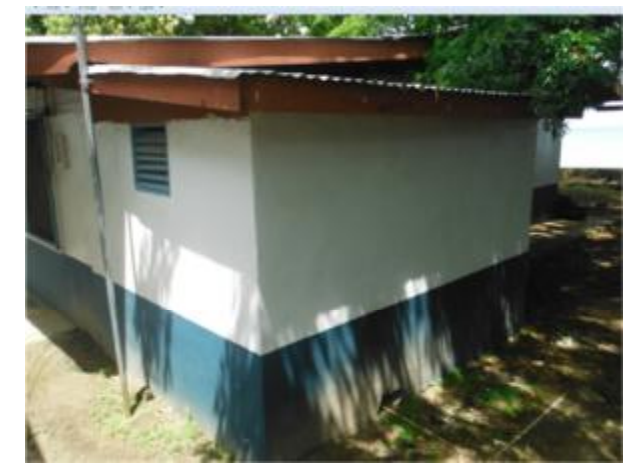
D – CAMPUS DEAN’S OFFICE

1.00	Total Sub-Structure	3	50%						0	0	0	0	35,886	0.0%		
2.00	Total Frame	3	50%						0	0	27,618	27,618	27,618	100.0%		
3.00	Total Structural Walls	4	70%						0	0	40,020	40,020	40,020	100.0%

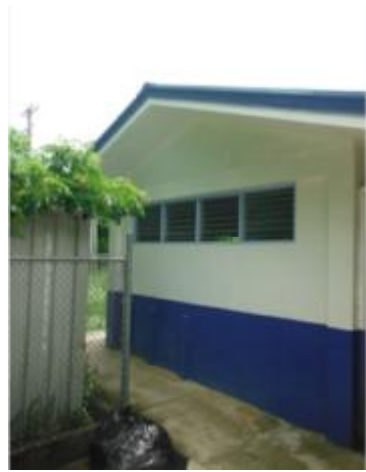
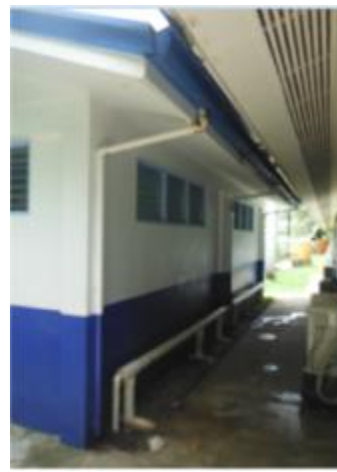
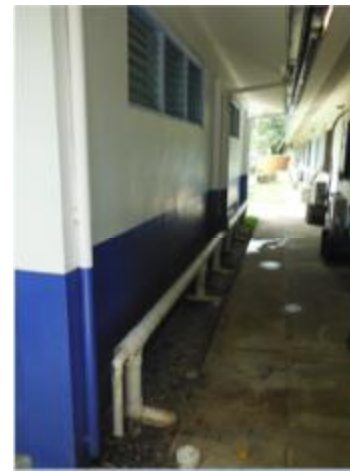
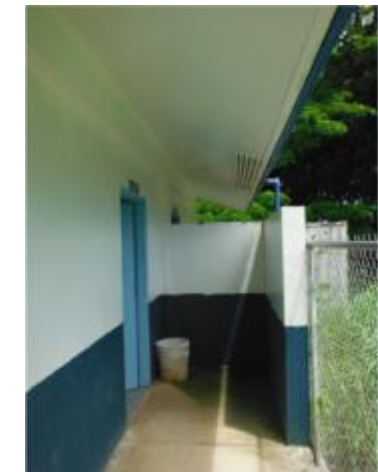
E - RESTROOMS

19.00	Total Vertical Transportation	0	0%						0	0	0	0	0	0.0%			
20.00	Total Special Services	0	0%						0	0	0	0	0	0.0%			
C	TOTAL BUILDING SERVICES	2	30%						0	28,463	0	28,463	40,662	70.0%			
	TOTAL BUILDING	3	50%						0	78,524	17,171	95,695	192,464	49.7%			
															Overall Recommendation/Action	Targeted regular maintenance and cleaning. To extend asset life
