College of Micronesia - FSM Space Utilization and Facilities Master Plan Study, Part 3 - Detailed Report for the National Campus

Prepared for the College of Micronesia - FSM

Prepared by Beca International Consultants Ltd (Beca)

28 February 2014

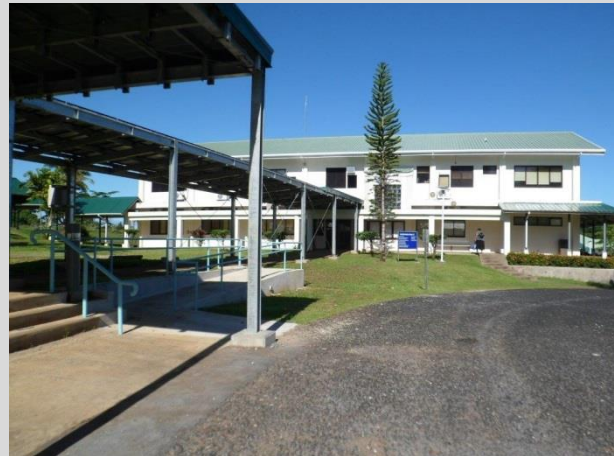
Main entry - provision for disabled access, additional seating and cover for pick up drop off area requested through the focus group discussions

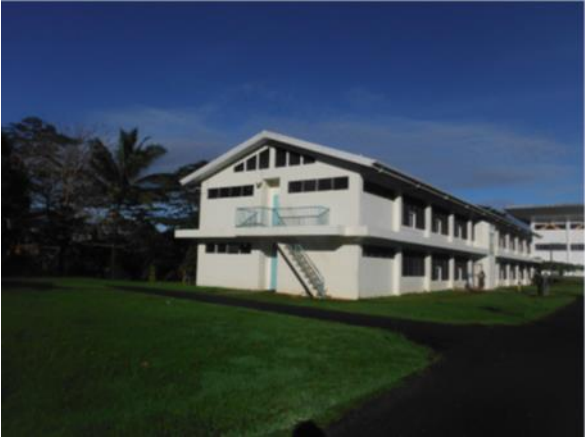
| Building | Outline |
|---|---|
| <p>Building D – Men’s Residence Hall</p> <p>Points to consider for future planning – Increase access to wifi connection - currently patchy connection available</p> | <p>Building D is the two storey men’s residence hall</p> <p>Location for its function – Well located in the accommodation zone adjacent to the basketball hard-court area and the soccer field to the north and the student services facilities</p> <p>Quality and suitability of spaces for its function – The rooms were designed for four students. This has been revised in practice to three students. There are 29 rooms with an ability to accommodate 87 students</p> <p>Disabled access - access only to the ground floor, toilets/showers not designed to be accessible</p> <p>Amenities, toilets - 8 toilets in total</p> <p>Building condition points - Treat rust and spot prime corroded gutters and re-paint roof immediately. Check roof for rust and treat if necessary. Repair water damage/leaks to ceiling/soffit immediately. Refurbish floor finishes by 2023. Regularly maintain and replace mechanical, fire and special services by 2023</p> <p>Building age -17 years</p> |

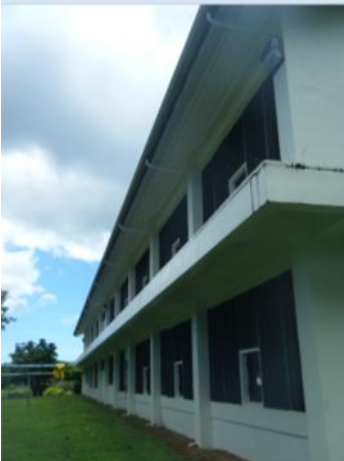
| Building | Outline |
|---|---|
| <p>Building E - Women’s Residence Hall</p> <p>Points to consider for future planning – Provide a place where students can meet with matrons to discuss private issues</p> | <p>Building E is the two storey women’s residence hall</p> <p>Location for its function - Well located in the accommodation zone adjacent to the student services facilities</p> <p>Quality and suitability of spaces for its function - – The rooms were designed for four students. This has been revised in practice to three students. There are 19 rooms with an ability to accommodate 57 students</p> <p>Disabled access - access only to the ground floor, toilets/showers not designed to be accessible</p> <p>Amenities, toilets - 8 toilets in total</p> <p>Building condition points - Targeted regular maintenance and cleaning to extend asset life. Repair water damage/leaks to ceiling/soffit immediately. Repair leaking AC unit and treat corrosion immediately. Refurbish floor finishes by 2023. Regularly maintain and replace mechanical, fire and special services by 2023</p> <p>Building age -17 years</p> |

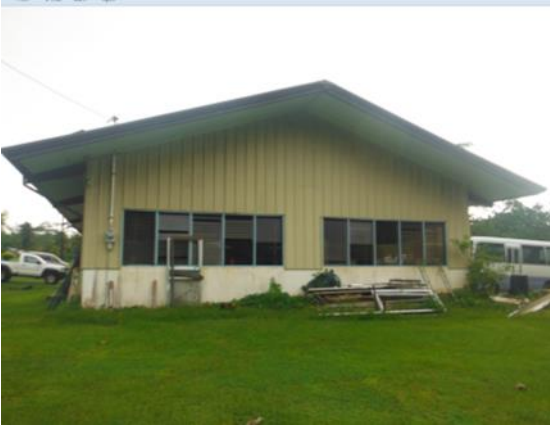
| Building | Outline |
|--|---|
| <p>Building N – Maintenance, CRE, Music Classroom</p> | <p>Building N is the maintenance area, CRE and music room</p> <p>Location for its function – The music room seems disconnected from the rest of the campus - a location in the academic zone in a suitably acoustically treated space would seem more appropriate</p> <p>Quality and suitability of spaces for its function – Wide span building suits the maintenance function</p> <p>Disabled access - level access</p> <p>Teaching spaces - nil</p> <p>Amenities, toilets - 1 mens/ 1 womens</p> <p>Building condition points - Localized roof, gutter and soffit repairs or rust treatment required immediately</p> <p>Building age – 17 years, mid 1990s</p> |

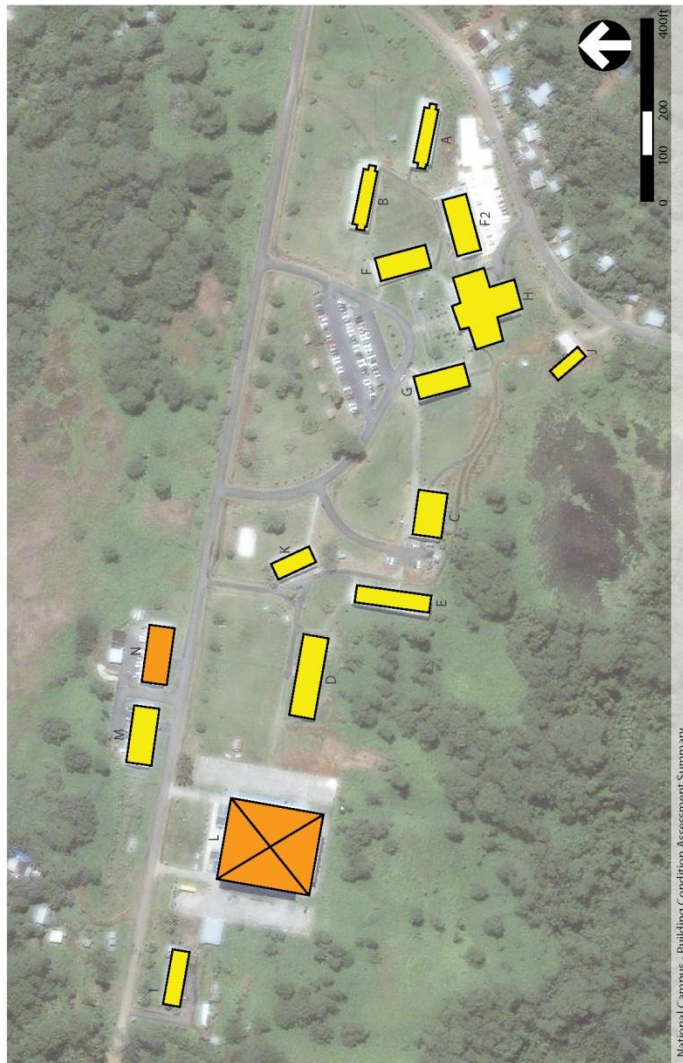
National Campus - Building Condition Assessment Summary

From our condition assessment of the National campus we observe the following:

1. China Friendship Sports Center. 31% of the operational costs are dedicated to this building which has a condition grade 4 highlighting that it is in poor condition and is showing signs of significant failure. Replacement windows (a health and safety issue) and the repair of leaks are required urgently. This asset needs specific funding to prevent deterioration and to extend its life.

3. The majority of the buildings are rated as condition grade 3 which means that these assets are reaching the end of their serviceable life, but they are still functioning as intended. Targeted regular maintenance on all of the assets is required to extend their life. A clear, well organised asset renewal and routine maintenance plan needs to be developed and this needs to be implemented. An indicative maintenance and asset plan has been included in Appendix C.

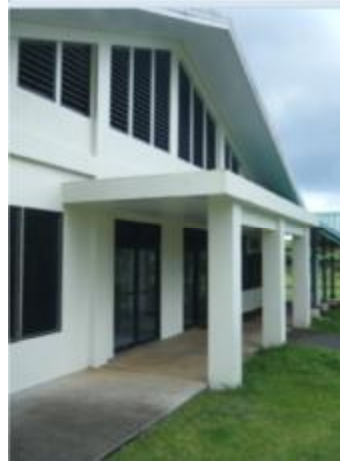
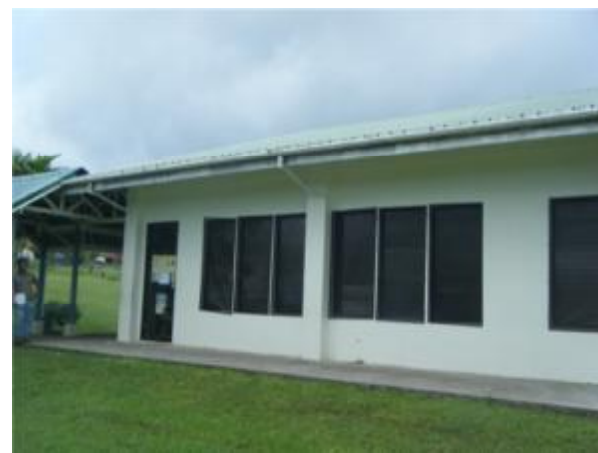
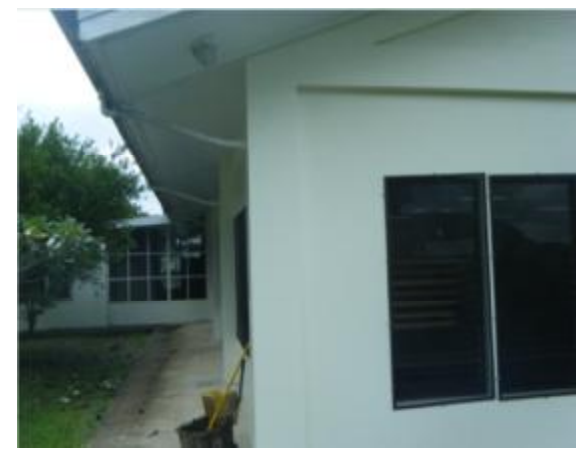
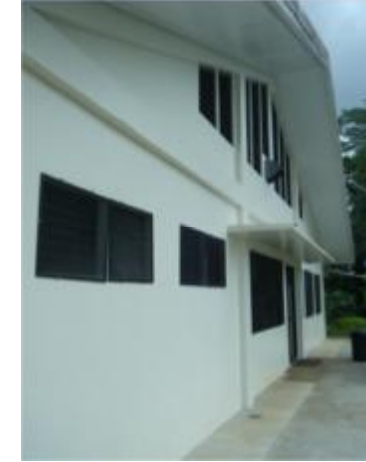
C – DINING HALL

| ID Code | Element | Condition Grading | | Condition Gauge | | | | | Asset Renewal Cost | | | | | Full Replace | | Element | Observed Deterioration/Recommendations |
|---|---|---|---|---|---|---|---|---|---|---|---|---|---|---|--|---|--|
| 1.00 | Total Sub-Structure | 2 | 30% | | | | | | 0 | 0 | 0 | 0 | 166,789 | 0.0% | <p>TOP 5 MAJOR ELEMENTS REQUIRING URGENT MAINTENANCE, RENEWAL OR REPLACEMENT</p> <p>Element</p> <p>Observed Deterioration/Recommendations</p> <p>Tiled Floor Finishes To café, kitchen, student offices, WC's and Store - marked and stained with some loose tiles</p> <p>Air-Conditioning - Window Mounted or "Through the Wall" Type Manual remote control - day time use only, office unit not working but others are in OK condition</p> <p>Profiled Metal Sheet Roof Cladding (Pre-Finished) Paint fading, black marks/stains evident. Re-paint roof immediately</p> <p>Metal Gutters Metal flaking and rust spots starting to appear</p> <p>Fibre Cement Ceiling/Soffit Lining with Painted Finishes Marked with evidence of humidity or moisture damage</p> <p>Overall Recommendation/Action Targeted regular maintenance and cleaning to extend asset life. Treat rust and spot prime corroded gutters immediately. Check roof for rust and treat if necessary and re-paint immediately. Repair water damage/leaks to ceiling/soffit immediately. Refurbish windows & doors and floor finishes by 2023. Regularly maintain and replace mechanical, fire and special services by 2023</p> | | |

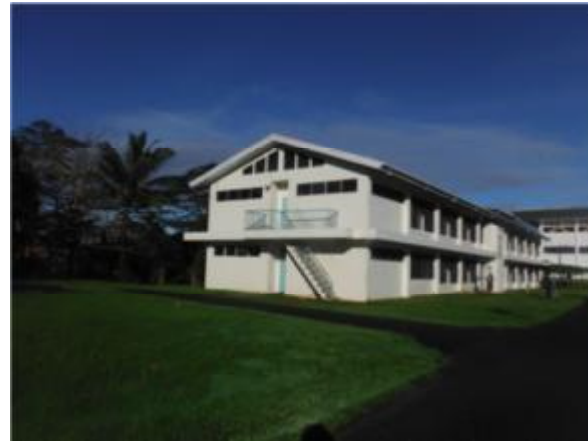
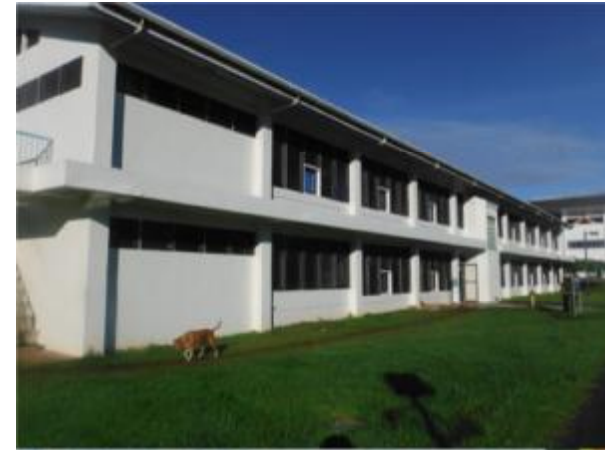
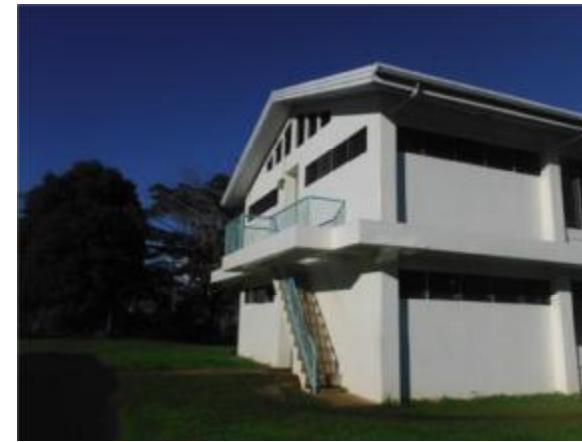
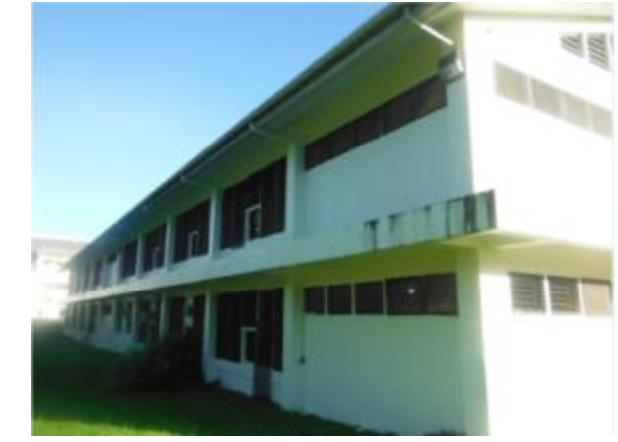
D – MEN’S RESIDENCE HALL

| Element | Observed Deterioration/Recommendations |
|---|---|
| Vinyl Floor Finishes | Evidence of lifting, marks, tears, and worn flooring |
| Tiled Floor Finishes | Evidence lifting tiles, loose grout, marks, stains, etc. |
| Plywood Soffit Lining with Painted Finish | Evidence of leaks internally, cracks, impact damage, etc. |
| Plywood Ceiling linings with Painted Finishes | Evidence of leaks internally, cracks, distortion in sheets, etc. |
| Metal Gutters and Roofing | Evidence of corrosion in gutter – spot prime and repair immediately. Re-paint roof and gutters immediately |

| Element | Observed Deterioration/Recommendations |
|---|---|
| Overall Recommendation/Action | Targeted regular maintenance and cleaning to extend asset life. Treat rust and spot prime corroded gutters and re-paint roof immediately. Check roof for rust and treat if necessary. Repair water damage/leaks to ceiling/soffit immediately. Refurbish floor finishes by 2023. Regularly maintain and replace mechanical, fire and special services by 2023 |

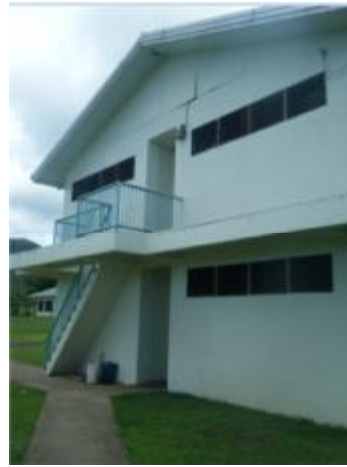
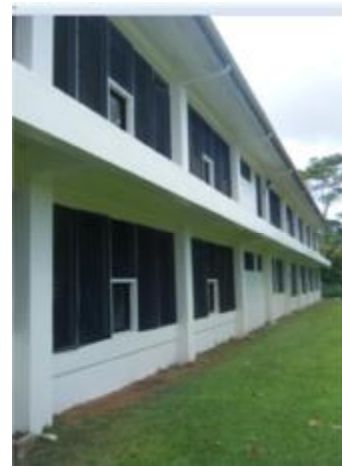
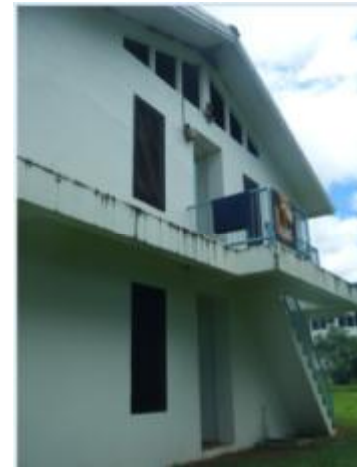
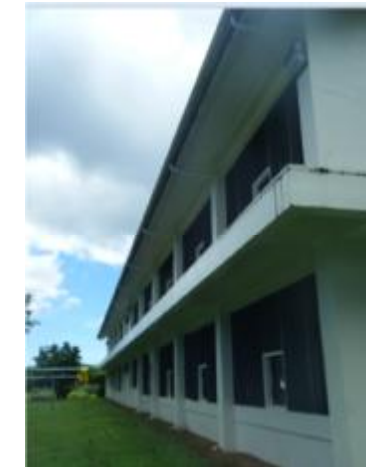
E – WOMAN'S RESIDENCE HALL

| ID Code | Element | Condition Grading | | Condition Gauge | | | | | Asset Renewal Cost | | | | | Full Replace | | Observed Deterioration/Recommendations |
|---|---|---|---|---|---|---|---|---|---|---|---|---|---|---|---|---|
| 3.00 | Total Structural Walls | 2 | 30% | | | | | | 0 | 0 | 0 | 0 | 213,001 | 0.0% | Vinyl Floor Finishes | Evidence of impact damage, lifting tiles, loose grout, marks, etc. |
| 5.00 | Total Roof | 3 | 50% | | | | | | 0 | 9,871 | 76,288 | 86,158 | 86,158 | 100.0% | Plaster and Paint finish | Evidence of impact damage |
| 7.00 | Total Windows & Doors | 2 | 30% | | | | | | 0 | 0 | 0 | 0 | 225,803 | 0.0% | Plywood Soffit Lining with Painted Finish and Metal roofing | Evidence of leaks internally, cracks, impact damage, etc to soffit. Re-paint roof immediately. |
| 8.00 | Total Stairs Balustrades & Handrails | 3 | 50% | | | | | | 0 | 0 | 0 | 0 | 53,320 | 0.0% | Air-Conditioning - Window Mounted Unit) | Corrosion, mould at wall unit junction. Mould indicates leaking from unit. |
| 10.00 | Total Internal Doors | 2 | 30% | | | | | | 0 | 0 | 0 | 0 | 72,864 | 0.0% | Plywood Ceiling linings with Painted Finishes | Evidence of leaks internally, cracks, distortion in sheets, etc. |

| ID Code | Element | Condition Grading | | Condition Gauge | | | | | Asset Renewal Cost | | | | | Full Replace | | Observed Deterioration/Recommendations |
|---|---|---|---|---|---|---|---|---|---|---|---|---|---|---|---|---|
| 12.00 | Total Wall Finishes | 3 | 50% | | | | | | 0 | 15,939 | 0 | 15,939 | 478,827 | 3.3% | Overall Recommendation/Action | Targeted regular maintenance and cleaning to extend asset life. Repair water damage/leaks to ceiling/soffit immediately. Repair leaking AC unit and treat corrosion immediately. Refurbish floor finishes by 2023. Regularly maintain and replace mechanical, fire and special services by 2023 |

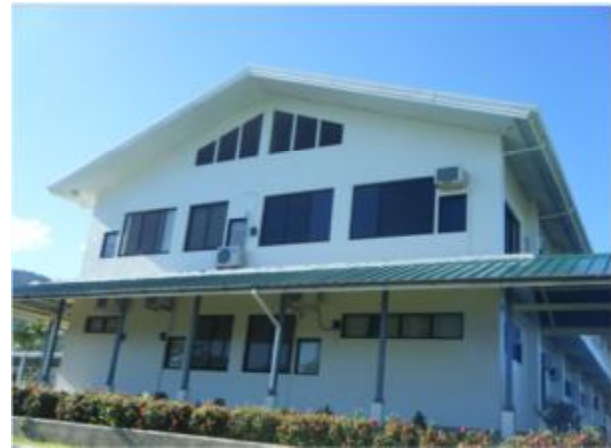
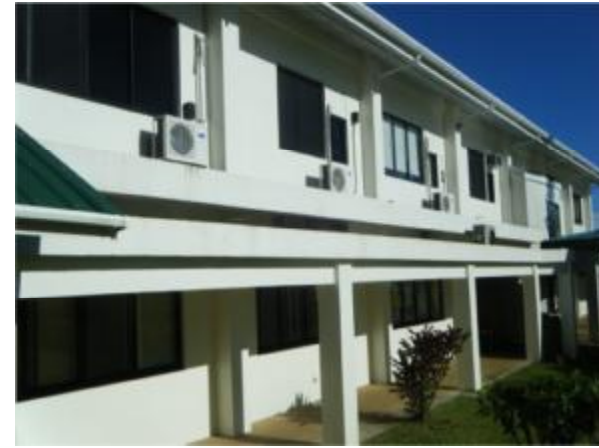
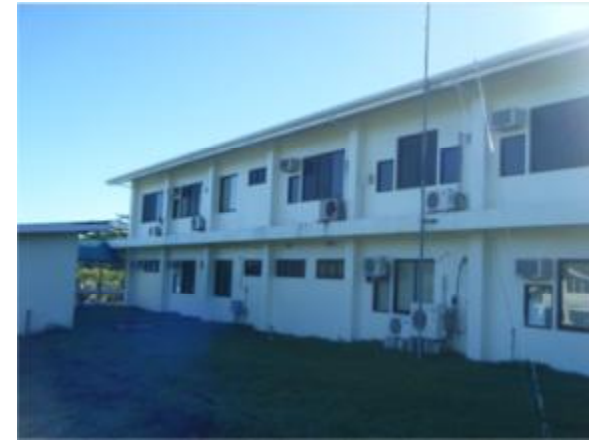
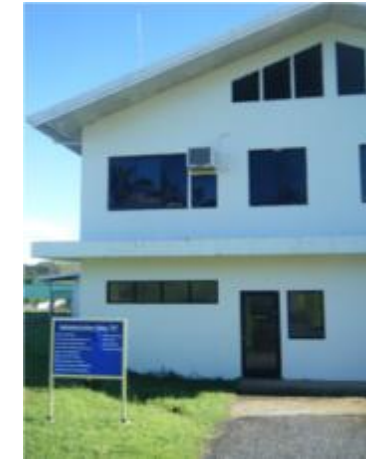
G - ADMINISTRATION

| Element | Observed Deterioration/Recommendations |
|--|---|
| Proprietary Suspended Ceilings (Exposed Grid Suspension System) with Tiles | Some damaged or miss-aligned tiles but generally OK |
| Drinking Fountain | Poor appearance but OK condition |
| Air-Conditioning - Window Mounted Unit) | Manual remote control - day time use only, most in OK condition, 1 or 2 need replacing |
| Lighting (Internal) - Incandescent | Generally OK, some missing bulbs or not working |
| Metal Gutters and Roof | Rust spots appearing in gutters – treat, repair and spot prime. Rust treat and spot prime roof (due for replacement by 2023). |

| Element | Observed Deterioration/Recommendations |
|--|---|
| Overall Recommendation/Action | Targeted regular maintenance and cleaning to extend asset life. Treat rust and spot prime corroded gutters immediately. Replace roof by 2023. Refurbish floor, wall and ceiling finishes by 2023. Replace 1-2 AC window mounted units immediately. Regularly maintain and replace mechanical, fire and special services by 2023 |

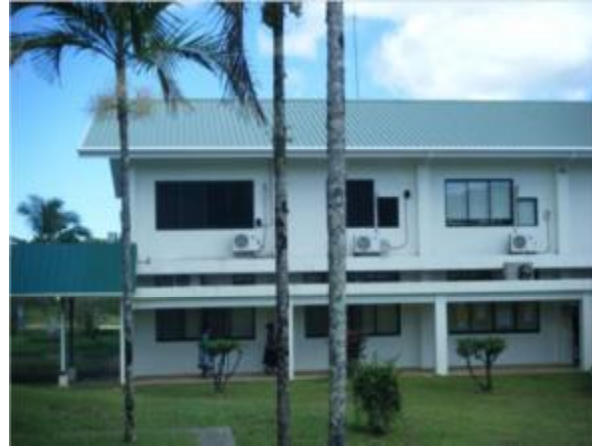
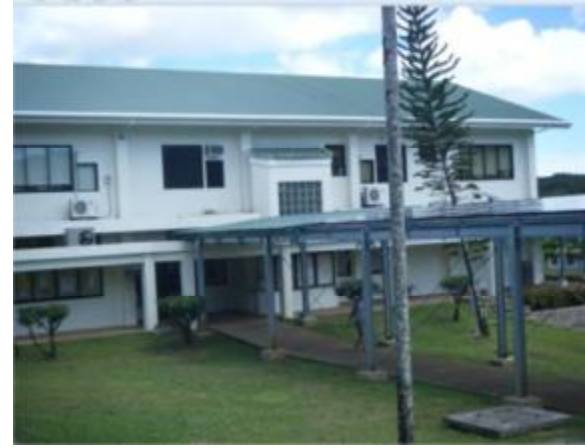
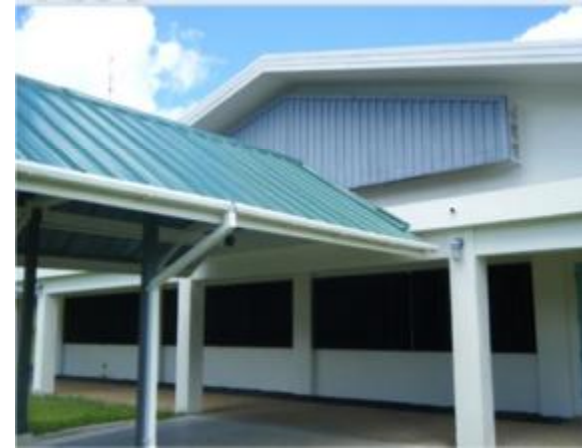
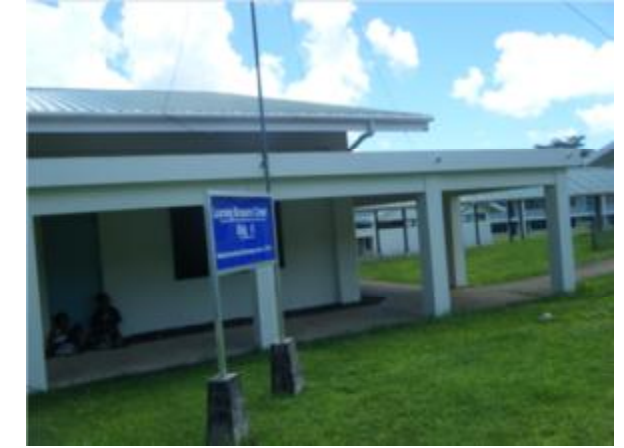
H - LEARNING RESOURCE CENTER AND MITC

| ID Code | Element | Condition Grading | | Condition Gauge | | | | | Asset Renewal Cost | | | | | Full Replace | | Element | Observed Deterioration/Recommendations |
|---|---|---|---|---|---|---|---|---|---|---|---|---|---|---|--|--|--|
| 1.00 | Total Sub-Structure | 2 | 30% | | | | | | 0 | 0 | 0 | 0 | 243,611 | 0.0% | Insitu Reinforced Concrete Upper Floor - Canopy | Good condition but not sealed/ protected | |
| 3.00 | Total Structural Walls | 2 | 30% | | | | | | 0 | 0 | 0 | 0 | 171,799 | 0.0% | Profiled Metal Sheet Roof Cladding (Pre-Finished) | Minor rust damage and paint deterioration. Re-paint roof immediately | |
