College of Micronesia - FSM Facilities Master Plan, Part 3 - Detailed Report for the Pohnpei Career and Technical Education Center

Prepared by Beca International Consultants Ltd (Beca)

28 February 2014

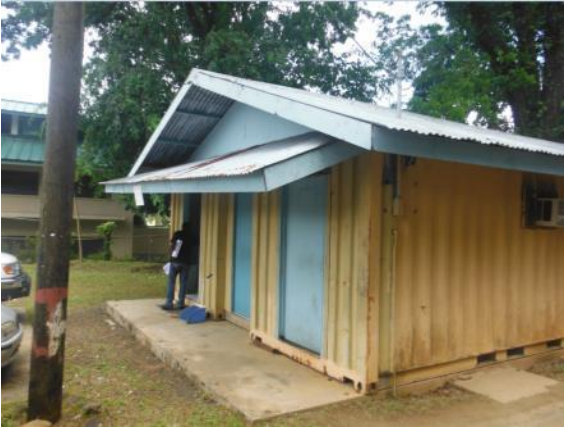
Building	Outline
<p>I - IT Shop</p>

<p>Points to consider for future planning – Consider removal to provide through site access.</p>	<p>Building I is a container base building</p> <p>Location for its function – not adequate, occupies critical space</p> <p>Quality and suitability of spaces for its function – not adequate condition or size</p> <p>Disabled access - nil</p> <p>Teaching spaces - nil</p> <p>Amenities, toilets - nil</p> <p>Building condition points – Targeted regular maintenance and cleaning. Localised repairs and rust treatment to roof required immediately. Repair decay to plywood storeroom floor.</p> <p>Building age – not available</p>
<p>J - Classroom Building B</p>

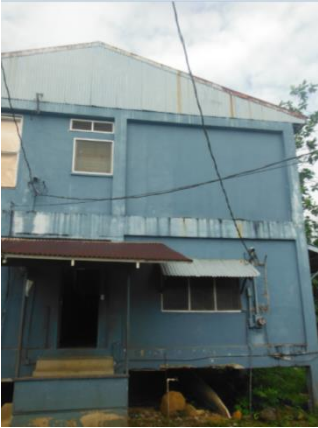
<p>K - Vocational Classrooms, TSP,UB, CES</p>

<p>Building K is a half utilized building currently housing extension programs</p> <p>Location for its function – could be located elsewhere</p> <p>Quality and suitability of spaces for its function – not adequate as building was historically a dormitory</p> <p>Disabled access - nil</p> <p>Teaching spaces - nil</p> <p>Amenities, toilets - not assessed</p> <p>Building condition points – Asset appears to be structurally unsound and needs immediate review by a structural engineer (collapsed column and spalled concrete) as it is a health and safety risk. \$2.68M estimated renewal cost (75% of replacement cost) over the next 10 years. Consider demolition or replacement</p>

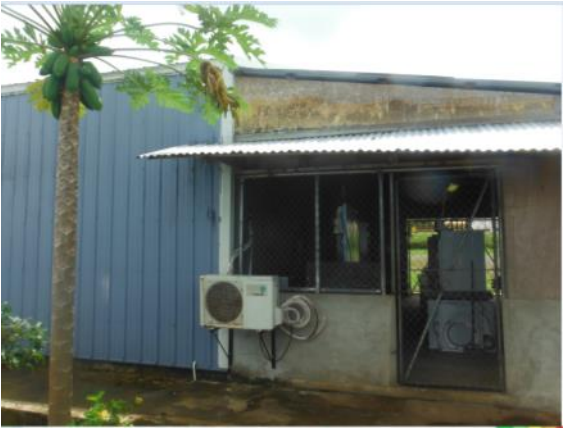
<p>Points to consider for future planning – Consider removal to release land for through site access.</p>	<p>Building M is the mechanic shop next to the carpentry shop</p> <p>Location for its function – well located with a road frontage</p> <p>Quality and suitability of spaces for its function - adequate</p> <p>Disabled access - nil</p> <p>Teaching spaces - 1</p> <p>Amenities, toilets - nil</p> <p>Building condition points – Targeted regular maintenance and cleaning. Repair leaks and rot around windows and install missing WC doors immediately.</p> <p>Building age – not available</p>

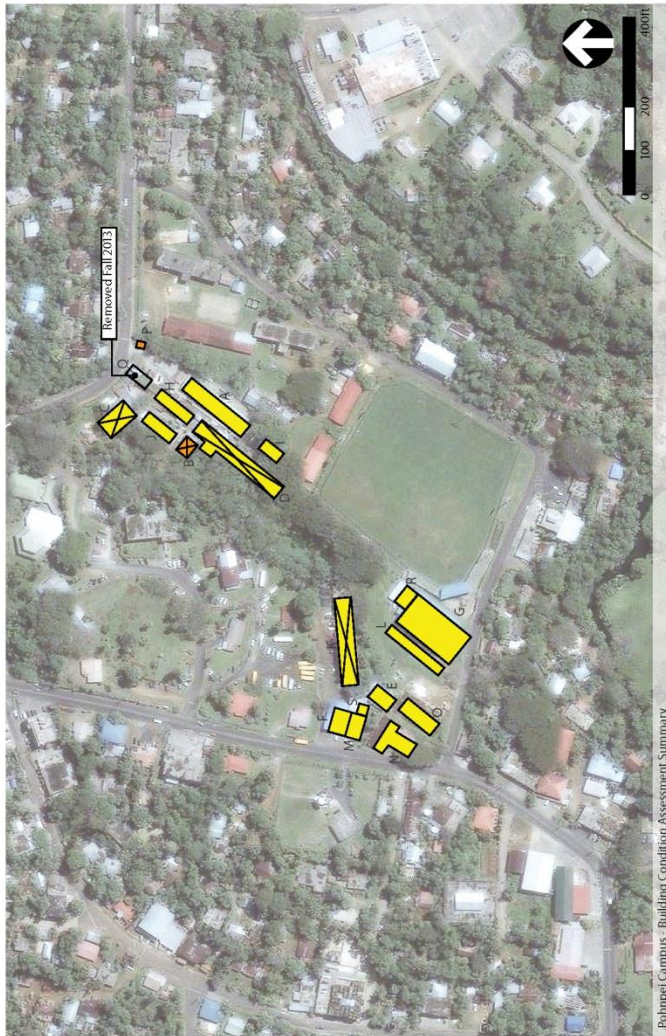
Pohnpei Campus

From our condition assessment of the Pohnpei campus we observe the following:

1. Upward Bound and TSP Building. The estimated replacement value of this building is 17% of the Pohnpei capital assets but 49% of the operational cost is dedicated to this building which is out of proportion to all other campus assets. This building is rated condition grade 5 and has significant structural and elemental defects. We consider that it is uneconomic to operate and should be demolished and replaced.

3. Twelve (of the 16) buildings are rated as condition grade 3 which means that these assets are reaching the end of their serviceable life, but they are still functioning as intended. The remaining assets are rated condition grade 4 or 5 meaning that they require additional attention or should be considered for demolition/replacement. Targeted regular maintenance on all of the assets is required to extend their life. A clear, well organised asset renewal and routine maintenance plan needs to be developed and this needs to be implemented. An indicative maintenance and asset plan has been included in Appendix C.

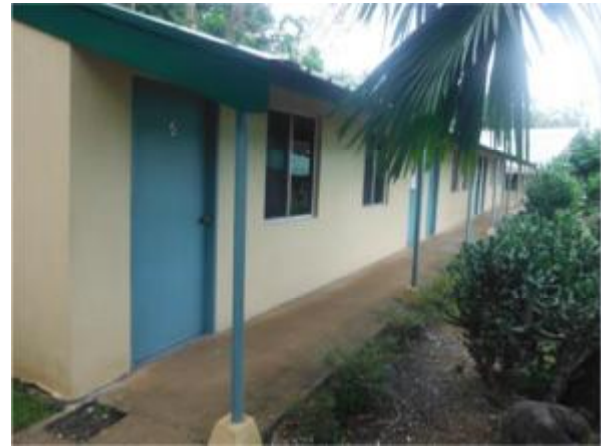
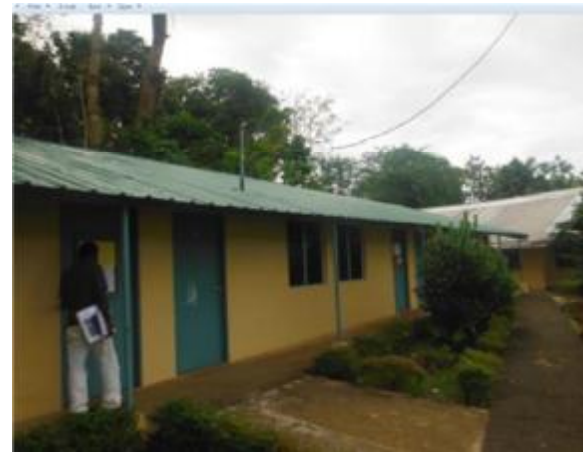
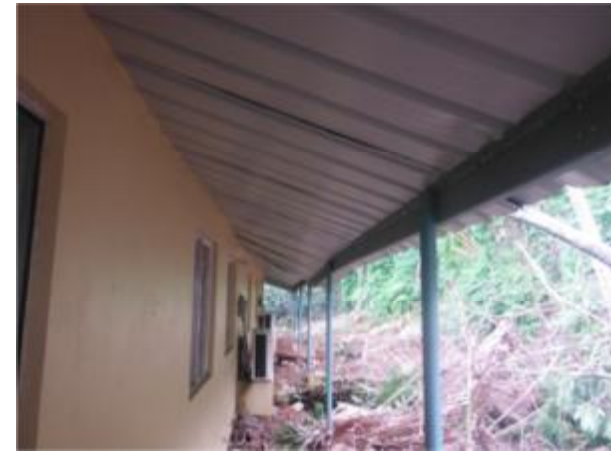
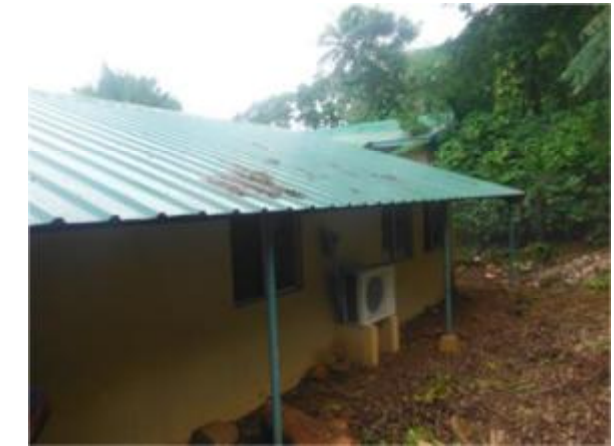
J - CLASSROOM BUILDING B

<table><tr> <th>Element</th> <th>Observed Deterioration/Recommendations</th> </tr><tr> <td>Structural Steel Frame (Portal/Truss/Columns/Beams, etc.)</td> <td>Part damaged by previously fallen tree (say 5% of roof area)</td> </tr><tr> <td>Profiled Metal Sheet Roof Cladding (Pre-Finished)</td> <td>Evidence of damaged section of roofing</td> </tr><tr> <td>Window Glazing Treatments</td> <td>To some windows only. Is peeling with sections missing and bubbles in film present</td> </tr><tr> <td>Plywood ceiling lining with painted finish</td> <td>Some evidence of previous leaks to the building before roof cladding replaced</td> </tr><tr> <td>Vinyl Floor Finishes</td> <td>Broken and missing tiles around columns and at door entrances</td> </tr></table>

<table><tr> <th>Element</th> <th>Observed Deterioration/Recommendations</th> </tr><tr> <td>Overall Recommendation/Action</td> <td>Targeted regular maintenance and cleaning. Localised roof and frame repairs due to tree damage required... Refurbish floor and ceiling finishes by 2023. Regularly maintain and replace mechanical services by 2023</td> </tr></table>

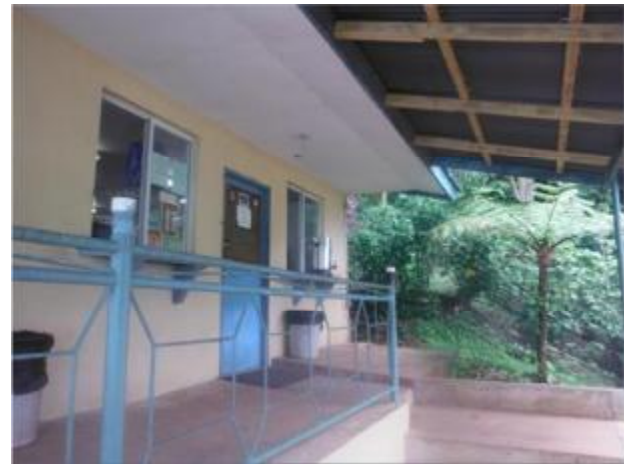
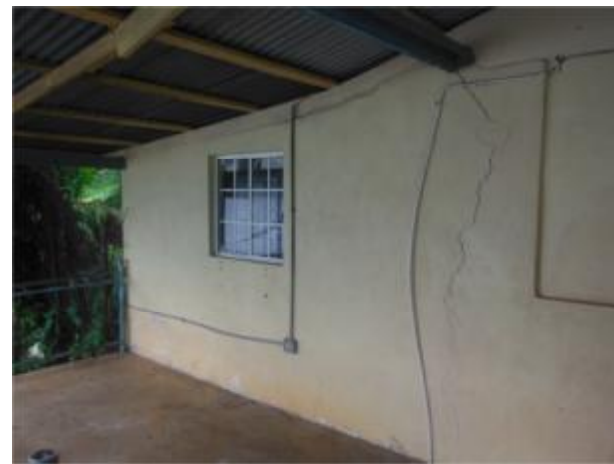
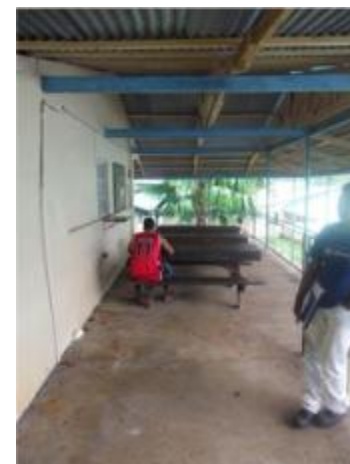
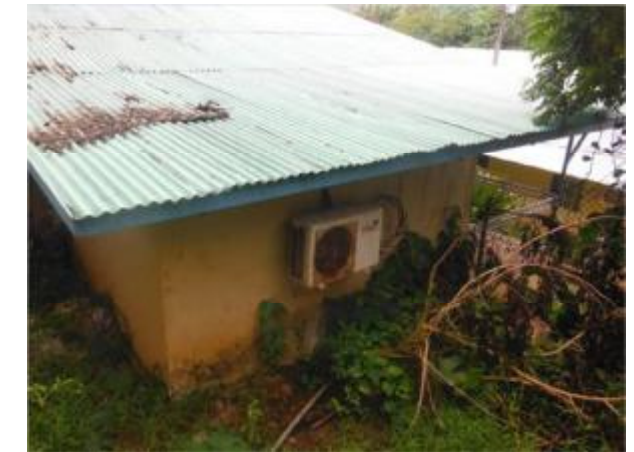
B – BOOKSTORE

3.00	Total Structural Walls	5	90%						25,206	0	0	25,206	25,206	100.0%	Evidence of settlement and structural cracking	
4.00	Total Upper Floors	0	0%						0	0	0	0	0	0.0%

7.00	Total Windows & Doors	4	70%						1,898	243	5,161	7,302	7,059	103.4%	Evidence of staining and impact damage	
A	TOTAL STRUCTURE	4	70%						46,592	12,088	105,931	164,612	205,256	80.2%

8.00	Total Stairs Balustrades & Handrails	3	50%						0	0	14,946	14,946	14,946	100.0%	Evidence of lifted tiles, marks, and heavy wear and tear of floor. Also noted that floor does not appear to be level

9.00	Total Internal Walls/Partitions	0	0%						0	0	0	0	0	0.0%		
10.00	Total Internal Doors	3	50%						0	0	1,518	1,518	1,518	100.0%	Evidence of termite attack and decay

11.00	Total Floor Finishes	4	70%						3,583	0	7,079	10,662	7,079	150.6%		
12.00	Total Wall Finishes	5	90%						10,094	0	0	10,094	10,094	100.0%	Evidence of structural and plaster cracks in several locations and extensive

13.00	Total Ceiling Finishes	5	90%						4,666	0	0	4,666	4,666	100.0%		
14.00	Total Fixed Joinery Units	3	50%						202	0	582	784	582	134.8%	Evidence of termite attack and decay	
B	TOTAL INTERNAL FIT-OUT	4	70%						18,545	0	24,124	42,670	38,885	109.7%

15.00	Total Sanitary Plumbing	0	0%						0	0	0	0	0	0.0%	Targeted regular maintenance and cleaning. Localised structural wall and frame repairs required. Replace roof by 2023. Refurbish external walls, windows and doors, floor, wall and ceiling finishes by 2023. Regularly maintain and replace mechanical services by 2023

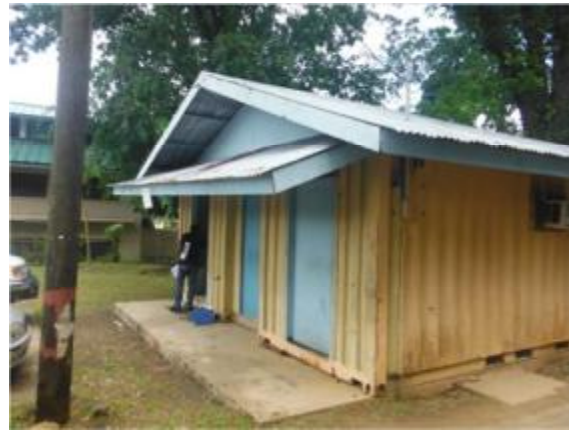
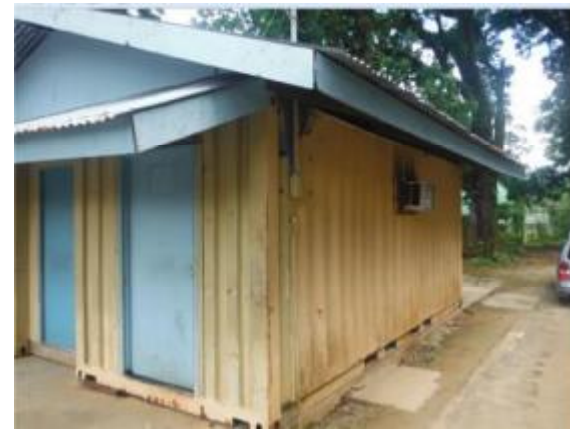
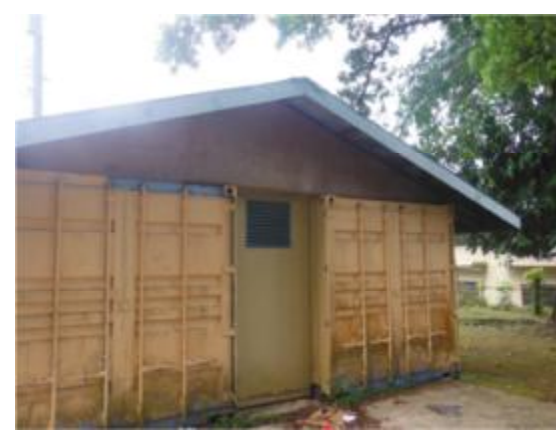
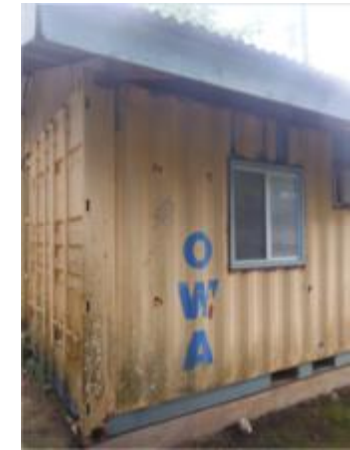
I - IT SHOP

1.00	Total Sub-Structure	4	70%						0	0	7,407	7,407	17,631	42.0%	<p>TOP 5 MAJOR ELEMENTS REQUIRING URGENT MAINTENANCE, RENEWAL OR REPLACEMENT</p> <p>Element</p> <p>Profiled Metal Sheet Roof Cladding (Pre-Finished)</p> <p>Timber Doors (Solid/No Glazing)</p> <p>Plywood flooring</p> <p>Reinforced Concrete Slab on Grade</p> <p>Plywood wall lining to infill wall</p> <p>Overall Recommendation/Action</p> <p>Targeted regular maintenance and cleaning. Localised repairs and rust treatment to roof required immediately. Repair decay to plywood storeroom floor. Replace roof, external wall linings, windows and doors by 2023. Refurbish floor finishes by 2023. Regularly maintain and replace mechanical services by 2023</p>

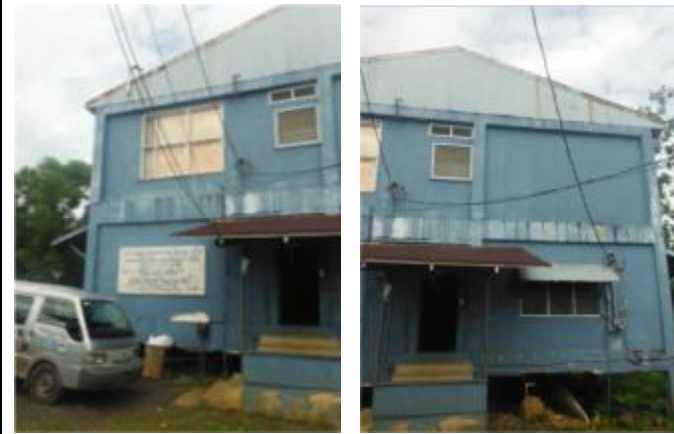
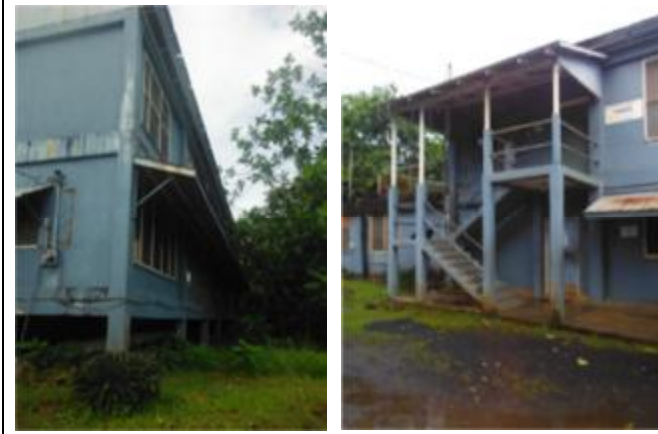
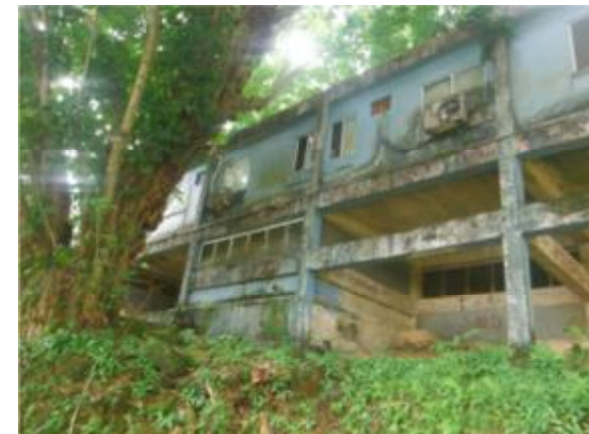
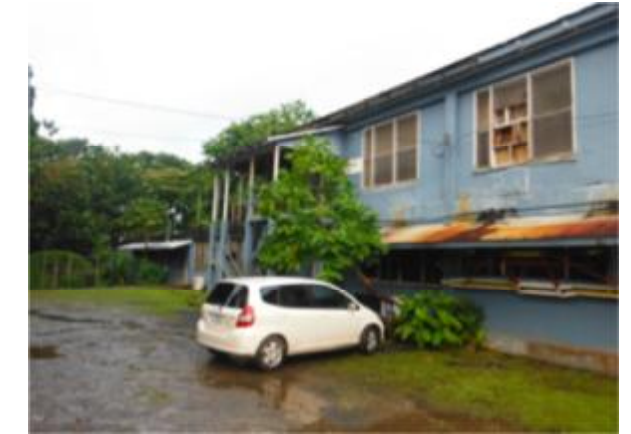
K – Upward Bound & TSP

1.00	Total Sub-Structure	0	0%						0	0	0	0	0	0.0%		
2.00	Total Frame	5	90%						652,731	0	0	652,731	652,731	100.0%	Evidence of spalling concrete, cracking, corrosion, etc. H&S risk of structural failure (1 column collapsed)	Review by Structural Engineer, Repair or Replace

3.00	Total Structural Walls	5	90%						719,081	0	0	719,081	719,081	100.0%	Reinforced Concrete Brick/Block Masonry Walls	Review by Structural Engineer, Repair or Replace

4.00	Total Upper Floors	5	90%						364,487	0	0	364,487	364,487	100.0%	Pre-cast/Insitu Reinforced Concrete Upper Floor	Evidence of spalling concrete, cracking, corrosion, poor workmanship, etc.

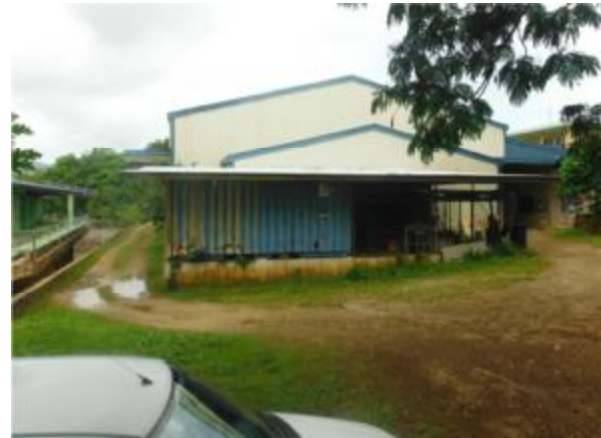
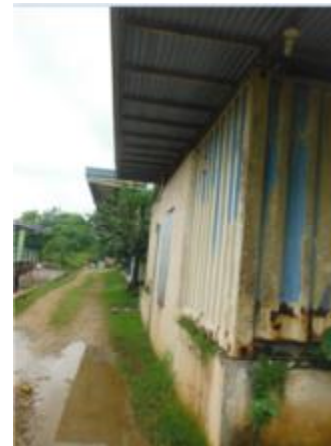
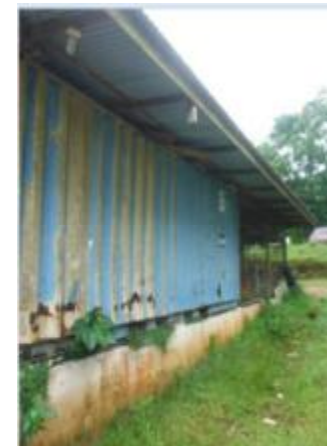
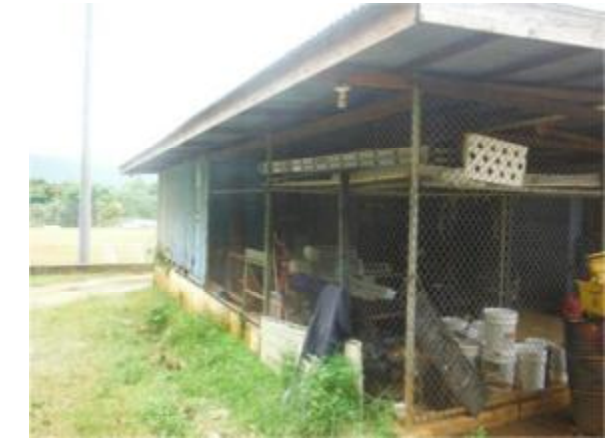
R - MAINTENANCE BUILDING

1.00	Total Sub-Structure	3	50%						0	0	17,415	17,415	45,941	37.9%	<p>TOP 5 MAJOR ELEMENTS REQUIRING URGENT MAINTENANCE, RENEWAL OR REPLACEMENT</p> <p>Element</p> <p>Profiled Metal Sheet Roof Cladding (Pre-Finished)</p> <p>Plywood wall linings with Painted Finishes</p> <p>Paint finish to metal cladding</p> <p>Vinyl Floor Finishes</p> <p>Prefinished timber veneer panelling</p> <p>Overall Recommendation/Action</p>	<p>Galvanized steel iron -Evidence of rust and deterioration in several locations</p> <p>To trusses. Only partially clad at rear of building. Cladding present is water damaged and delaminating</p> <p>Evidence of rust, marks, and staining</p> <p>Staining, marks and wear and tear. No threshold strip at doorway</p> <p>Evidence of holes in wall and impact damage</p> <p>Targeted regular maintenance and cleaning. Localised repairs to metal roof and wall cladding and plywood cladding required immediately. Replace roof, external walls, windows and doors by 2023. Refurbish floor and wall finishes by 2023. Regularly maintain and replace mechanical, electrical and special services by 2023</p>

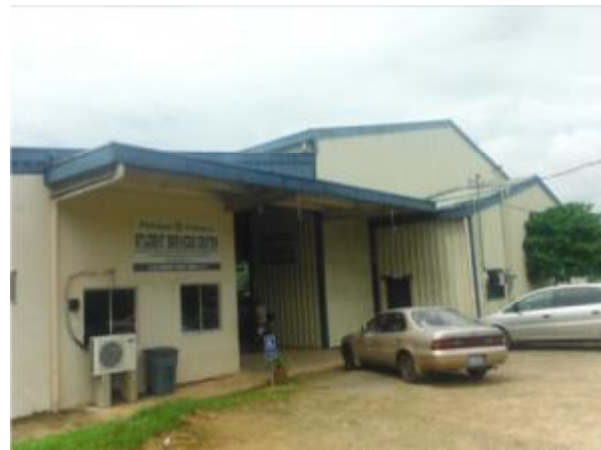
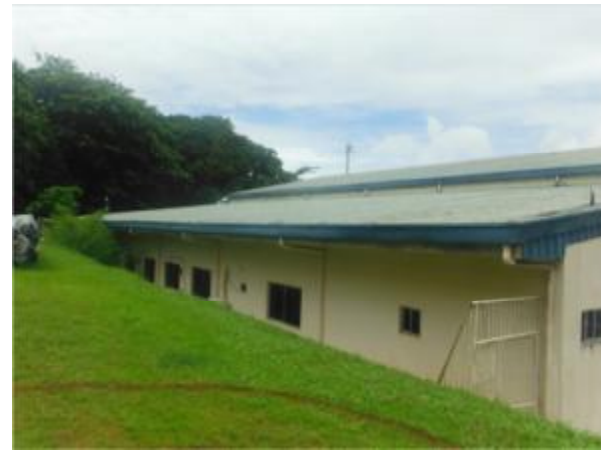
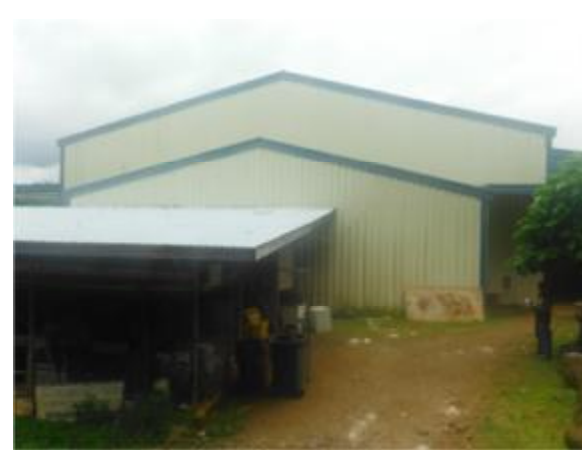
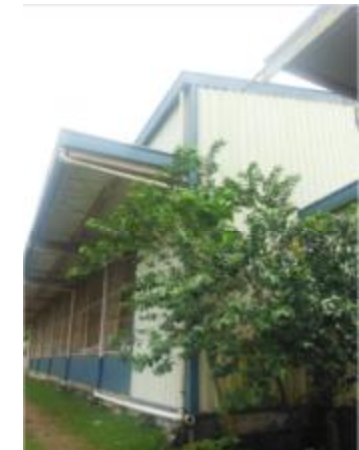
L - STUDENT SERVICES CENTER

1.00	Total Sub-Structure	2	30%						0	0	0	0	116,573	0.0%	Fibre Cement Cladding with Painted Finishes	Evidence of flaking paint where deterioration of panel where window mounted AC removed

5.00	Total Roof	3	50%						0	86,039	12,167	98,206	98,206	100.0%	Fibre Cement Ceiling Lining with Painted Finishes	Evidence of leaks in the Multipurpose room

8.00	Total Stairs Balustrades & Handrails	0	0%						0	0	0	0	0	0.0%	Timber Door - Single	Evidence of termite attack to door frames. Impact damage and marks to doors

9.00	Total Internal Walls/Partitions	2	30%						0	0	0	0	1,027	0.0%			
10.00	Total Internal Doors	3	50%						0	4,554	1,771	6,325	18,722	33.8%	Vinyl Floor Finishes	Water stains, marks and wear and tear

11.00	Total Floor Finishes	3	50%						8,337	33,349	14,837	56,523	48,186	117.3%			
12.00	Total Wall Finishes	3	50%						99,335	0	3,825	103,160	103,160	100.0%	Overall Recommendation/Action	Targeted regular maintenance and cleaning. Repair leaks to Multipurpose room and treat/repair termite damage to doors... Refurbish floor, wall and ceiling finishes by 2023. Regularly maintain and replace mechanical, fire and electrical services by 2023

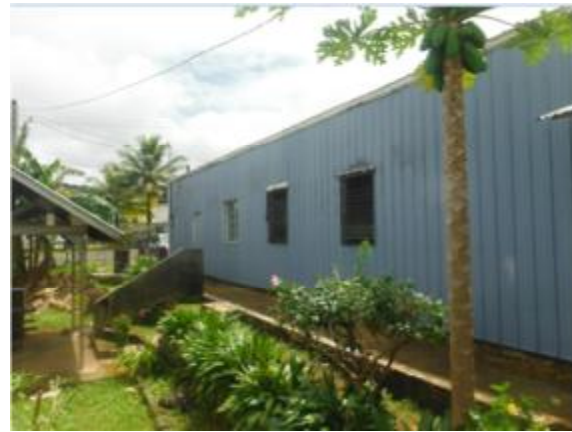
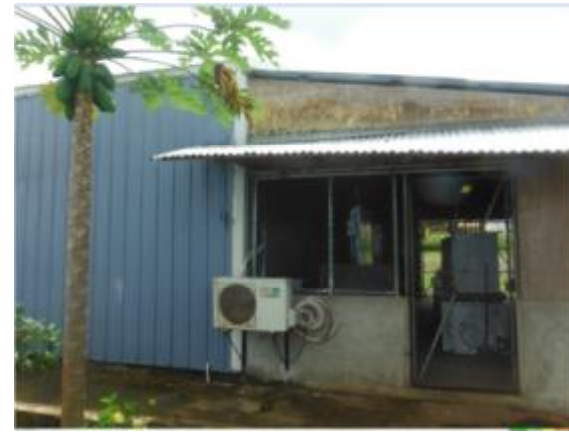
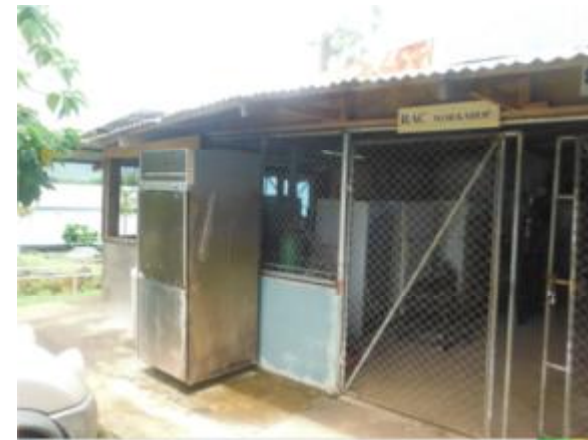
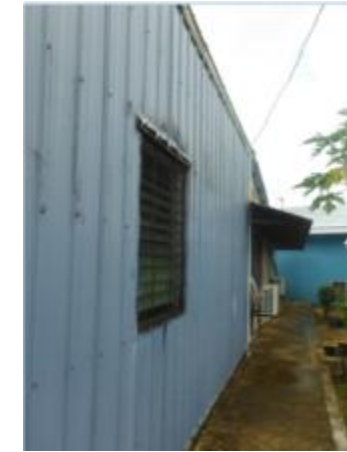
M - MECHANIC SHOP & REFRIGERATION SHOP (S)

Element	Observed Deterioration/Recommendations
Timber framing fixed to steel columns/portals to Mechanic Shop	Rot and decay apparent around openings particularly windows
Timber framed, profiled metal sheet lined wall cladding	Three single doors and two large double doors. One single door locked shut inside, both single doors are buckled. Holes in metal cladding to large doors and do not seal closed
Metal bar and mesh screen to windows	Bars corroded, mesh damaged
Timber Door to WCs	Missing doors to WCs
Vinyl Floor Finishes	Stains, lifting and chipping of tiles
Overall Recommendation/Action	Targeted regular maintenance and cleaning. Repair leaks and rot around windows and install missing WC doors immediately. Replace external walls, windows and doors by 2023. Refurbish internal doors, floor and wall finishes by 2023. Regularly maintain and replace sanitary plumbing, mechanical and fire services by 2023

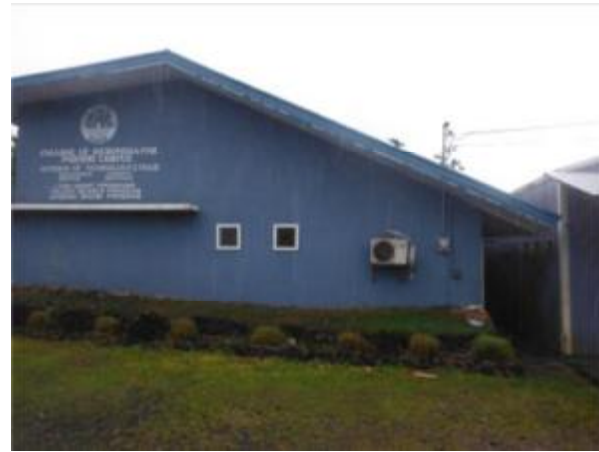
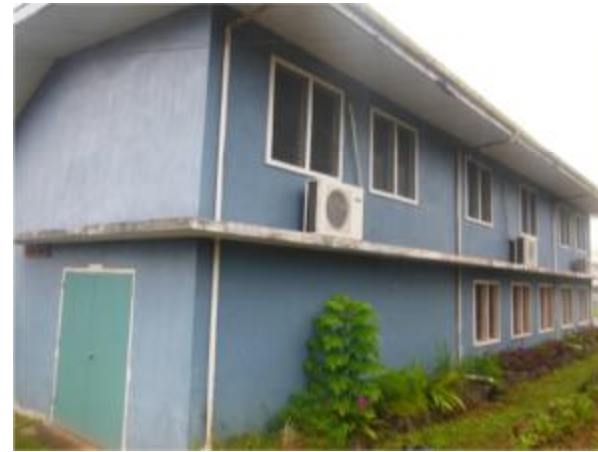
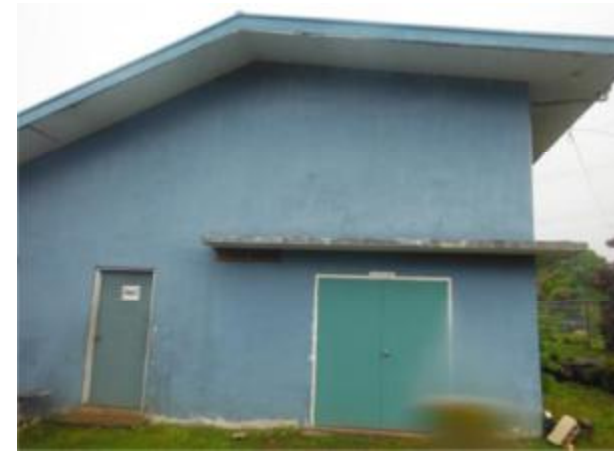
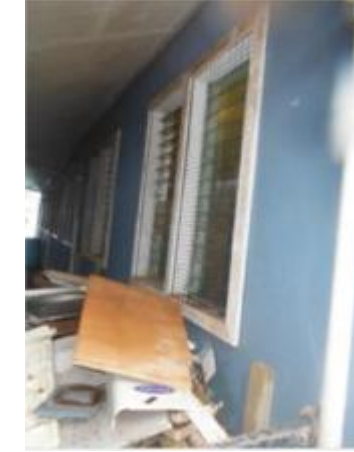
F - CARPENTRY SHOP

1.00	Total Sub-Structure	2	30%						0	0	0	0	82,733	0.0%	PVC Gutters	Buckled, damaged and missing end section and cap that is contributing to the roof leak

2.00	Total Frame	2	30%						0	0	0	0	170,209	0.0%		
3.00	Total Structural Walls	2	30%						0	0	0	0	96,158	0.0%	Solid Plaster Wall Lining with Painted Finishes to WCs	Evidence of marks, water damage and staining to WCs

4.00	Total Upper Floors	3	50%						0	0	0	0	47,910	0.0%		
5.00	Total Roof	4	70%						40,949	7,375	2,370	50,694	48,324	104.9%	Painted Ply with Painted finish to soffit of main roof	Mould and rot apparent to soffits to underside of main roof. Requires replacement

6.00	Total External Walls & Finishes	3	50%						0	0	29,728	29,728	29,728	100.0%		
7.00	Total Windows & Doors	3	50%						0	6,424	35,358	41,782	46,527	89.8%	Plywood ceiling Lining with painted Finish -to Classrooms	Water damaged ply sheet particularly at far corner in room V5 and above AC unit
A	TOTAL STRUCTURE	3	50%						40,949	13,799	67,456	122,204	521,590	23.4%

9.00	Total Internal Walls/Partitions	0	0%						0	0	0	0	0	0.0%		
10.00	Total Internal Doors	2	30%						0	0	0	0	9,108	0.0%	Overall Recommendation/Action	Targeted regular maintenance and cleaning. Repair leaks and rot in soffits/ceilings and replace sections of gutter immediately. Replace roof by 2023. Refurbish wall and ceiling finishes and joinery fittings by 2023. Regularly maintain and replace mechanical and fire services by 2023
