College of Micronesia - FSM Space Utilization and Facilities Master Plan Study, Part 3 - Detailed Report for the Yap Campus

Prepared for the College of Micronesia - FSM

Prepared by Beca International Consultants Ltd (Beca)

28 February 2014

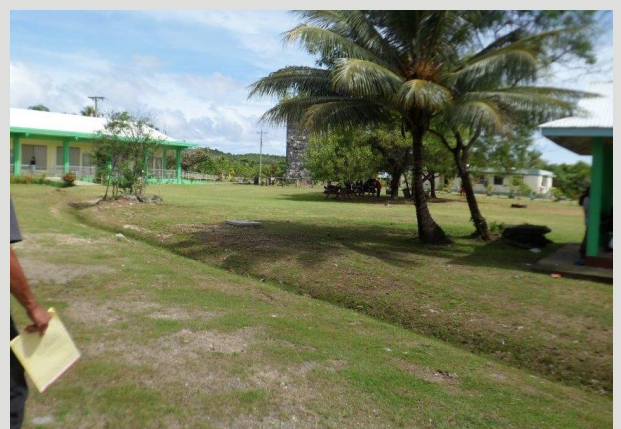
Drainage channel through the Center of the campus - landscape treatment and pedestrian access across needs to be considered

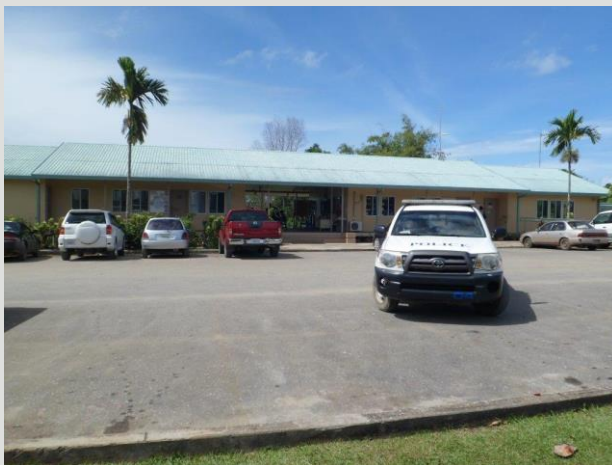
Provide pedestrian connection across this car park and designated car parks

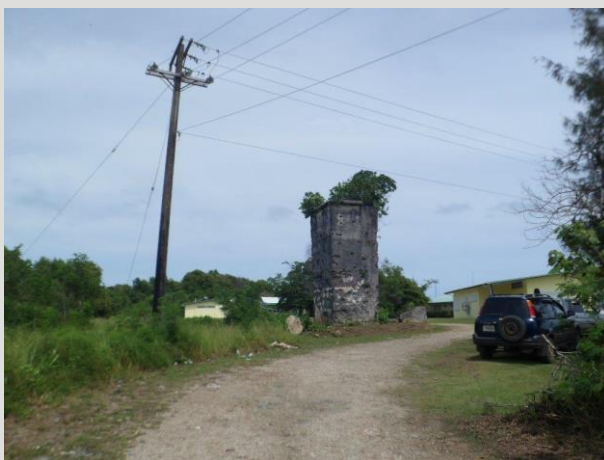
Existing power pole in the proposed path of the access road

- Review services on site - relocate power supply to others in the location of the proposed secondary access road onto the campus

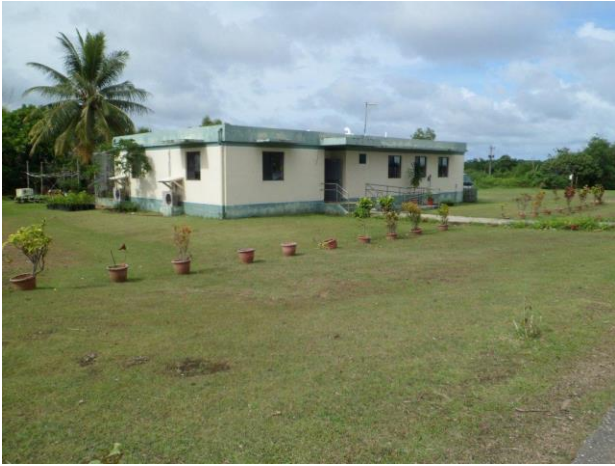
Building	Outline
<p>C - CRE Building</p>

<p>Building C is the CRE Research building with two laboratories and associated offices.</p> <p>Location for its function – Well located on the edge of the campus with space around for outdoor research</p> <p>Quality and suitability of spaces for its function – Follows required template</p> <p>Disabled access - Ramp access at the rear of the building</p> <p>Teaching spaces - nil</p> <p>Amenities, toilets - 1 men's and women's WC provided</p> <p>Building condition points - Targeted regular maintenance and cleaning. Replace roof immediately.</p> <p>Building age -12 years , early 2000s</p>
<p>D - Science Laboratory</p>

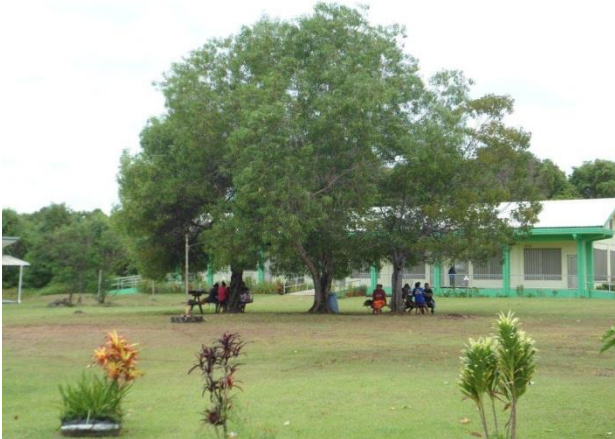
<p>Points to consider in future planning</p> <p>Future location of the Learning Resource Center could move to a location closer to the public entry area for more access by the community</p>	<p>Building D is a building with the science laboratory and the Learning Resource Center</p> <p>Location for its function – Well located on the edge of the academic zone</p> <p>Quality and suitability of spaces for its function – The learning resource Center is small for the size of the campus roll</p> <p>Disabled access - ramp access to the building but require a path beyond this to connect to other buildings</p> <p>Teaching spaces – one science classroom 810sqft</p> <p>Amenities, toilets - 1 men's WC, 1 urinal; 2 women's WC</p> <p>Building condition points - Targeted regular maintenance and cleaning. Review paint on metal balustrades and repaint if corroded.</p> <p>Building age – 4 years, mid 2000's</p>

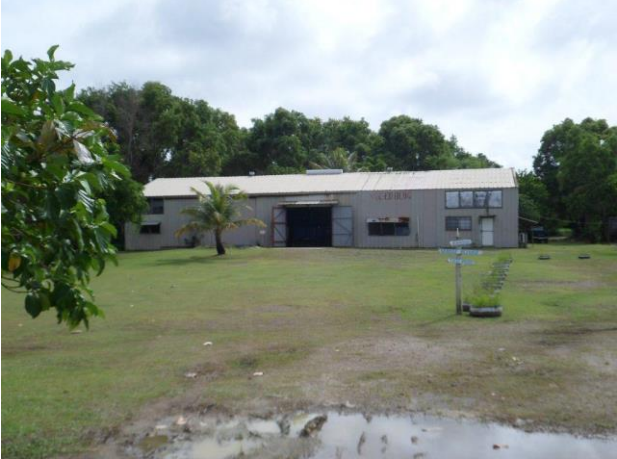
<p>G – Vocational building</p>	<p>Building G is an existing vocational building with teaching spaces on the ground floor and faculty accommodation on the upper floor</p> <p>Location for its function – located on the edge of</p>

<p>Points to consider in future planning</p> <p>Provide external access to other spaces - no need to walk through the workshop to access classroom spaces Relocate the function onto the campus site in the short term</p>	<p>the campus on leased land</p> <p>Quality and suitability of spaces for its function – Access to classrooms is through the workshop area, access should be restricted to workshop users</p> <p>Disabled access - nil</p> <p>Teaching spaces – three classrooms - move to new classroom block in 2013</p> <p>Building condition points - This building has a very high renewal & maintenance cost over the next 30 years (40% of Yr. 1-10 renewal budget & 96% of full replacement cost over 30 years) making it uneconomic to renew/maintain. Carry out minimal maintenance (to protect against health & safety issues), run down and replace circa 2018 or before</p> <p>Building age – 40+ years</p>

2. Building G – Vocational Building has very high renewal and maintenance costs over the next 30 years (40% of Yap Year 1-10 renewal budget and 96% of full replacement cost over 30 years). In our view this building is uneconomic to renew and maintain. We consider that minimum operational costs should be spent on this asset (with the exception of any protection /health and safety remedial works) and that the asset should be run-down and replaced in 2018 or before.

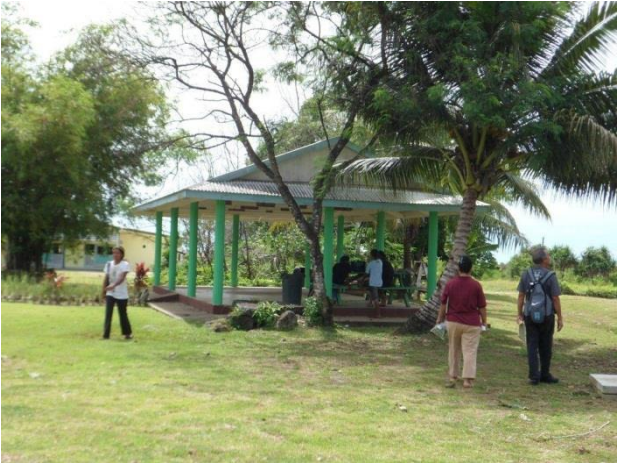
<p>H – Student Open Lounge</p>

<p>Points to consider in future planning</p> <p>Rebuild when required in a location to suit the structured landscape plan</p>	<p>Building H is an open meeting area in the Center of the open campus area</p> <p>Location for its function – Well located in the Center of the open campus area</p> <p>Quality and suitability of spaces for its function – Allows for a range of uses</p> <p>Disabled access - nil</p> <p>Teaching spaces - nil</p> <p>Amenities, toilets - nil</p> <p>Building condition points - Targeted regular maintenance and cleaning. Treat rust and spot prime roof. Replace roof by 2023.</p> <p>Building age – 3 years, late 2000's</p>

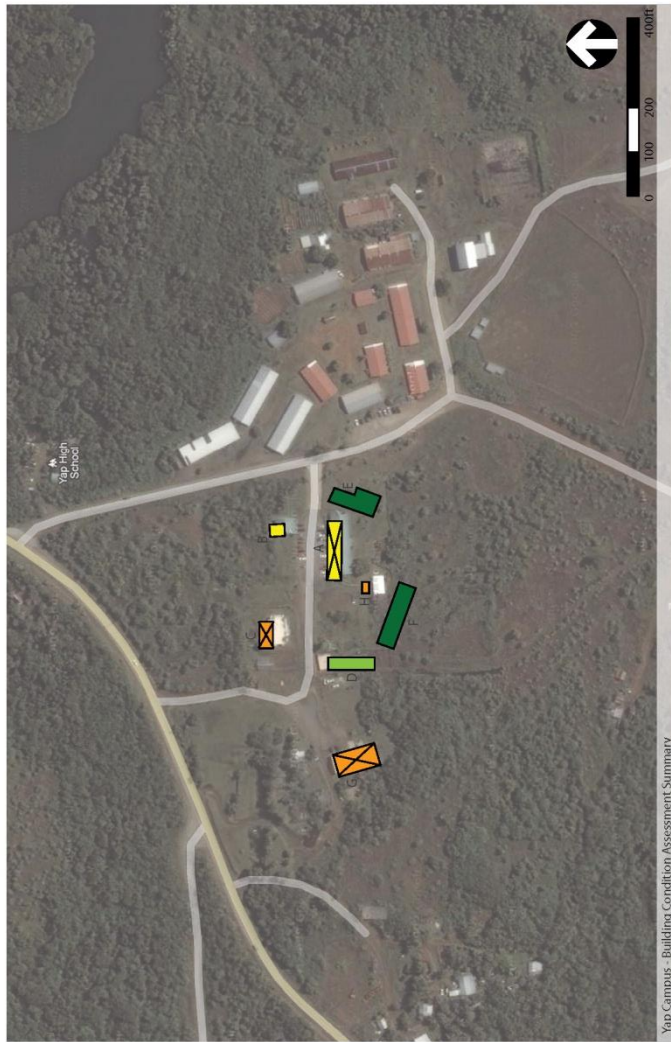
From our condition assessment of the Yap campus we observe the following:

1. Building A – Administration Building. The severe corrosion of the steel substructure and decay in the timber flooring makes this building, in our opinion, uneconomic to renew and maintain. We consider that minimum operational costs should be spent on this asset (i.e. carry out protection /health and safety remedial works only) and that the asset should be run-down and replaced in 2018 or before.
