College of Micronesia - FSM Space Utilization and Facilities Master Plan Study, Part 3 - Detailed Report for the Kosrae Campus

Prepared for the College of Micronesia - FSM

Prepared by Beca International Consultants Ltd (Beca)

28 November 2013

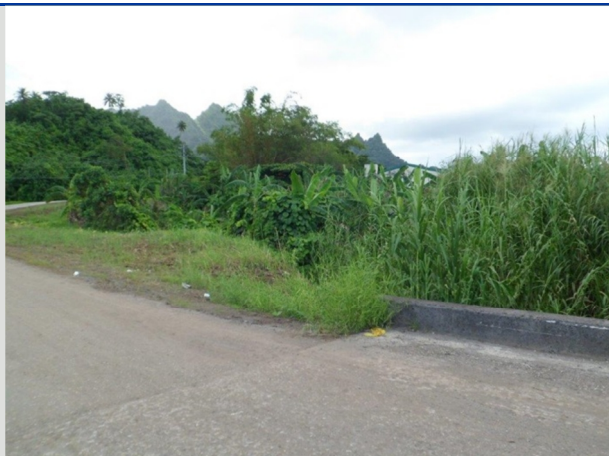
Views to the stream and access could be improved by clearing out vegetation and extending rip rap to bank edges

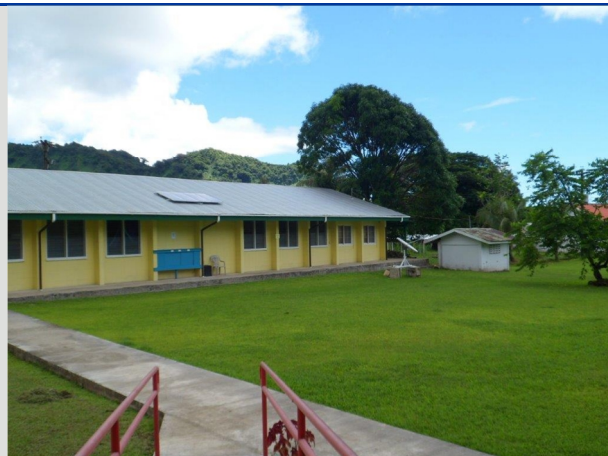
The open area could be more readily used with improvement to drainage across the site

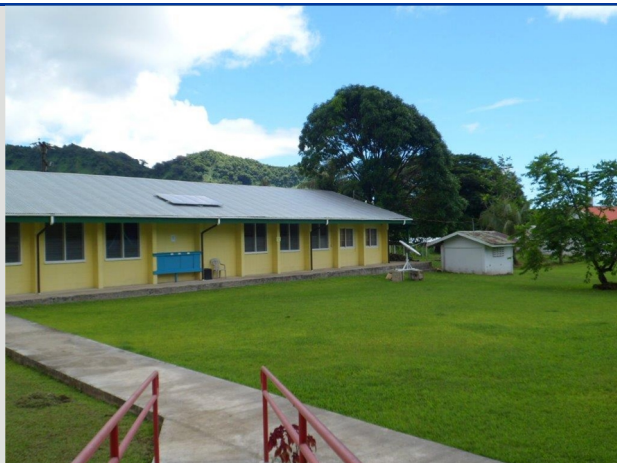
Laptop charging station (blue box area) need to provide a larger covered area

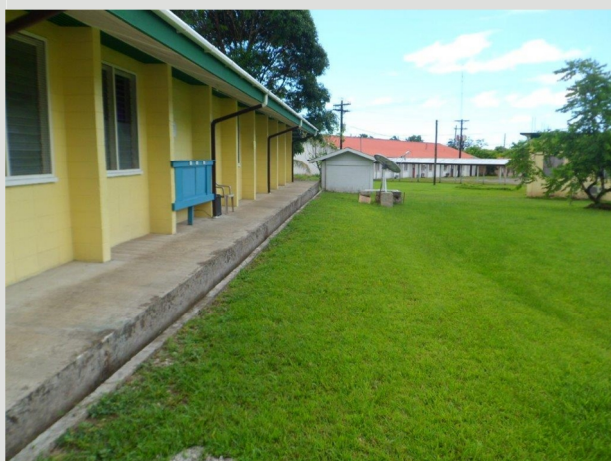
Narrow pedestrian walkway – suggest localised areas for seating to break up the length of the path and provide places for seating

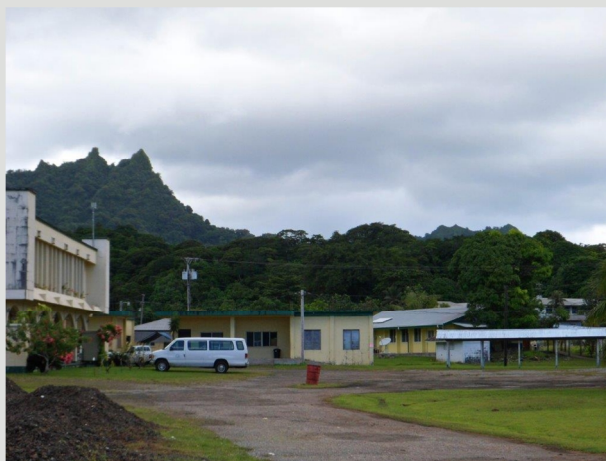
Mix of building styles

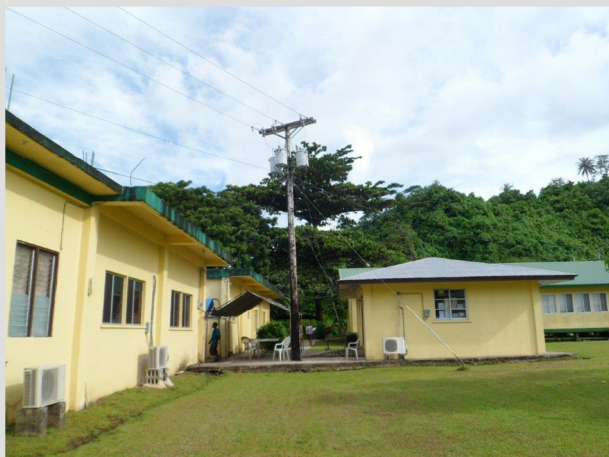
Power lines crossing through the middle of the campus

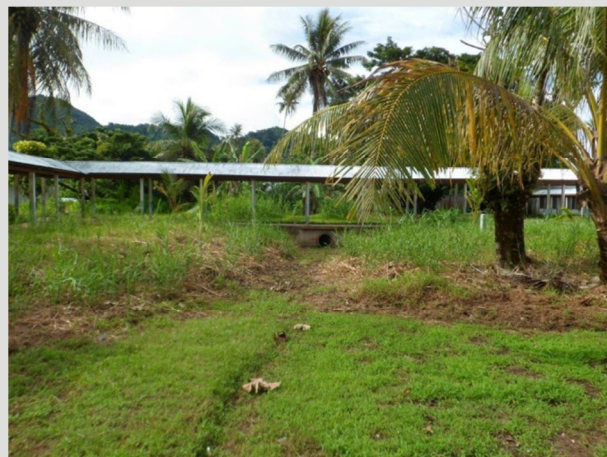
Drainage and culvert through the centre of the site

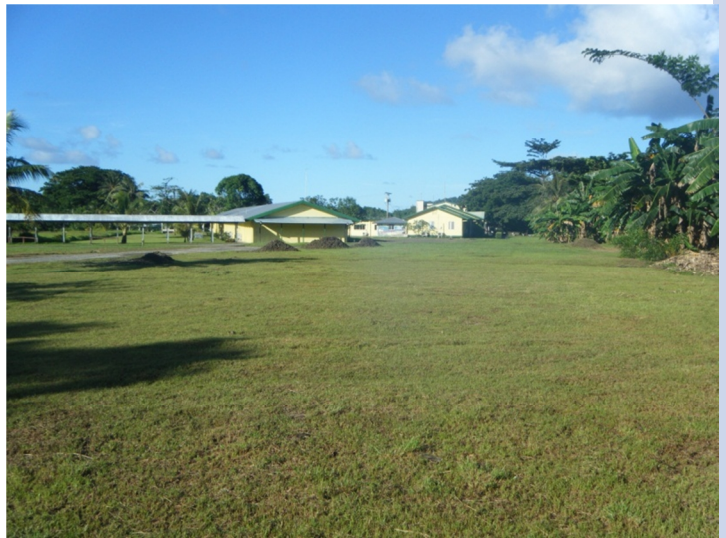
A – ADMINISTRATION BUILDING/CLASSROOMS

Building	Outline
<p>A – Administration Building/ Classrooms</p>   <p>Points to consider for future planning – Administration could be relocated closer to main entry</p>	<p>Building A has administration, classrooms, toilets and a covered area for students (pictured)</p> <p>Location for its function – in the centre of the Academic zone</p> <p>Quality and suitability of spaces for its function – Administration has limited space, provision of student services facility would high student demand in this area</p> <p>Disabled access - Ramp access and accessible toilet</p> <p>Teaching spaces – general classroom, computer lab and specialized science classroom</p> <p>Amenities, toilets - men (1 urinal/ 1 toilet), women (2 toilets), accessible toilet</p> <p>Building condition points - Repair corrosion to steel framed floor and decayed timber flooring immediately as this is a health and safety issue.</p> <p>Building age – 1998, 14 years (refurbished 2010 and 2012)</p>

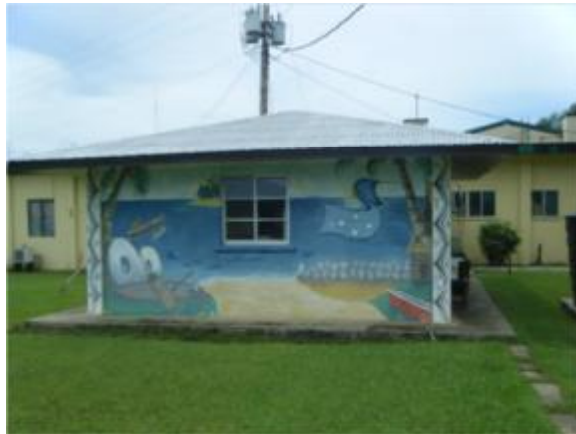
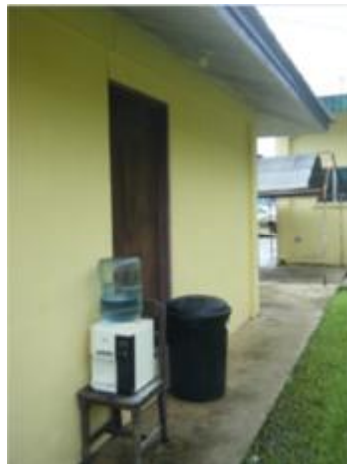
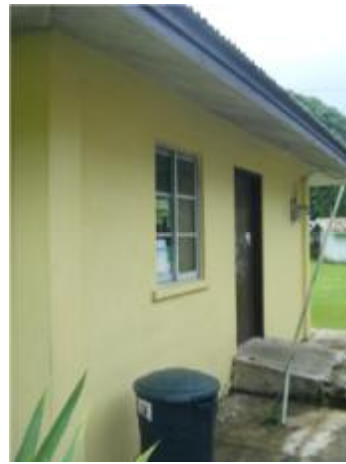
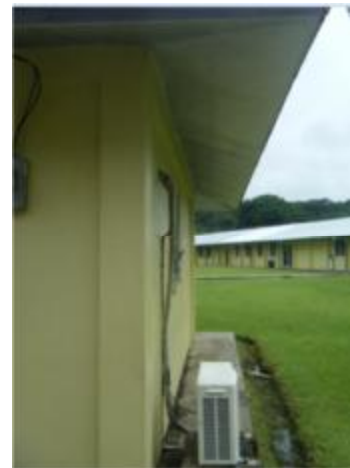
I - BOOKSTORE

4.00	Total Upper Floors	0	0%						0	0	0	0	0	0.0%		
5.00	Total Roof	4	70%						8,780	0	0	8,780	8,780	100.0%		
6.00	Total External Walls & Finishes	3	50%						0	0	8,001	8,001	8,001	100.0%	Vinyl Floor Finishes	Tiles lifted throughout and should be replaced

9.00	Total Internal Walls/Partitions	0	0%						0	0	0	0	0	0.0%		
10.00	Total Internal Doors	0	0%						0	0	0	0	0	0.0%	Profiled Metal Sheet Roof Cladding (Pre-Finished)	Evidence of flaking paint and rusted fixings to roof plus corrosion at base of sheets

18.00	Total Electrical Services	3	50%						0	14,830	0	14,830	14,830	100.0%		
19.00	Total Vertical Transportation	0	0%						0	0	0	0	0	0.0%	Overall Recommendation/Action	Targeted regular maintenance and cleaning. Treat rust, re-paint or replace roof immediately. Refurbish windows, doors, floor wall and ceiling finishes by 2023. Regularly maintain and replace mechanical and special services by 2023

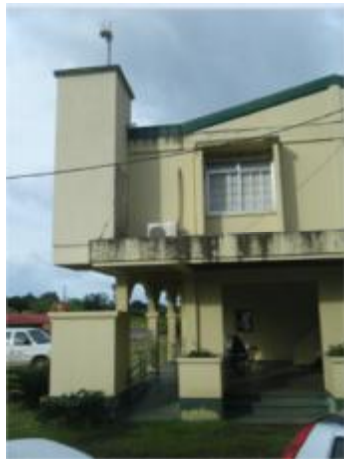
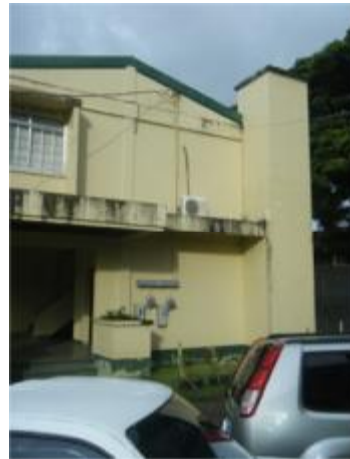
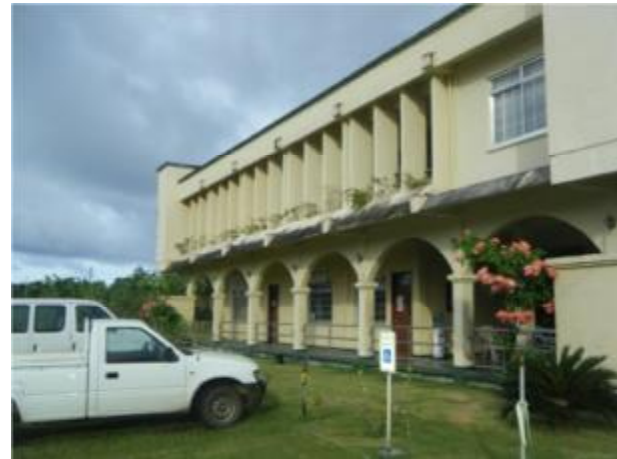
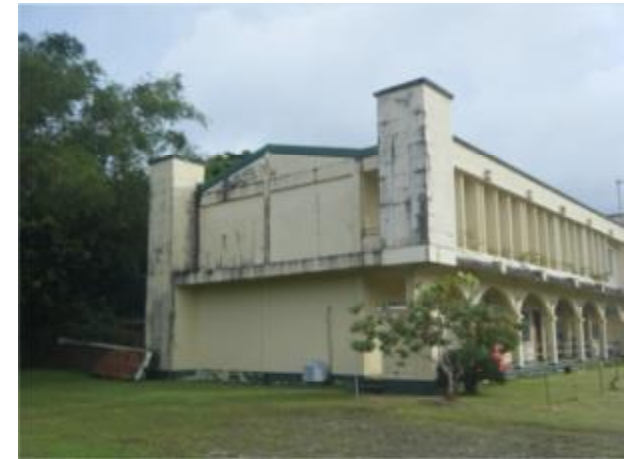
H – KSBDC BUILDING - SMALL BUSINESS DEVELOPMENT CENTRE (PART)

1.00	Total Sub-Structure	2	30%						0	0	0	0	133,462	0.0%		
2.00	Total Frame	2	30%						0	0	0	0	208,951	0.0%	Membrane Roof Cladding to canopy gutters	Assumed not present to canopy gutters but this or similar should be applied to provide water tightness

8.00	Total Stairs Balustrades & Handrails	4	70%						0	29,882	0	29,882	42,532	70.3%	Air-Conditioning - DX/Split System	Not operating and requires attention

12.00	Total Wall Finishes	3	50%						52,879	0	10,031	62,910	77,482	81.2%		
13.00	Total Ceiling Finishes	4	70%						33,072	0	22,866	55,938	55,938	100.0%	Solid Plaster Cladding with Painted Finishes	Evidence of cracking in and around windows

17.00	Total Fire Services	5	90%						3,795	3,795	1,898	9,488	1,898	500.0%	Overall Recommendation/Action	Targeted regular maintenance and cleaning. Review waterproofing (some leaks observed) and repair immediately. Provide fire extinguishers immediately. Replace roof by 2023. . Refurbish windows, doors, floor and ceiling finishes and joinery fittings by 2023. Regularly maintain and replace mechanical, fire and special services by 2023

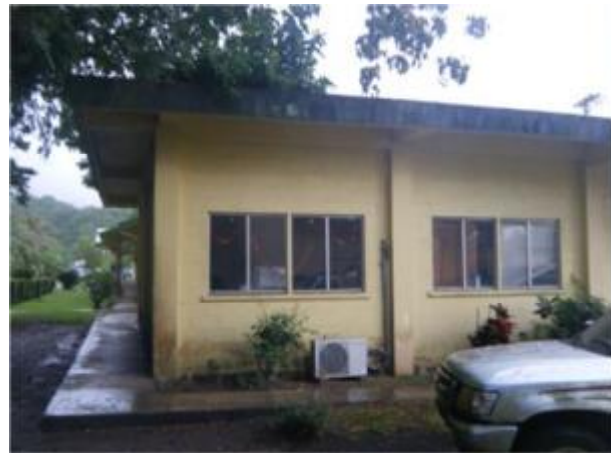
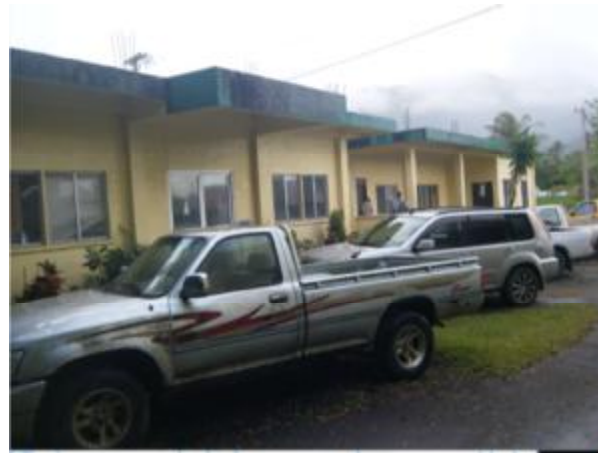
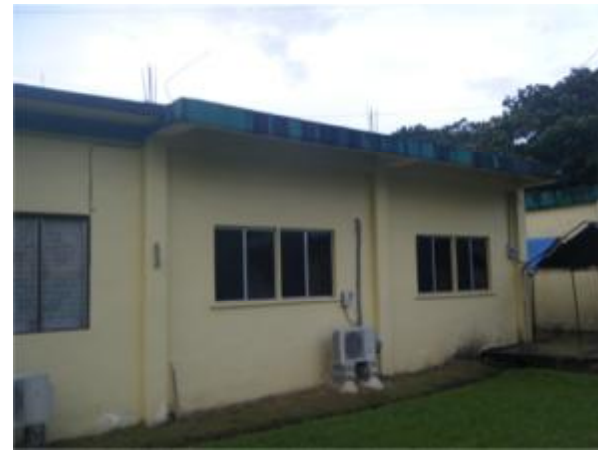
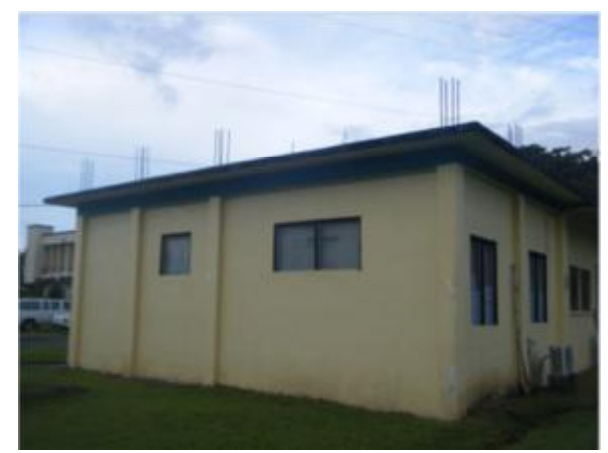
C - FACULTY BUILDING

3.00	Total Structural Walls	3	50%						0	0	0	0	49,557	0.0%		
4.00	Total Upper Floors	0	0%						0	0	0	0	0	0.0%	Reinforced Concrete Roof	Evidence of cracking, ponding of water and unprotected reinforcing

5.00	Total Roof	3	50%						21,353	0	21,353	42,705	21,353	200.0%		
6.00	Total External Walls & Finishes	3	50%						0	0	24,047	24,047	24,047	100.0%		
7.00	Total Windows & Doors	5	90%						4,574	779	14,614	19,968	19,188	104.1%	Membrane Roof Cladding	Evidence of spalling of concrete, leaks, ponding and deterioration of concrete roof
A	TOTAL STRUCTURE	4	70%						25,927	779	60,013	86,720	317,488	27.3%

8.00	Total Stairs Balustrades & Handrails	3	50%						0	0	2,220	2,220	16,135	13.8%		
9.00	Total Internal Walls/Partitions	0	0%						0	0	0	0	0	0.0%	Timber Doors (Solid/No Glazing)	Delaminated and damaged timber doors

10.00	Total Internal Doors	0	0%						0	0	0	0	0	0.0%		
11.00	Total Floor Finishes	4	70%						14,183	0	15,841	30,024	15,841	189.5%		
12.00	Total Wall Finishes	4	70%						18,824	0	0	18,824	18,824	100.0%	Vinyl Floor Finishes	Evidence of staining, lifting and marks. Floor feels uneven

13.00	Total Ceiling Finishes	4	70%						0	15,070	5,825	20,895	20,895	100.0%		
14.00	Total Fixed Joinery Units	3	50%						0	700	0	700	700	100.0%		
B	TOTAL INTERNAL FIT-OUT	4	70%						33,007	15,770	23,886	72,663	72,395	100.4%	Overall Recommendation/Action	Targeted regular maintenance and cleaning. Repair/seal cracking, level roof to prevent ponding, repair unprotected reinforcing and concrete spalling on roof immediately. Consider sealing roof with a bitumen paint to seal it, or apply roofing membrane. Refurbish windows, doors, floor and wall finishes and joinery fittings by 2023. Regularly maintain and replace mechanical, fire and special services by 2023.

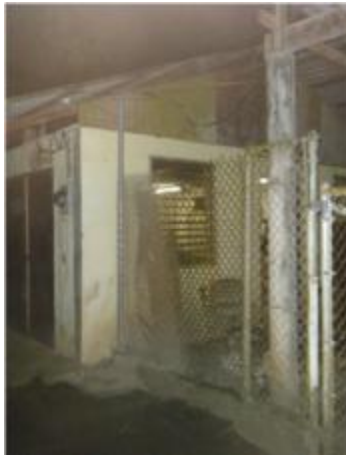
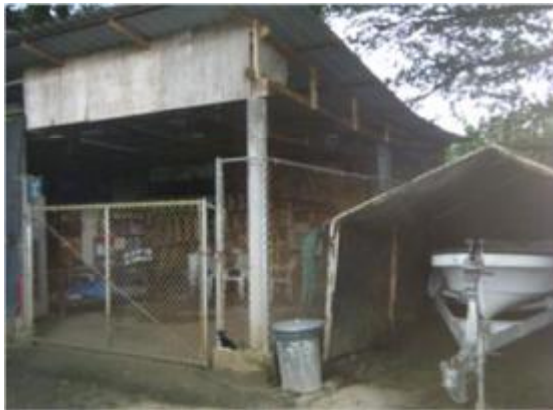
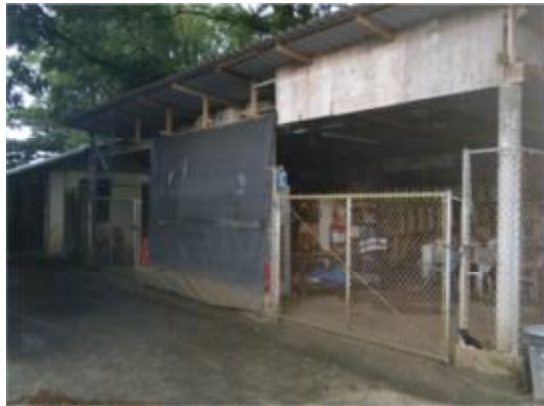
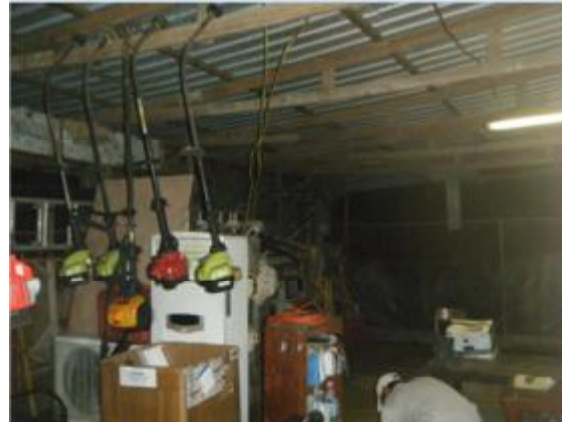
F - MAINTENANCE SHOP

3.00	Total Structural Walls	0	0%						0	0	0	0	0	0.0%	Compacted earth ground	Not assessed as part of condition assessment however recommend that this is monitored

4.00	Total Upper Floors	0	0%						0	0	0	0	0	0.0%		
5.00	Total Roof	3	50%						0	14,446	0	14,446	14,446	100.0%	Fire Extinguisher	Replacement fire extinguishers required (we understand these have been ordered)

8.00	Total Stairs Balustrades & Handrails	0	0%						0	0	0	0	0	0.0%	Chain Link Fencing and Swing gates	Evidence of corrosion on fence
9.00	Total Internal Walls/Partitions	4	70%						0	0	2,119	2,119	2,119	100.0%

12.00	Total Wall Finishes	0	0%						0	0	0	0	0	0.0%	Overall Recommendation/Action	Asset is run-down but is functioning as intended. We are uncertain about the condition of the substructure and this needs monitoring. Consider strengthening/propping to roof trusses. Maintain as necessary for building to function. Review in 2018.

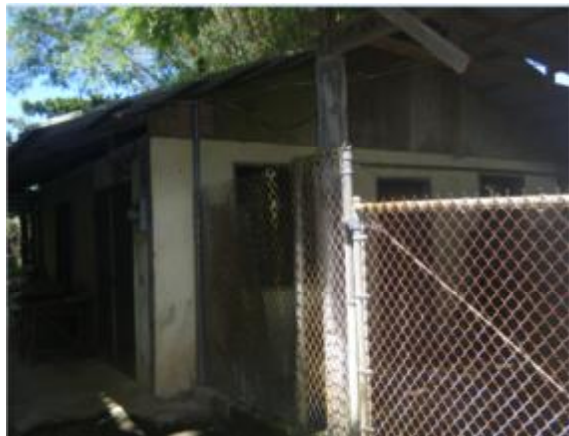
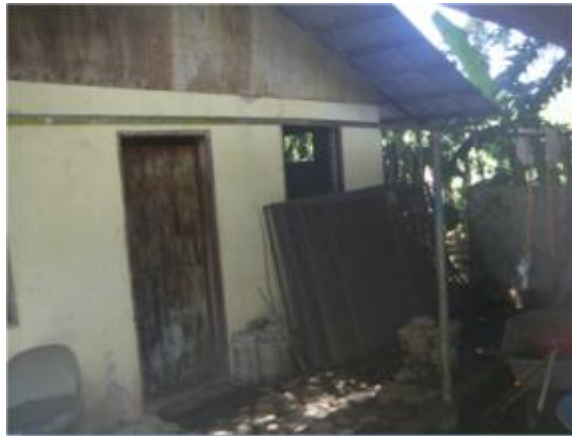
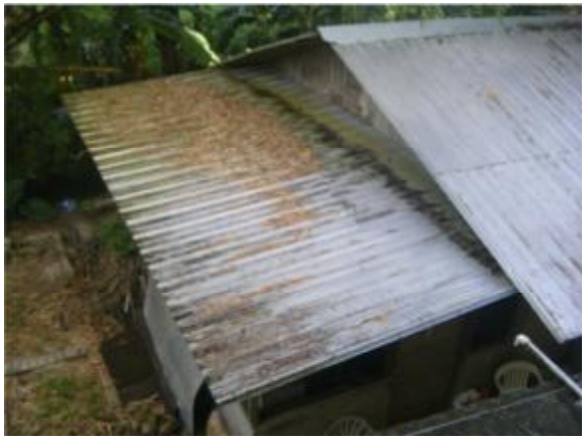
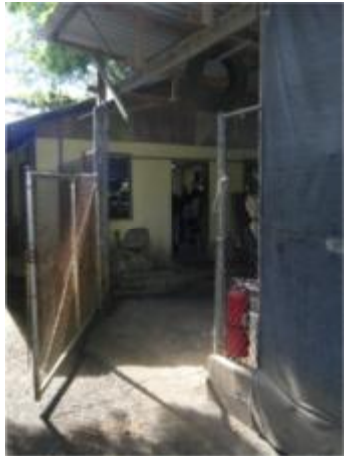
G - MAINTENANCE OFFICE

Element	Observed Deterioration/Recommendations
Reinforced Concrete Brick/Block Masonry Walls	Evidence cracking and spalling of concrete particularly to rear portion of building
Painted ply to gable ends	Deteriorated, delaminating and rot especially at rear end of building
Fire Extinguisher	Replacement fire extinguishers required (we understand these have been ordered)
Reinforced Concrete Foundations Beams	Evidence of spalled concrete
Reinforced Concrete Slab on Grade	Some evidence of spalled and heavily worn concrete
Overall Recommendation/Action	Targeted regular maintenance and cleaning. Repair exposed reinforcing and concrete spalling immediately. Provide fire extinguishers immediately. Replace roof by 2023. . Refurbish wall finishes by 2023. Regularly maintain and replace fire and special services by 2023

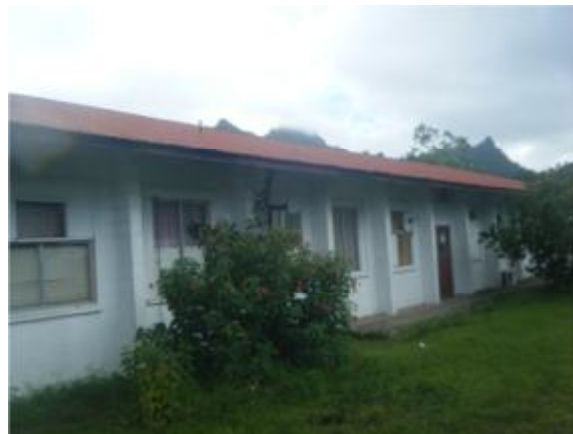
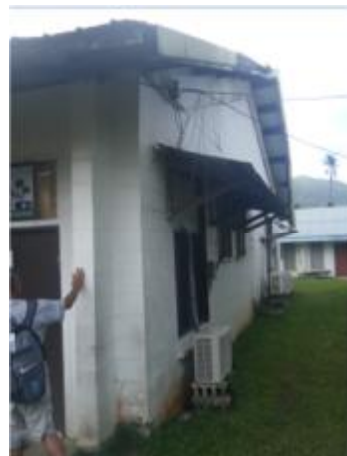
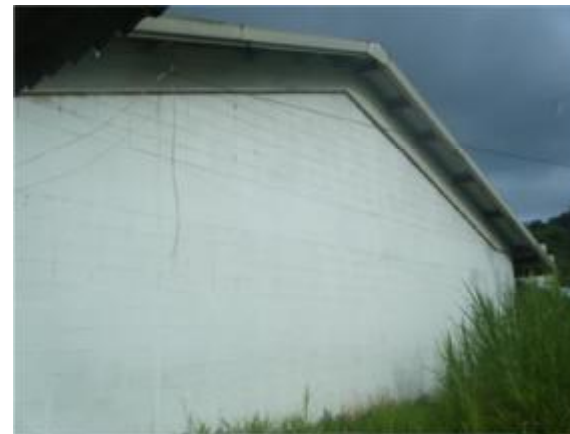
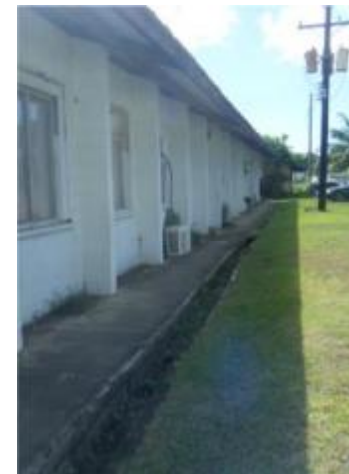
D - ROSE MACKWELUNG BUILDING (FORMER LIBRARY PART)

1.00	Total Sub-Structure	2	30%						0	0	0	0	48,238	0.0%		
2.00	Total Frame	4	70%						0	0	69,567	69,567	69,567	100.0%	Timber Door - Single	Evidence of impact damage, termite attack, delamination of panels at base

8.00	Total Stairs Balustrades & Handrails	0	0%						0	0	0	0	0	0.0%	Structural Steel Frame (Portal/Truss/Columns/Beams, etc.)	Evidence of advanced corrosion to roof beams and rafters, internal columns are painted and in good condition

11.00	Total Floor Finishes	4	70%						19,768	0	14,326	34,094	19,768	172.5%	Profiled Metal Sheet Roof Cladding (Pre-Finished)	Evidence of corrosion and impact damage particular at road entrance end of building

12.00	Total Wall Finishes	4	70%						0	36,670	21,410	58,080	58,080	100.0%		
13.00	Total Ceiling Finishes	4	70%						0	0	12,559	12,559	12,559	100.0%		
14.00	Total Fixed Joinery Units	2	30%						0	0	5,542	5,542	5,542	100.0%	Timber Framed Windows & Doors (external)	Evidence of decay and termite damage to doors, frames and infill panels
B	TOTAL INTERNAL FIT-OUT	4	70%						28,876	36,670	67,959	133,505	119,179	112.0%

15.00	Total Sanitary Plumbing	2	30%						0	0	16,445	16,445	16,445	100.0%		
16.00	Total Mechanical Services	3	50%						19,608	37,318	19,608	76,533	19,608	390.3%	Overall Recommendation/Action	Targeted regular maintenance and cleaning. Provide fire extinguishers immediately. Repair decay and termite damage to windows and doors immediately. Replace roof by 2023. . Refurbish doors and wall finishes by 2023. Regularly maintain and replace mechanical, fire and special services by 2023

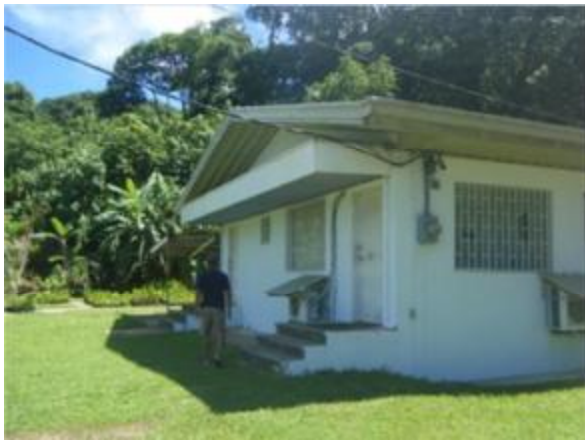
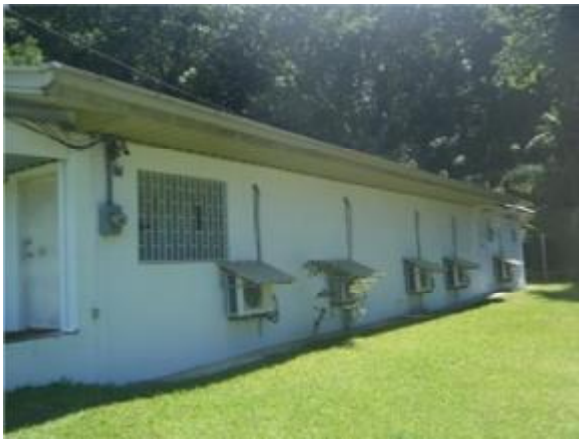
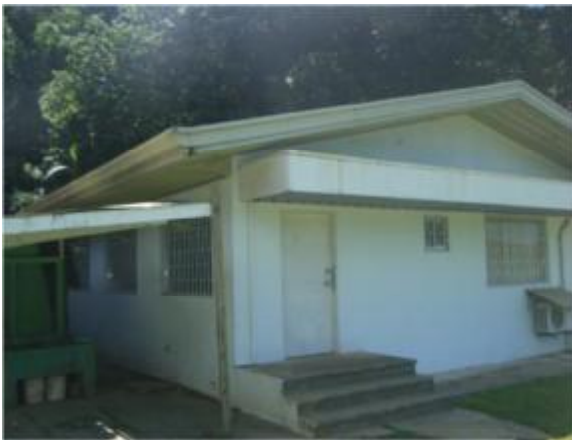
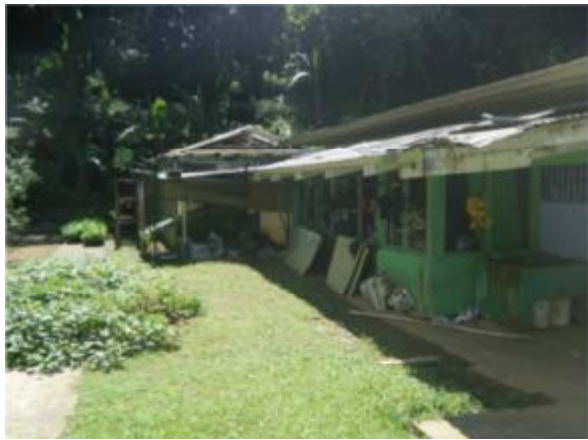
RESEARCH LAB (OFF CAMPUS)

4.00	Total Upper Floors	0	0%						0	0	0	0	0	0.0%	Metal Gutters	Evidence of corrosion and rapid deterioration
5.00	Total Roof	4	70%						4,499	33,700	2,328	40,527	40,527	100.0%

6.00	Total External Walls & Finishes	3	50%						0	14,579	0	14,579	30,748	47.4%	Cold Water Storage	Missing Cover to Rainwater tank
7.00	Total Windows & Doors	3	50%						0	0	14,956	14,956	44,511	33.6%		
A	TOTAL STRUCTURE	3	50%						4,499	48,279	17,283	70,061	284,342	24.6%

8.00	Total Stairs Balustrades & Handrails	2	30%						0	0	0	0	6,325	0.0%	Profiled Metal Sheet Roof Cladding (Pre-Finished) - Main Roof	Fading of protective paint and rust starting to show on fixings

9.00	Total Internal Walls/Partitions	0	0%						0	0	0	0	0	0.0%		
10.00	Total Internal Doors	2	30%						0	0	0	0	10,626	0.0%		
11.00	Total Floor Finishes	2	30%						0	12,886	739	13,625	13,625	100.0%	Profiled Metal Sheet Wall Cladding (Pre-Finished) - Main Roof soffit	Evidence of rust at junction with barge flashing and at fixings

12.00	Total Wall Finishes	3	50%						0	30,421	0	30,421	30,421	100.0%		
13.00	Total Ceiling Finishes	2	30%						0	0	17,488	17,488	17,488	100.0%		
14.00	Total Fixed Joinery Units	1	10%						0	0	4,807	4,807	4,807	100.0%	Timber Doors (Solid/No Glazing)	Impact damage at base of doors, general wear and tear and marks
B	TOTAL INTERNAL FIT-OUT	2	30%						0	43,308	23,034	66,342	83,293	79.6%

15.00	Total Sanitary Plumbing	2	30%						3,795	0	18,975	22,770	22,770	100.0%		
16.00	Total Mechanical Services	2	30%						22,138	47,058	22,138	91,333	24,921	366.5%	Overall Recommendation/Action	Targeted regular maintenance and cleaning. Replace roof by 2023. . Refurbish doors and wall finishes by 2023. Regularly maintain and replace sanitary plumbing, mechanical and fire services by 2023

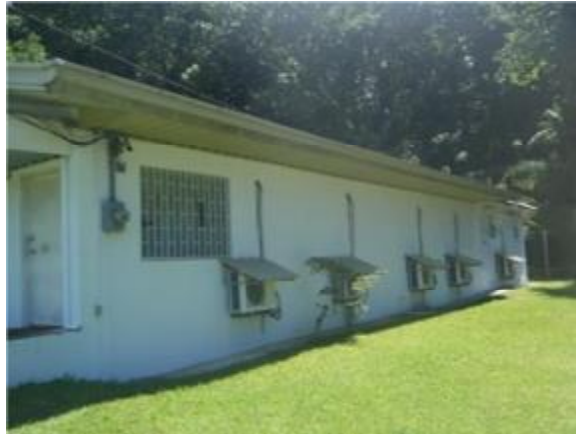
KOSRAE CAMPUS, TOFOL, KOSRAE STATE										TOILET BLOCK (ATTACHED TO LAB BUILDING OFF CAMPUS)

1.00	Total Sub-Structure	2	30%						0	0	0	0	20,709	0.0%	Timber Doors (Solid/No Glazing)					Damaged doors, rotten and delaminated at base				
2.00	Total Frame	3	50%						0	0	8,662	8,662	37,254	23.3%

6.00	Total External Walls & Finishes	3	50%						0	0	3,985	3,985	11,341	35.1%	Profiled Metal Sheet Roof Cladding (Pre-Finished)					Evidence of advanced corrosion to metal sheet cladding

8.00	Total Stairs Balustrades & Handrails	0	0%						0	0	0	0	0	0.0%										
9.00	Total Internal Walls/Partitions	0	0%						0	0	0	0	0	0.0%										
10.00	Total Internal Doors	2	30%						0	0	0	0	4,554	0.0%	Aluminium Framed Windows & Doors					Damaged mesh screen, partially removed rubber seal and glazing

19.00	Total Vertical Transportation	0	0%						0	0	0	0	0	0.0%	Overall Recommendation/Action					Targeted regular maintenance and cleaning. Replace windows, doors and roof by 2023. . Regularly maintain and replace sanitary plumbing, mechanical and fire services by 2023
