# College of Micronesia - FSM Space Utilization and Facilities Master Plan Study, Part 3 - Detailed Report for the Chuuk Campus

Prepared for the College of Micronesia - FSM

Prepared by Beca International Consultants Ltd (Beca)

28 November 2013

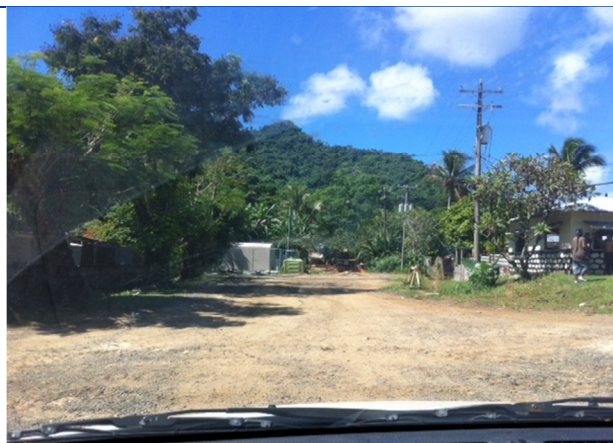
Area and unsealed road at the base of the hill in Pou

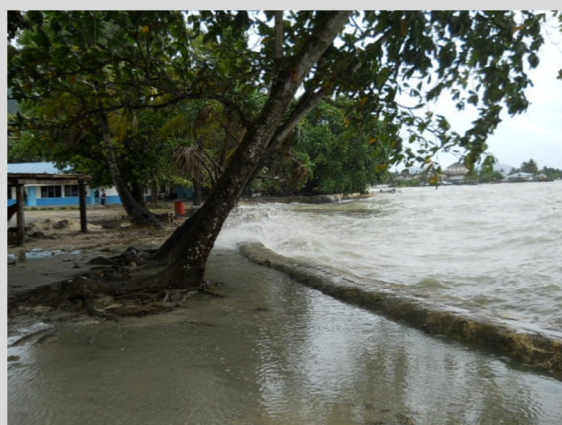
Exposure of the current site to storm surges with flooding of the buildings close to the sea frontage

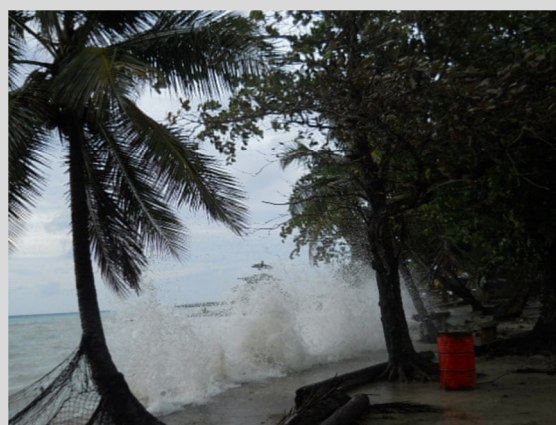
Exposure of the current site to storm surges with flooding of the buildings close to the sea frontage

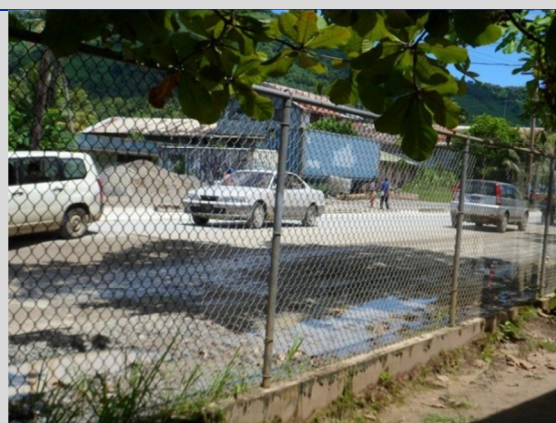
Chainlink fence around the perimeter

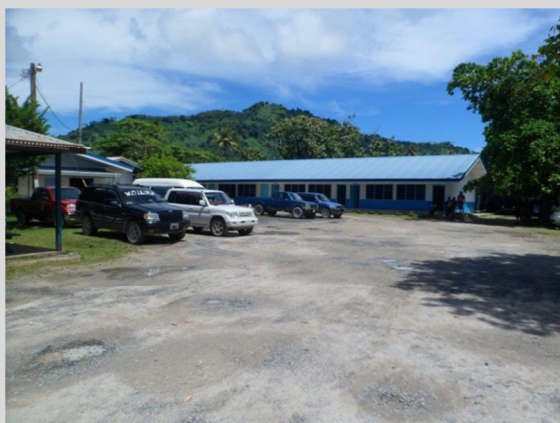
Cars park through the campus in a space that should be a pedestrian area

- Relocate the car parking zone from the centre to the edge of the campus
- With the removal of cars from the campus provide seating and recreation spaces

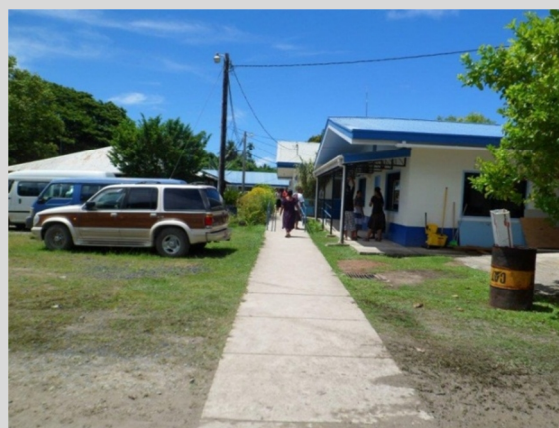
Space in front of buildings that could be used by students is occupied parked cars

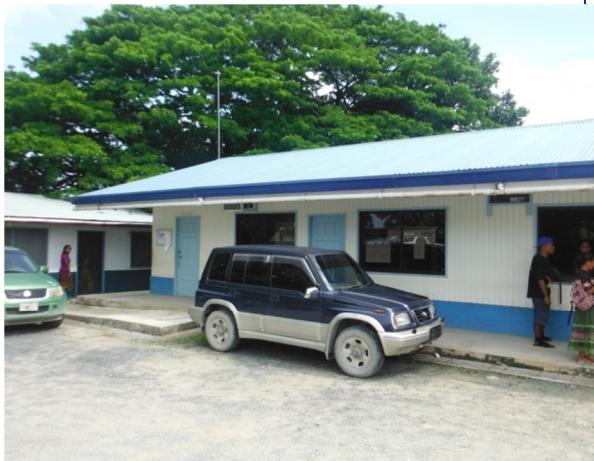
Building	Outline
<b>A – Administration/ Faculty office</b>

<p>Building A is the faculty offices with a mix of student service or administrative programs</p> <p>Location for its function – well located at the entry of the campus</p> <p>Quality and suitability of spaces for its function – The faculty rooms are a good size, additional space for storage of files would be beneficial. Considering using long desks instead of L shaped workstations to free up space</p> <p>Disabled access - Ramp access</p> <p>Teaching spaces - Nil</p> <p>Amenities, toilets - Single toilet for staff and a small kitchen bench. A lounge area attached to this space would enable staff to meet outside of the faculty rooms assisting collaborative work practices.</p> <p>Building condition points - Targeted regular maintenance and cleaning. Treat or replace rusted rainwater heads immediately. Repair decay (and any leaks) in soffit lining immediately.</p> <p>Building age – 7 years (mid 2000's)</p>

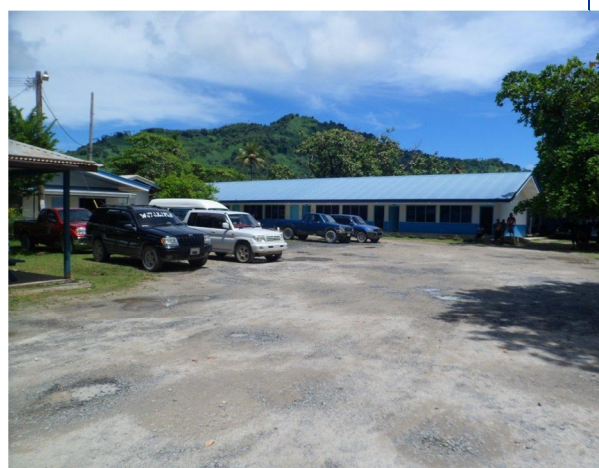
#### B – Classroom Building B

Building B is a classroom block with four large classrooms

Location for its function – well located but due to its proximity to other buildings limits cross ventilation through the site

Building condition points - Targeted regular maintenance and cleaning. Treat and spot prime rusted gutters immediately. Review roof and consider re-painting. Treat and repair termite damage to doors.

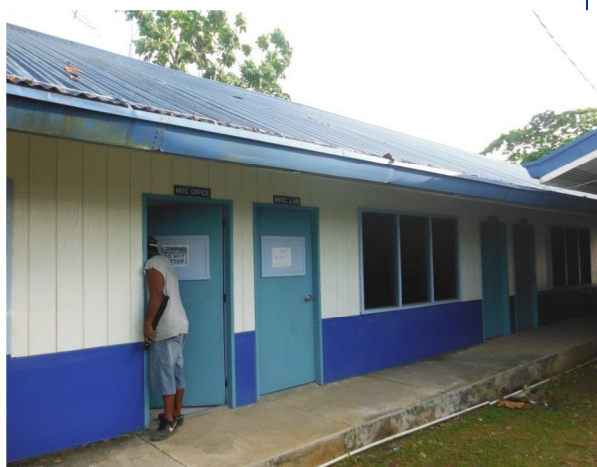
### C – Classroom Building C

Building C is another classroom block with four classrooms and film viewing facilities

Location for its function – well located but its proximity to other buildings limits the cross ventilation through the site

Building condition points - Targeted regular maintenance and cleaning. Treat and spot prime rusted roofing immediately. Review roof and consider re-painting. Treat and repair termite damage to windows.

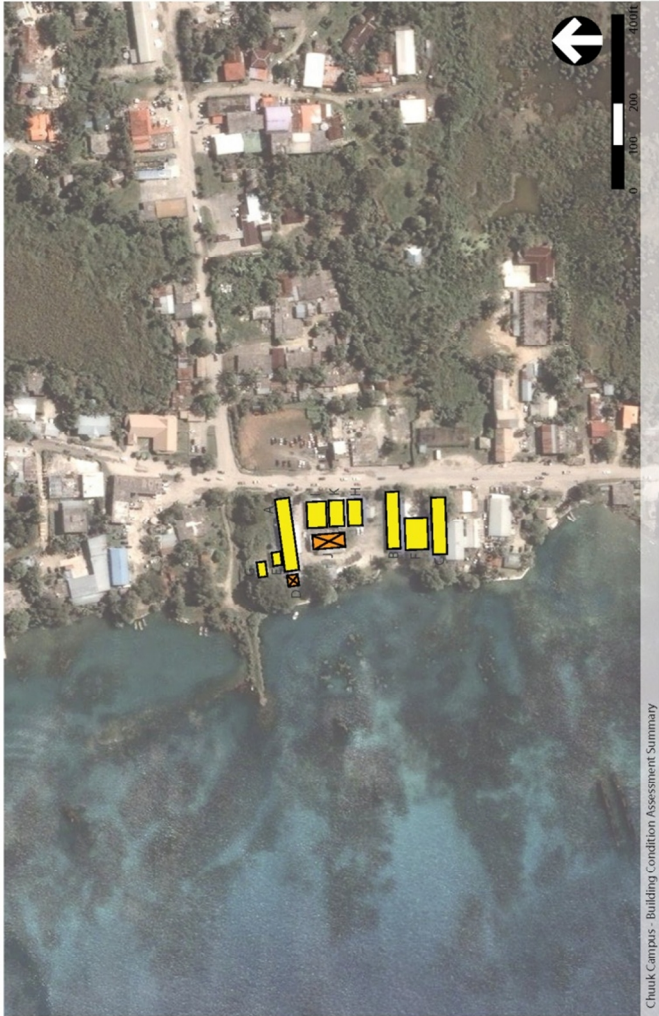
Chuuk Campus

From our condition assessment of the Chuuk campus we observe the following:

1. Midtown (off-campus) Building. 20% of the operational cost is dedicated to this off-campus building that is not owned by COM-FSM and is showing signs of significant structural and elemental failure. The use of this asset must be considered and if it is no longer required then operational costs could be reduced by diverting them to other facilities.

3. The majority of the buildings are rated as condition grade 3 which means that these assets are reaching the end of their serviceable life, but they are still functioning as intended. Targeted regular maintenance on all of the assets is required to extend their life. A clear, well organised asset renewal and routine maintenance plan needs to be developed and this needs to be implemented. An indicative maintenance and asset plan has been included in Appendix C.
