# College of Micronesia - FSM Facilities Master Plan, Part 3 - Detailed Report for the Pohnpei Career and Technical Education Center

Prepared for the College of Micronesia - FSM

Prepared by Beca International Consultants Ltd (Beca)

28 November 2013

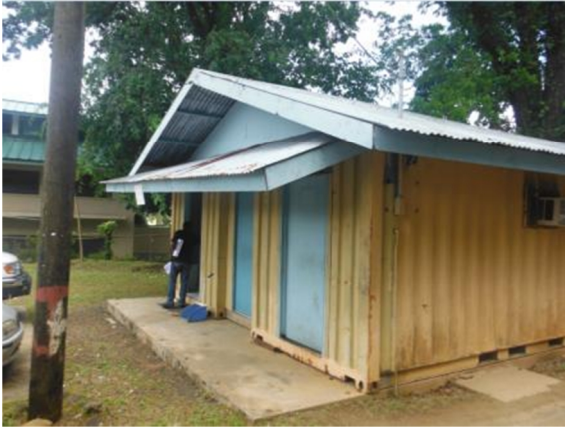
Building	Outline
<p><b>I - IT Shop</b></p>

<p><b>Points to consider for future planning</b> – Consider removal to provide through site access.</p>	<p>Building I is a container base building</p> <p>Location for its function – not adequate, occupies critical space</p> <p>Quality and suitability of spaces for its function – not adequate condition or size</p> <p>Disabled access - nil</p> <p>Teaching spaces - nil</p> <p>Amenities, toilets - nil</p> <p>Building condition points – Targeted regular maintenance and cleaning. Localised repairs and rust treatment to roof required immediately. Repair decay to plywood storeroom floor.</p> <p>Building age – not available</p>
<p><b>J - Classroom Building B</b></p>

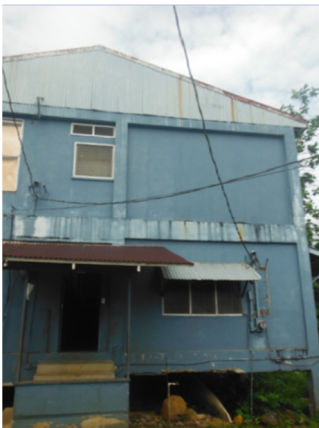
<p><b>K - Vocational Classrooms, TSP,UB, CES</b></p>

<p>Building K is a half utilized building currently housing extension programs</p> <p>Location for its function – could be located elsewhere</p> <p>Quality and suitability of spaces for its function – not adequate as building was historically a dormitory</p> <p>Disabled access - nil</p> <p>Teaching spaces - nil</p> <p>Amenities, toilets - not assessed</p> <p>Building condition points – Asset appears to be structurally unsound and needs immediate review by a structural engineer (collapsed column and spalled concrete) as it is a health and safety risk. \$2.68M estimated renewal cost (75% of replacement cost) over the next 10 years. Consider demolition or replacement</p>

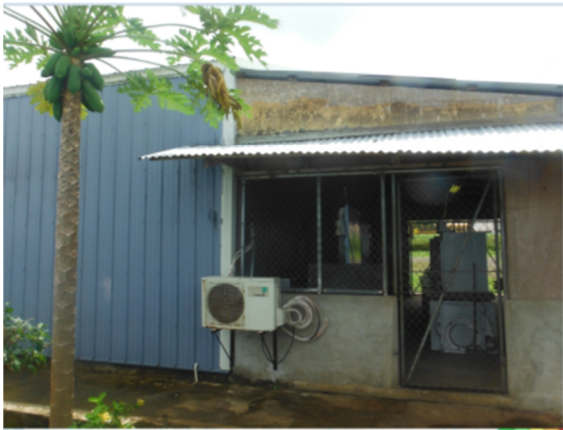
<p><b>Points to consider for future planning –</b> Consider removal to release land for through site access.</p>	<p>Building M is the mechanic shop next to the carpentry shop</p> <p>Location for its function – well located with a road frontage</p> <p>Quality and suitability of spaces for its function - adequate</p> <p>Disabled access - nil</p> <p>Teaching spaces - 1</p> <p>Amenities, toilets - nil</p> <p>Building condition points – Targeted regular maintenance and cleaning. Repair leaks and rot around windows and install missing WC doors immediately.</p> <p>Building age – not available</p>

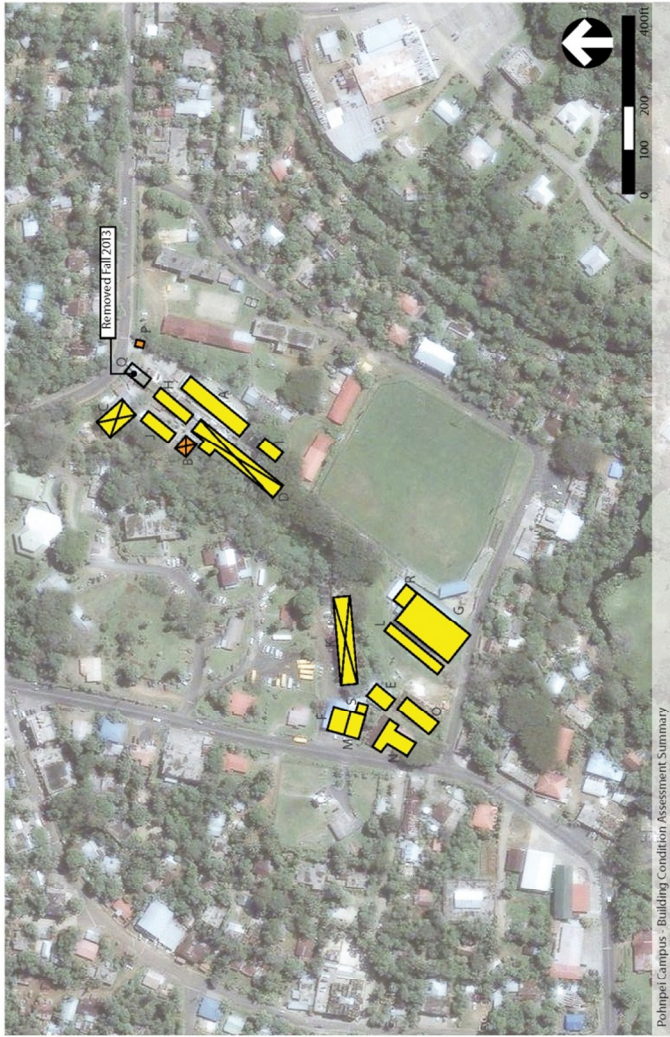
4.1.7 Campus condition grading summary plans

From our condition assessment of the Pohnpei campus we observe the following:

1. Upward Bound and TSP Building. The estimated replacement value of this building is 17% of the Pohnpei capital assets but 49% of the operational cost is dedicated to this building which is out of proportion to all other campus assets. This building is rated condition grade 5 and has significant structural and elemental defects. We consider that it is uneconomic to operate and should be demolished and replaced.

3. Twelve (of the 16) buildings are rated as condition grade 3 which means that these assets are reaching the end of their serviceable life, but they are still functioning as intended. The remaining assets are rated condition grade 4 or 5 meaning that they require additional attention or should be considered for demolition/replacement. Targeted regular maintenance on all of the assets is required to extend their life. A clear, well organised asset renewal and routine maintenance plan needs to be developed and this needs to be implemented. An indicative maintenance and asset plan has been included in Appendix C.

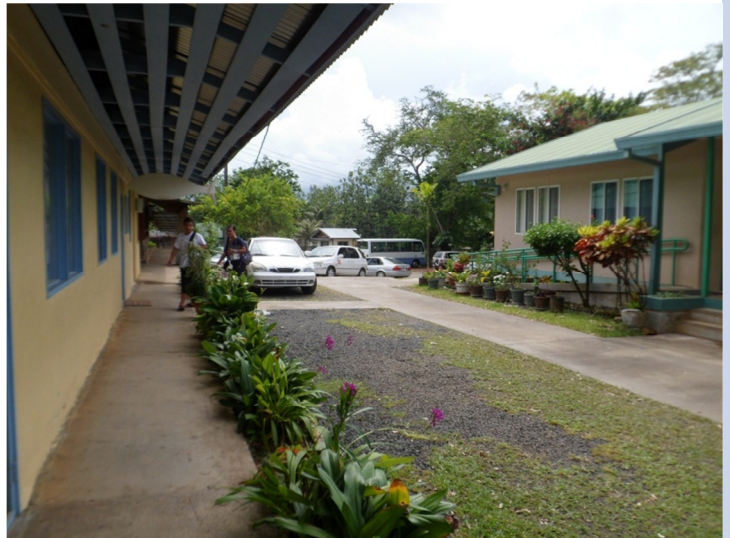
**POHNPEI CAMPUS, KOLONIA, POHNPEI STATE**
**A - ADMINISTRATION BUILDING**

3.00	Total Structural Walls	3	50%						0	0	40,331	40,331	40,331	100.0%	Timber Floor Boards	Severe decay of timber flooring present to outer edges of decking

4.00	Total Upper Floors	0	0%						0	0	0	0	0	0.0%		
5.00	Total Roof	3	50%						19,139	87,518	405	107,063	107,063	100.0%	Structural Steel Frame	Damaged perimeter edge beam to deck needs replacing

6.00	Total External Walls & Finishes	4	70%						7,580	0	30,320	37,900	37,900	100.0%		
7.00	Total Windows & Doors	3	50%						1,898	0	13,283	15,180	74,941	20.3%	Fibre Cement Cladding with Painted Finishes	Evidence of decay and water damage at base of sheets and where penetrations not sealed adequately
A	TOTAL STRUCTURE	3	50%						45,951	87,518	205,642	339,111	557,425	60.8%

8.00	Total Stairs Balustrades & Handrails	2	30%						0	0	0	0	9,108	0.0%	Timber Doors (Solid/No Glazing)	Damaged door to computer lab
9.00	Total Internal Walls/Partitions	0	0%						0	0	0	0	0	0.0%

10.00	Total Internal Doors	3	50%						0	0	13,283	13,283	13,283	100.0%	Tiled Floor Finishes to toilets	Some missing tiles, staining and cracked grout (say 20% of area)

11.00	Total Floor Finishes	4	70%						36,792	9,106	35,289	81,187	45,898	176.9%		
12.00	Total Wall Finishes	3	50%						112,966	4,030	112,966	229,962	116,996	196.6%	Overall Recommendation/Action	Targeted regular maintenance and cleaning. Repair timber decking immediately (health and safety issue) and steel beam to deck. Repair decay and leaks in wall cladding immediately to extend asset life. Replace roof and refurbish external walls, windows and doors by 2023. Refurbish floor, wall and ceiling finishes and joinery fittings by 2023. Regularly maintain and replace mechanical and fire services by 2023.

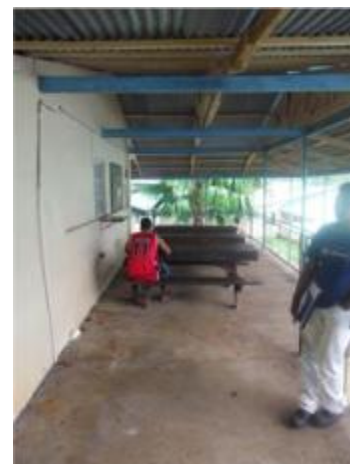
**POHNPEI CAMPUS, KOLONIA, POHNPEI STATE**
**B – BOOKSTORE**

1.00	Total Sub-Structure	4	70%						0	0	44,019	44,019	67,778	64.9%		
2.00	Total Frame	4	70%						0	0	49,849	49,849	66,977	74.4%	Reinforced Concrete Brick/Block Masonry Walls and Reinforced Concrete Frame	Evidence of settlement and structural cracking

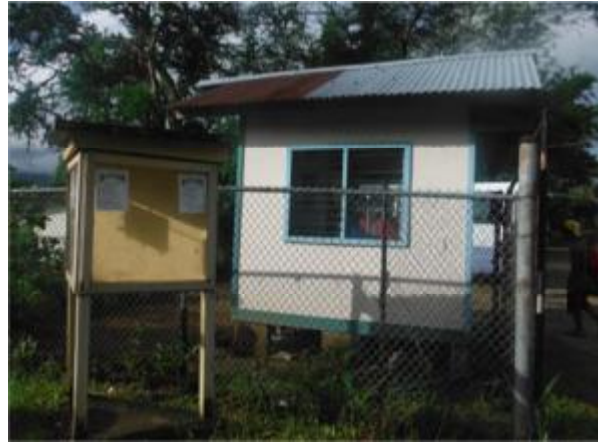
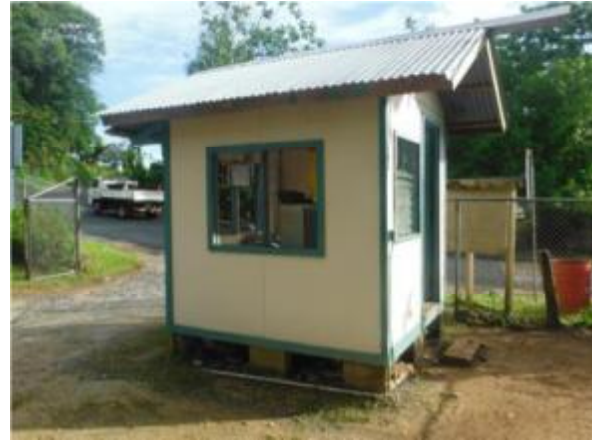
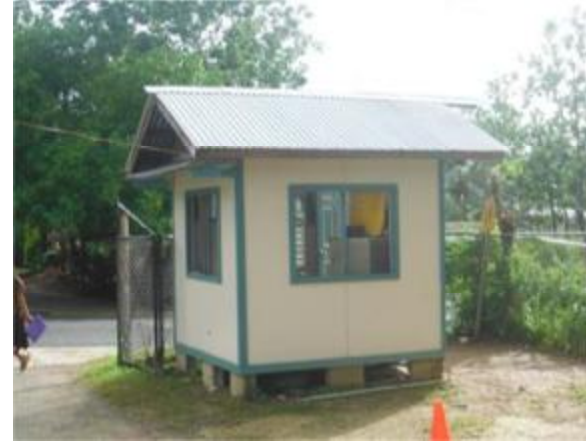
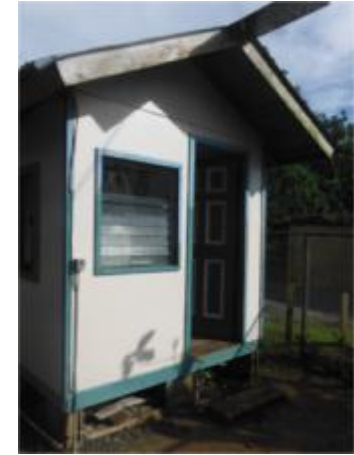
**POHNPEI CAMPUS, KOLONIA, POHNPEI STATE**
**P - SECURITY SHED**

1.00	Total Sub-Structure	5	90%						5,313	1,423	0	6,736	6,736	100.0%	Reinforced Concrete Block Foundation Walls	Timber floor sitting on spaced concrete blocks - not adequate

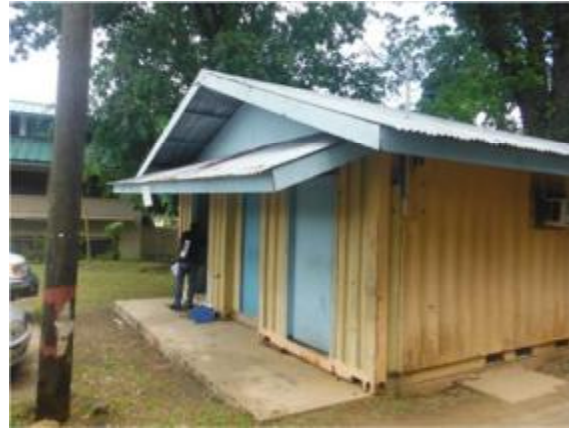
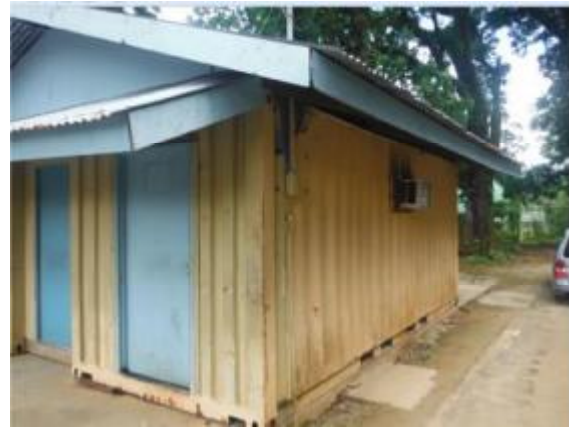
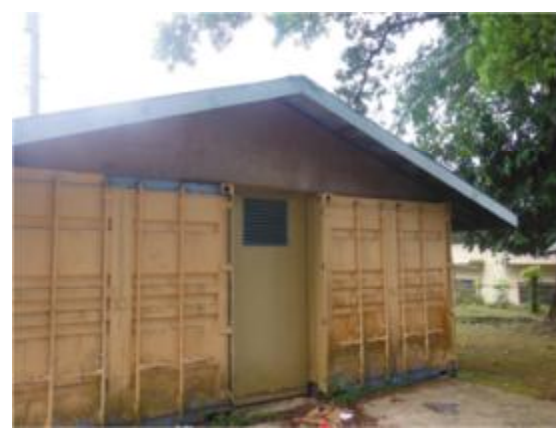
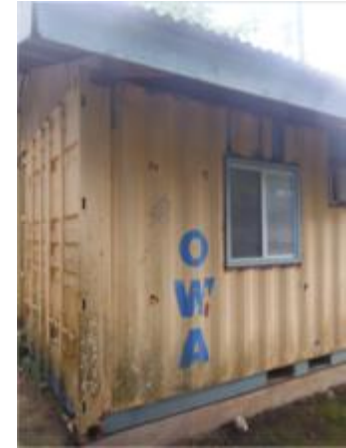
**POHNPEI CAMPUS, KOLONIA, POHNPEI STATE**
**I - IT SHOP**

1.00	Total Sub-Structure	4	70%						0	0	7,407	7,407	17,631	42.0%		
2.00	Total Frame	3	50%						0	0	1,549	1,549	29,648	5.2%	Profiled Metal Sheet Roof Cladding (Pre-Finished)	Corrugated Iron sheet - evidence of oxidation and corrosion. Two sheets to front canopy rusty appearance

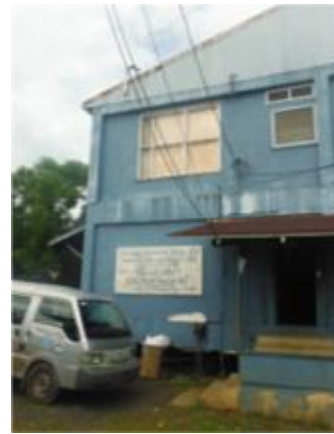
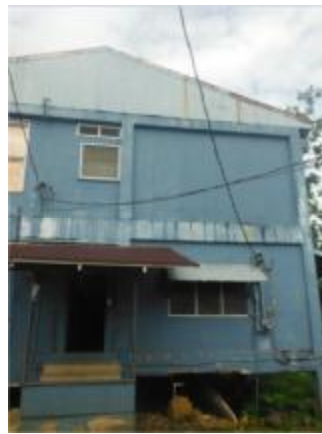
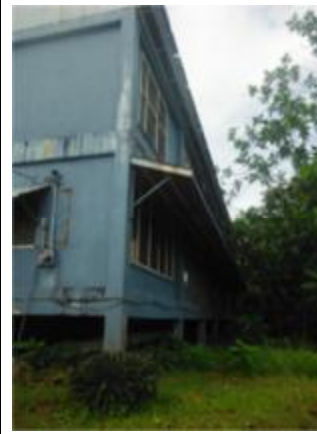
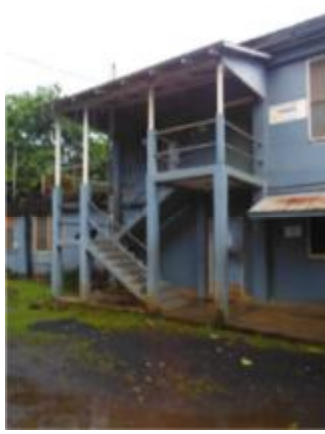
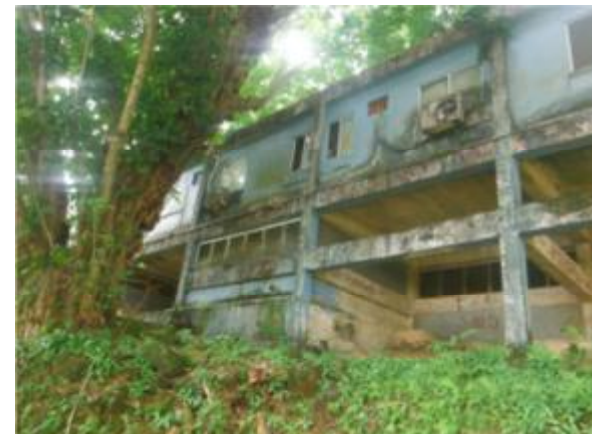
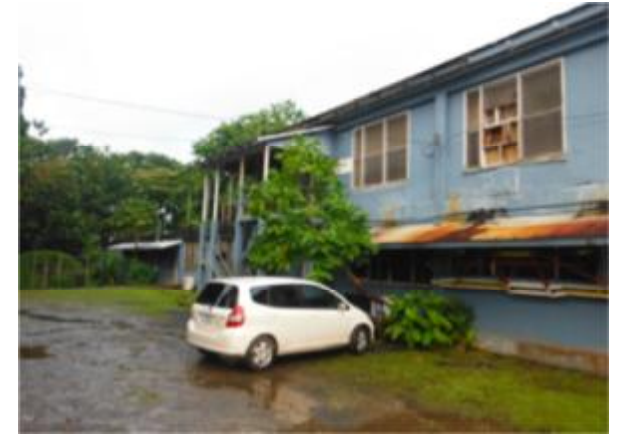
**POHNPEI CAMPUS, KOLONIA, POHNPEI STATE**
**K – Upward Bound & TSP**

1.00	Total Sub-Structure	0	0%						0	0	0	0	0	0.0%		
2.00	Total Frame	5	90%						652,731	0	0	652,731	652,731	100.0%	Evidence of spalling concrete, cracking, corrosion, etc. H&S risk of structural failure (1 column collapsed)	Review by Structural Engineer, Repair or Replace

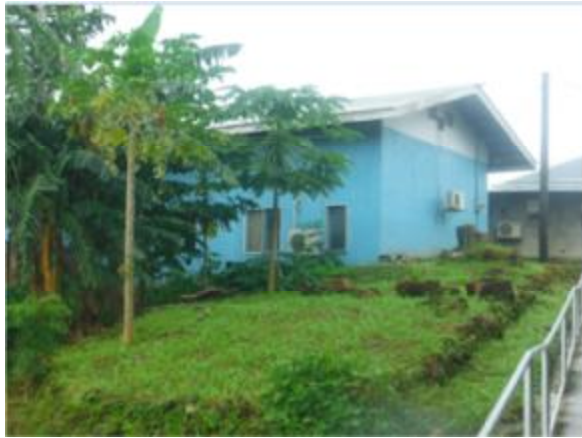
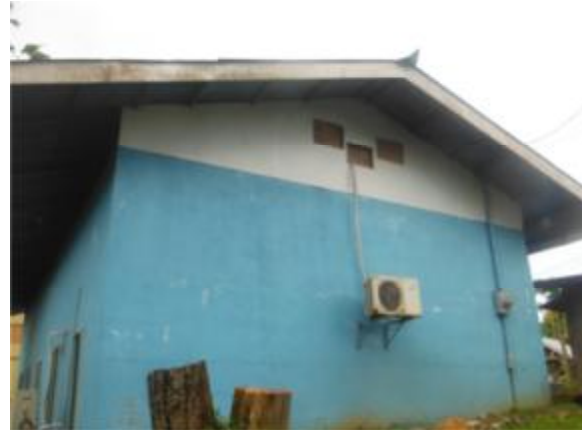
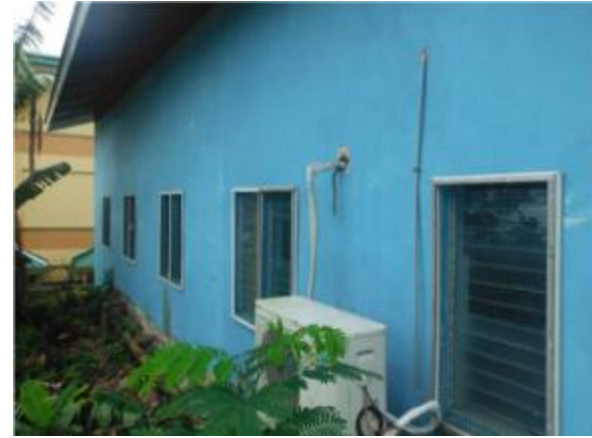
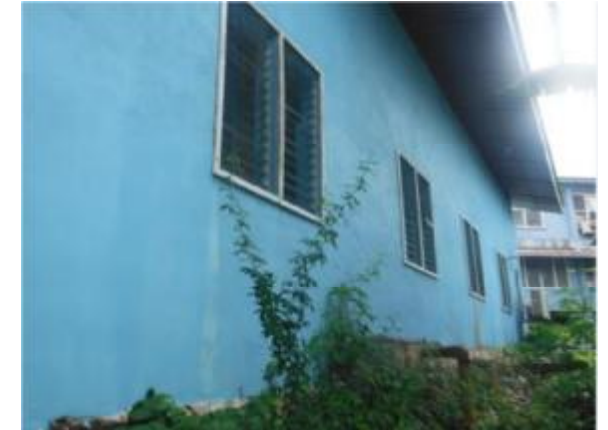
**POHNPEI CAMPUS, KOLONIA, POHNPEI STATE**
**E - ELECTRICAL BUILDING**

1.00	Total Sub-Structure	3	50%						0	0	12,841	12,841	67,090	19.1%		
2.00	Total Frame	3	50%						0	0	0	0	73,551	0.0%	Vinyl Floor Finishes	Chipped and damaged to entry to upper floor office

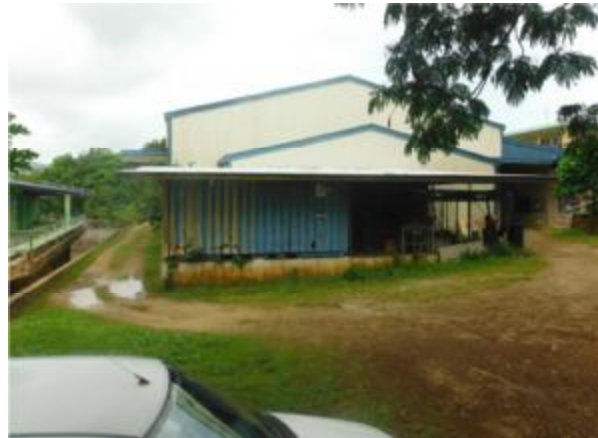
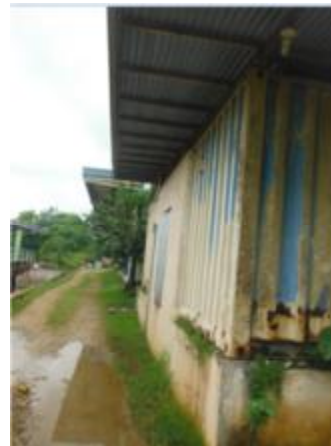
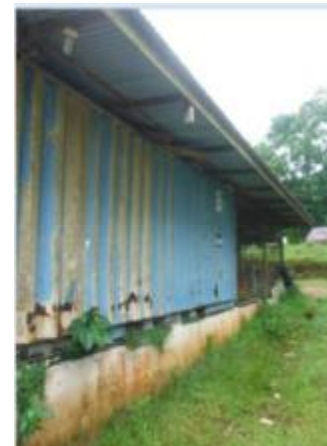
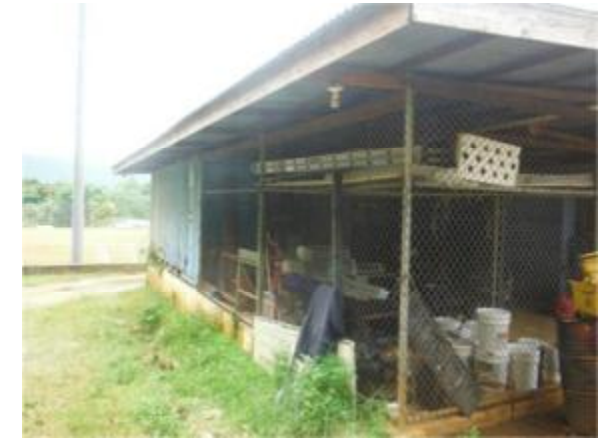
**POHNPEI CAMPUS, KOLONIA, POHNPEI STATE**
**R - MAINTENANCE BUILDING**

1.00	Total Sub-Structure	3	50%						0	0	17,415	17,415	45,941	37.9%		
2.00	Total Frame	4	70%						0	28,039	24,006	52,045	52,045	100.0%	Profiled Metal Sheet Roof Cladding (Pre-Finished)	Galvanized steel iron -Evidence of rust and deterioration in several locations

Element	Observed Deterioration/Recommendations
Profiled Metal Sheet Roof Cladding (Pre-Finished)	Galvanized steel iron -Evidence of rust and deterioration in several locations
Plywood wall linings with Painted Finishes	To trusses. Only partially clad at rear of building. Cladding present is water damaged and delaminating
Paint finish to metal cladding	Evidence of rust, marks, and staining
Vinyl Floor Finishes	Staining, marks and wear and tear. No threshold strip at doorway
Prefinished timber veneer panelling	Evidence of holes in wall and impact damage
Overall Recommendation/Action	Targeted regular maintenance and cleaning. Localised repairs to metal roof and wall cladding and plywood cladding required immediately. Replace roof, external walls, windows and doors by 2023. Refurbish floor and wall finishes by 2023. Regularly maintain and replace mechanical, electrical and special services by 2023

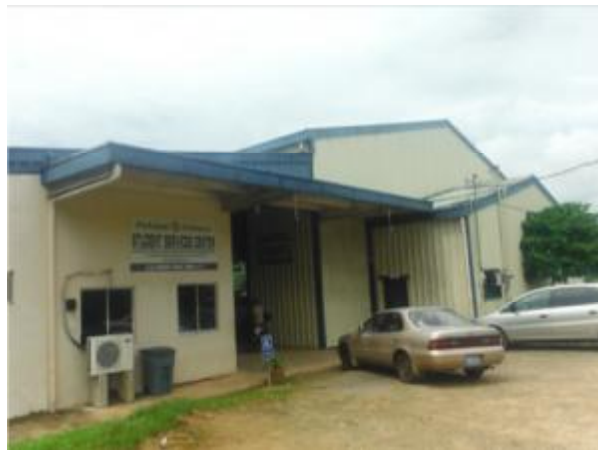
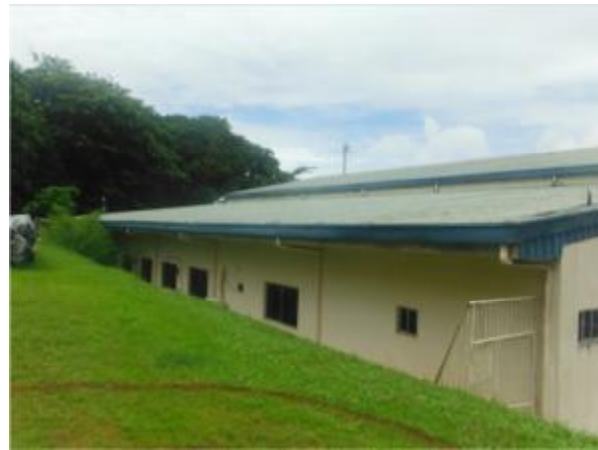
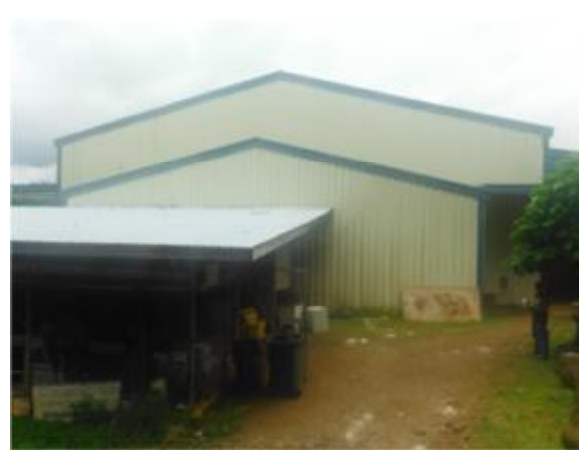
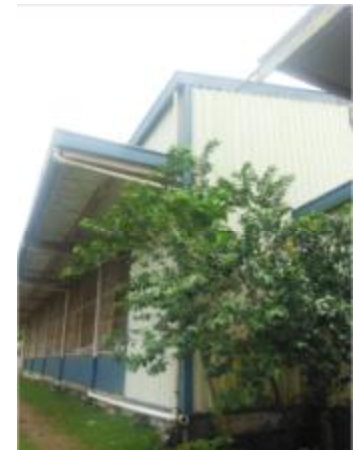
**POHNPEI CAMPUS, KOLONIA, POHNPEI STATE**
**L - STUDENT SERVICES CENTER**

1.00	Total Sub-Structure	2	30%						0	0	0	0	116,573	0.0%		
2.00	Total Frame	2	30%						0	0	0	0	264,986	0.0%	Fibre Cement Cladding with Painted Finishes	Evidence of flaking paint where deterioration of panel where window mounted AC removed

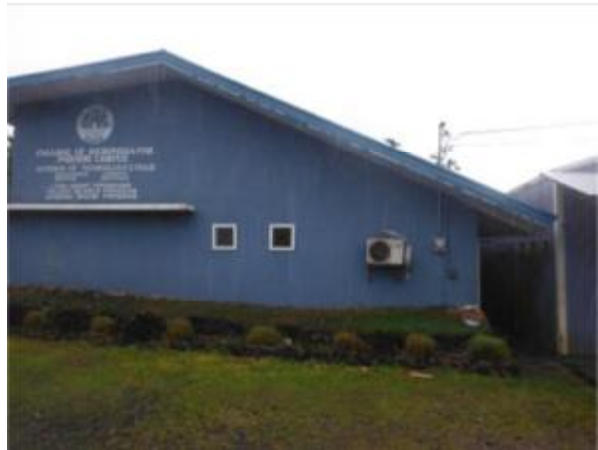
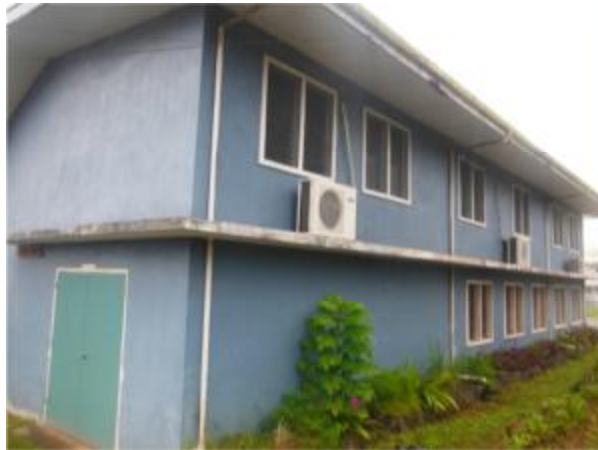
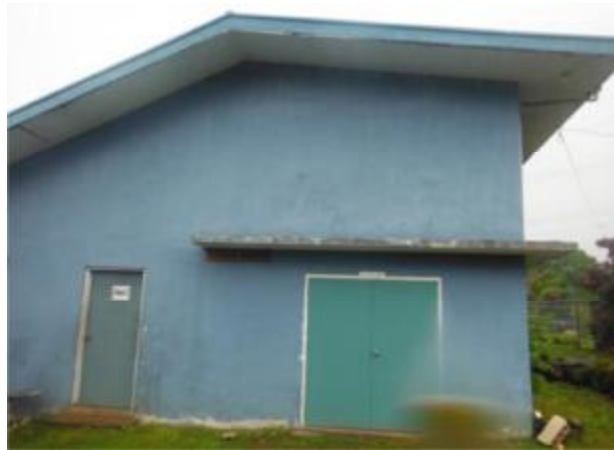
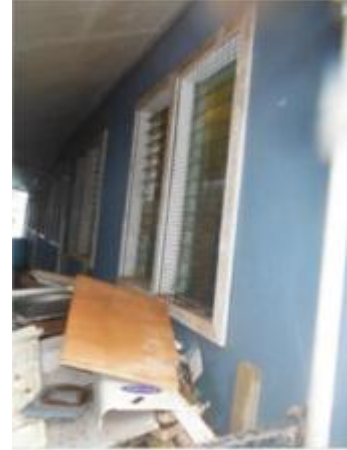
# F - CARPENTRY SHOP

Element	Observed Deterioration/Recommendations
PVC Gutters	Buckled, damaged and missing end section and cap that is contributing to the roof leak
Solid Plaster Wall Lining with Painted Finishes to WCs	Evidence of marks, water damage and staining to WCs
Painted Ply with Painted finish to soffit of main roof	Mould and rot apparent to soffits to underside of main roof. Requires replacement
Plywood ceiling Lining with painted Finish -to Classrooms	Water damaged ply sheet particularly at far corner in room V5 and above AC unit
Built-in Joinery - Timber framed, mesh screen doors on timber shelves	Unit looks tired
Overall Recommendation/Action	Targeted regular maintenance and cleaning. Repair leaks and rot in soffits/ceilings and replace sections of gutter immediately. Replace roof by 2023. Refurbish wall and ceiling finishes and joinery fittings by 2023. Regularly maintain and replace mechanical and fire services by 2023
