College of Micronesia - FSM Space Utilization and Facilities Master Plan Study, Part 3 - Detailed Report for the Yap Campus

Prepared for the College of Micronesia - FSM

Prepared by Beca International Consultants Ltd (Beca)

28 November 2013

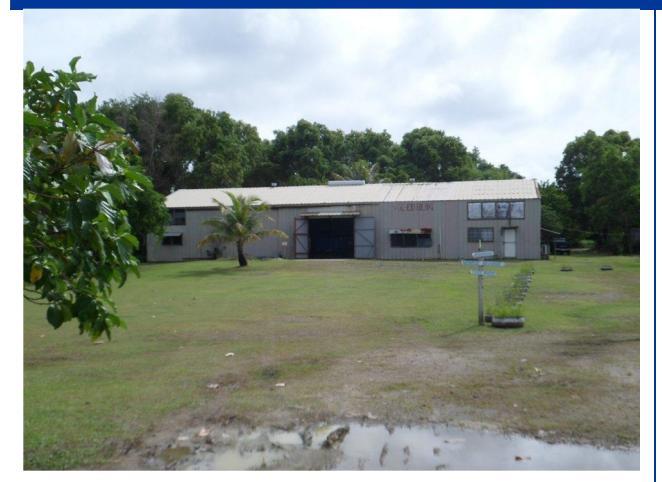
Building condition points - This building has a very high renewal &

maintenance cost over the next 30 years (40% of Yr. 1-10 renewal budget & 96% of full replacement cost over 30 years) making it uneconomic to renew/maintain. Carry out minimal maintenance (to protect against health & safety issues), run down and replace circa 2018 or before

Building age - 40+ years

Provide external access to other spaces - no need to walk through the workshop to access classroom spaces Relocate the function onto the campus site in the short term

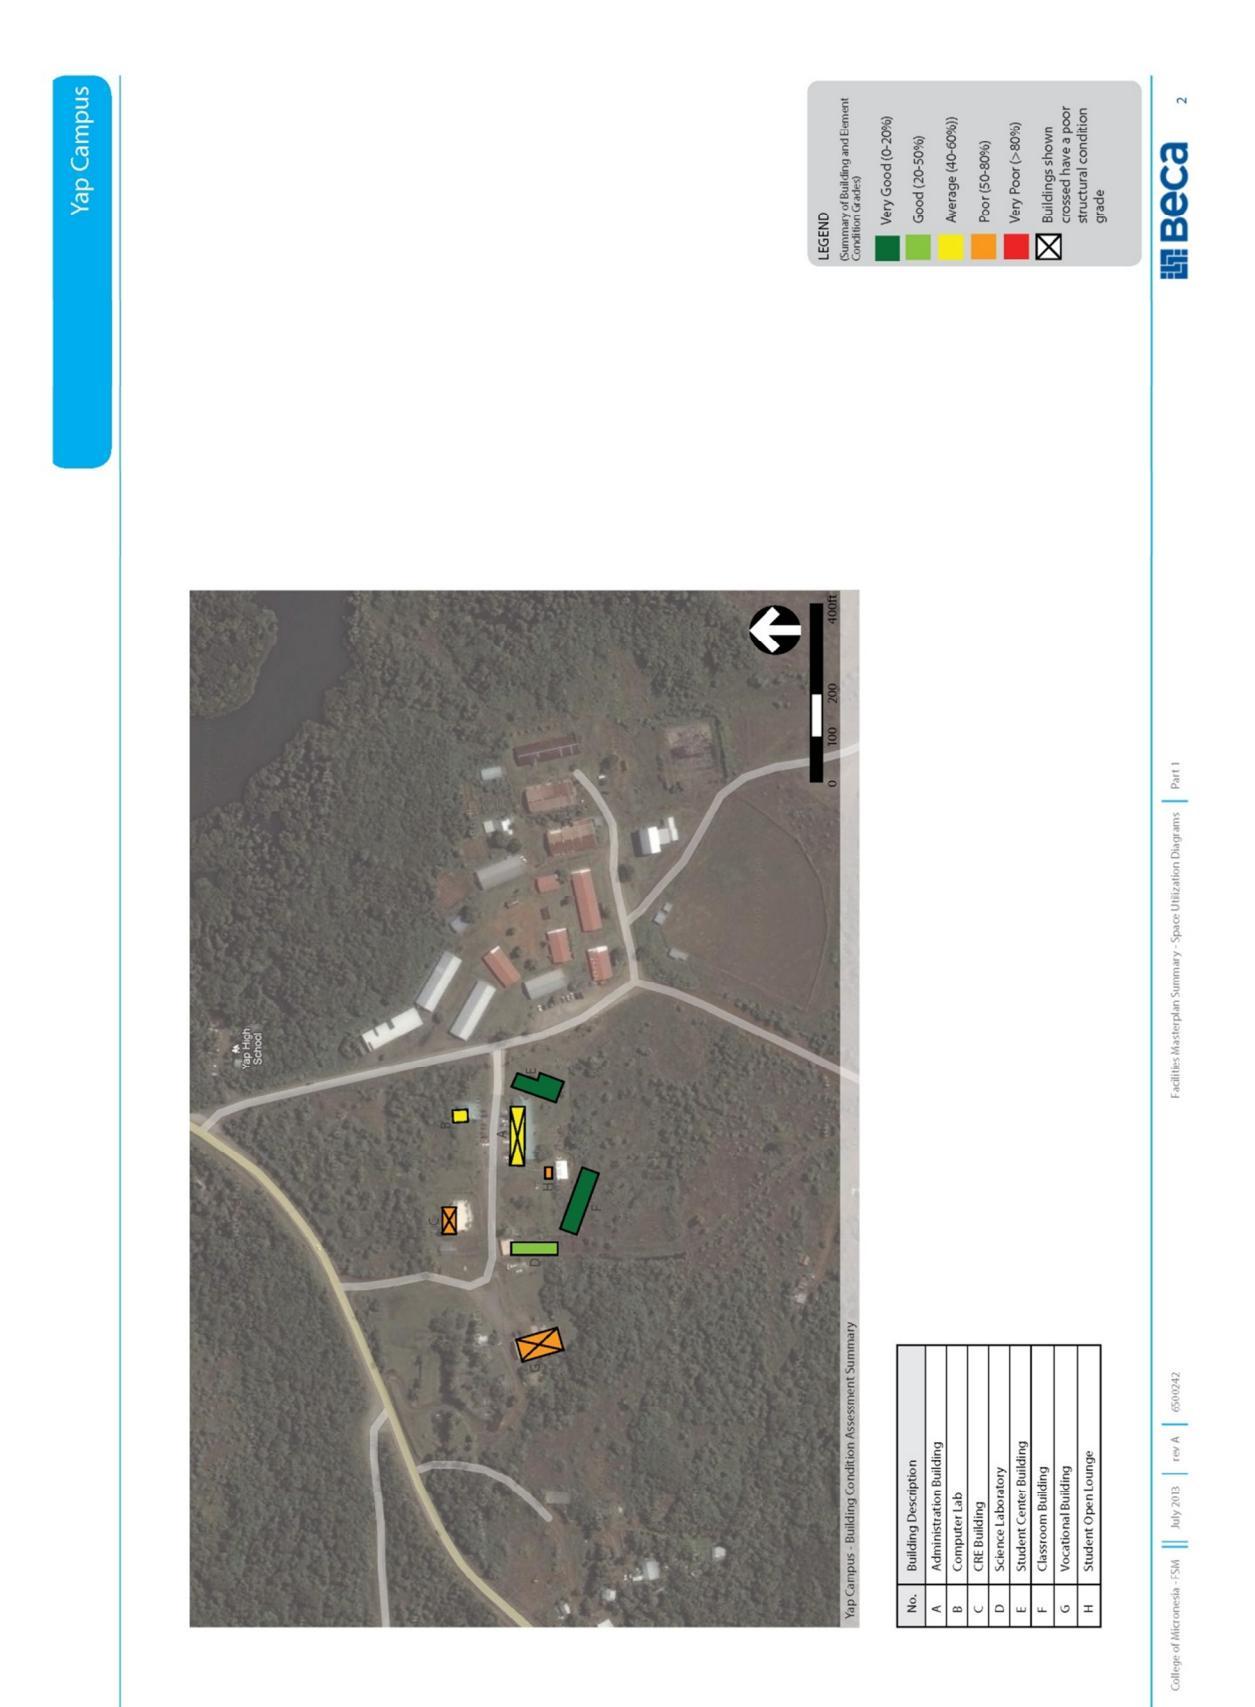
4.1.6.2 Campus condition grading summary plans

From our condition assessment of the Yap campus we observe the following:

- 1. Building A Administration Building. The severe corrosion of the steel substructure and decay ion the timber flooring makes this building, in our opinion, uneconomic to renew and maintain. We consider that minimum operational costs should be spent on this asset (i.e. carry out protection /health and safety remedial works only) and that the asset should be run-down and replaced in 2018 or before.

- 2. Building G Vocational Building has very high renewal and maintenance costs over the next 30 years (40% of Yap Year 1-10 renewal budget and 96% of full replacement cost over 30 years). In our view this building is uneconomic to renew and maintain. We consider that minimum operational costs should be spent on this asset (with the exception of any protection /health and safety remedial works) and that the asset should be run-down and replaced in 2018 or before.

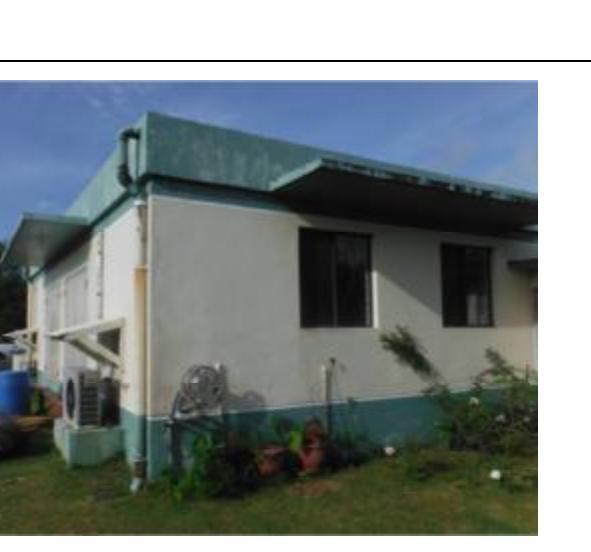
Observed Deterioration/Recommendations

Targeted regular maintenance and cleaning. Replace roof immediately. Refurbish floor finishes by 2023. Regularly maintain and replace mechanical, fire and special services by 2023.

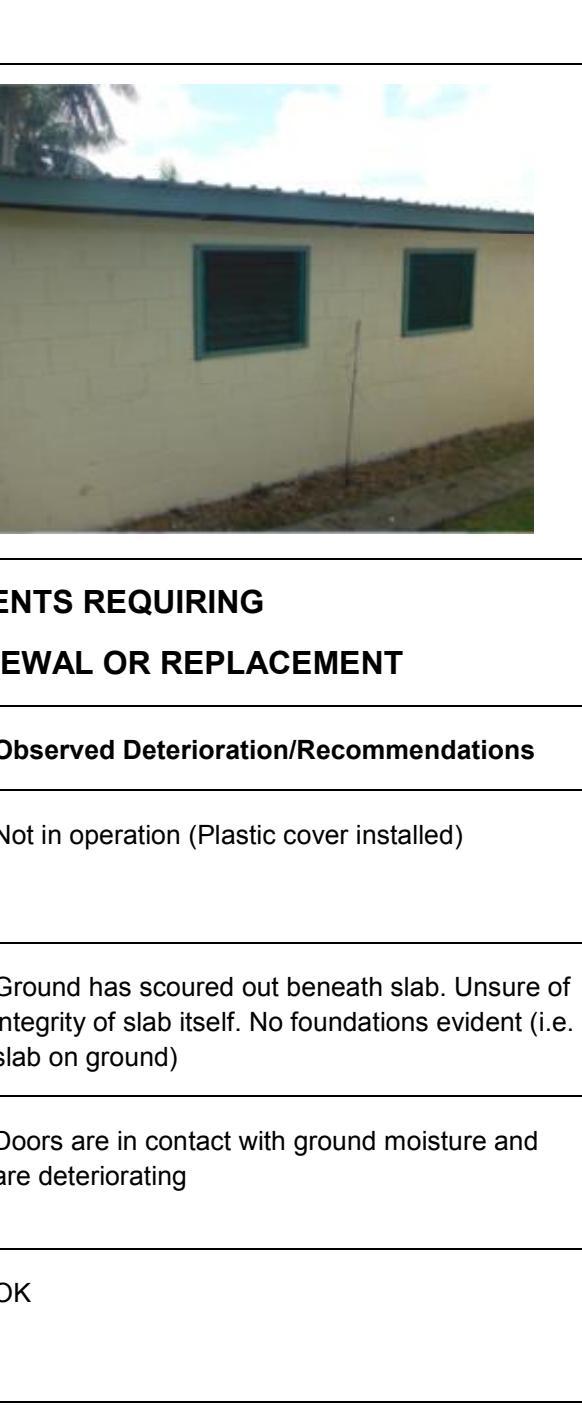
OK. MDF needs re-fixing to framing

Fargeted regular maintenance and cleaning. Replace sanitary fittings before 2023.
