College of Micronesia - FSM Space Utilization and Facilities Master Plan Study, Part 3 - Detailed Report for the FSM-FMI Campus

Prepared by Beca International Consultants Ltd (Beca)

28 November 2013

Building Condition Assessments

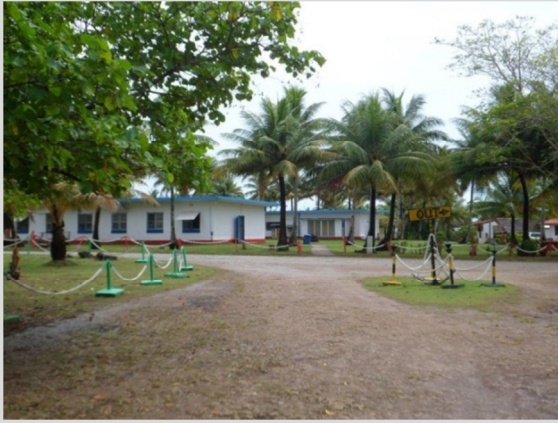
View across the road looking towards the southern wing of the male living quarters. Provide a formed walkway and rain shelter between both sides of the campus

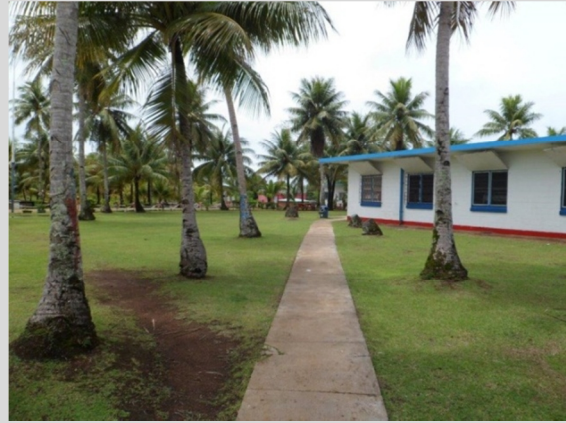
Informal path being formed to the security post - provide a formed walkway

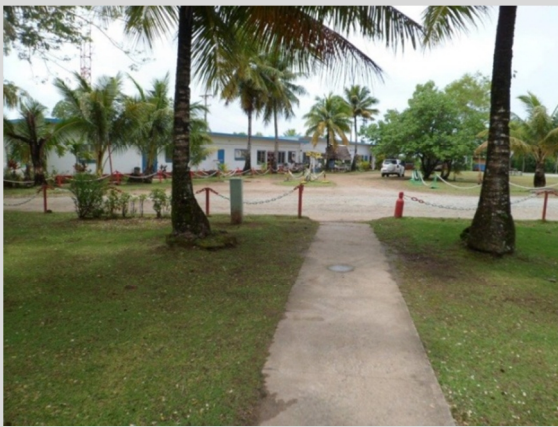
No link to a formed walkway on the classroom side of the campus

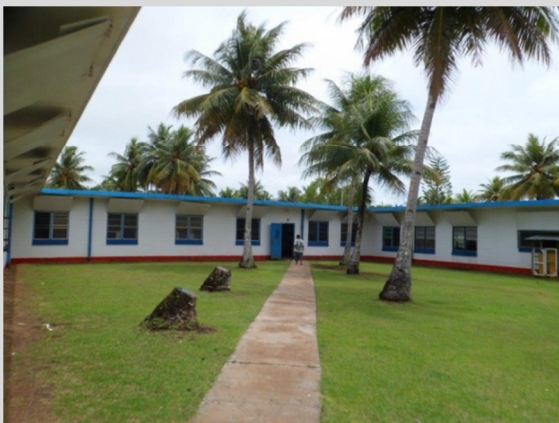
Coconut trees often line pathways. Replant coconut trees where they have

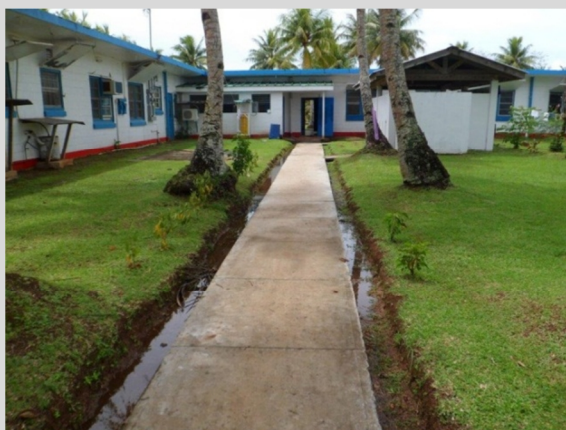
Drainage issues around the northern residential courtyard

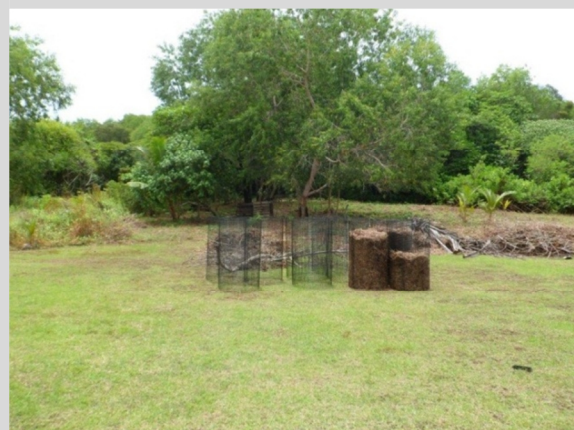
Potential to compost to reduce the amount of kitchen waste
